**NYC Department of Education
Building Condition Assessment Survey 2023-2024**

Architectural Inspection

Asset: P.S. 46 - BRONX, 2760 BRIGGS AVENUE, BRONX, NY, 10458

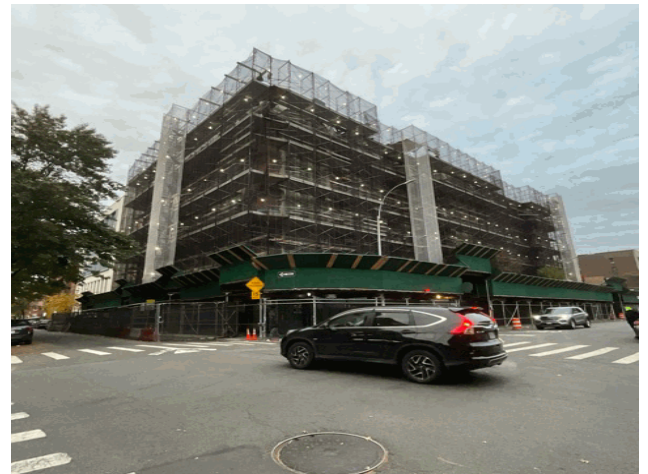
Corner of East 196th Street and Briggs Avenue - East View

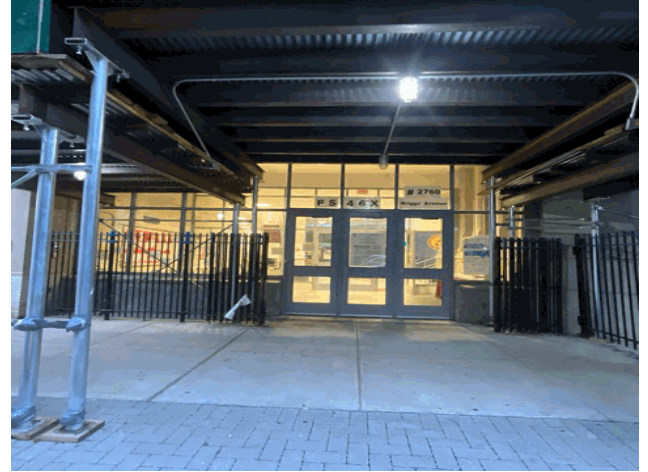
Facade B - Briggs Avenue
