**NYC Department of Education
Building Condition Assessment Survey 2023-2024**

Architectural Inspection

Asset: P.S. 53 - BRONX, 360 EAST 168 STREET, BRONX, NY, 10456

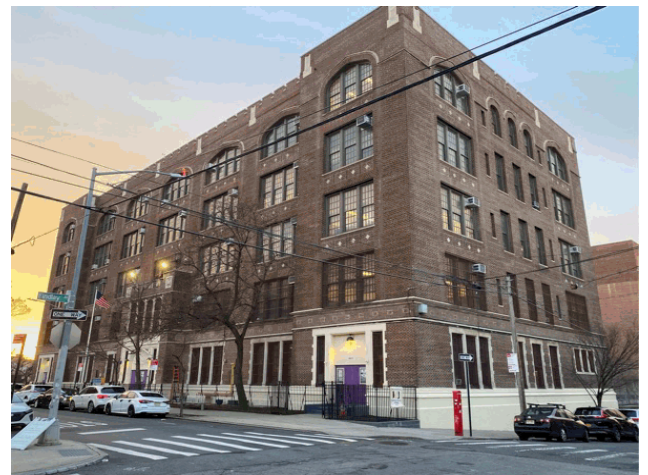
Corner of East 168th Street and Findlay Avenue - Southeast View

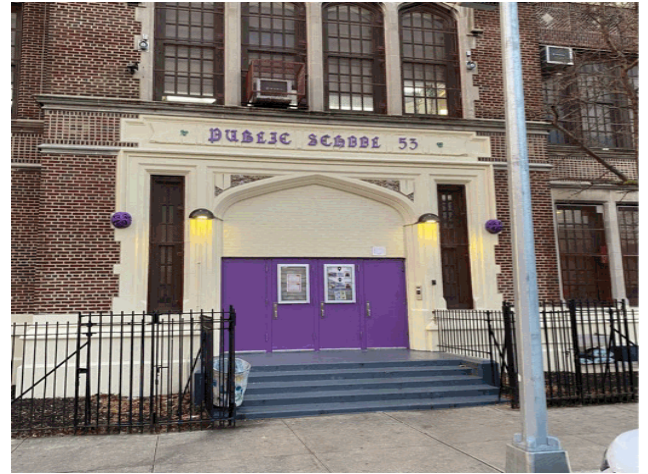
Facade A - East 168th Street

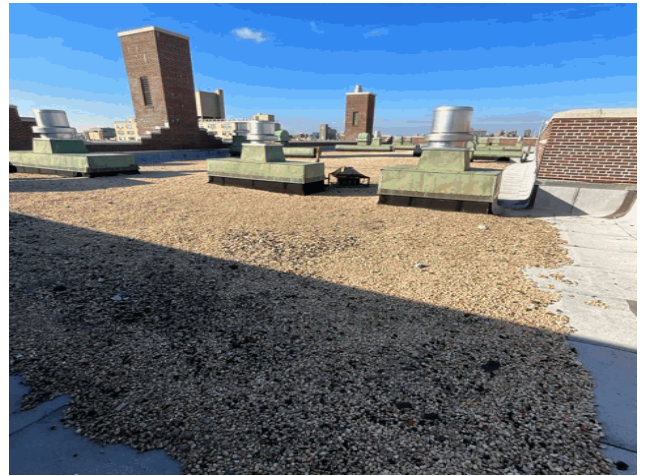
Roof 1 - West View
