**NYC Department of Education  
Building Condition Assessment Survey 2023-2024**

**Architectural Inspection**

**Asset: I.S. 201 - BRONX, 730 BRYANT AVENUE, BRONX, NY, 10474**

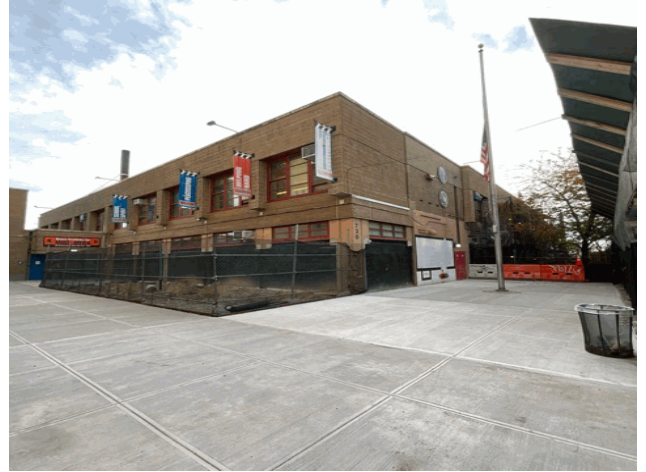
Facade Photo

Bryant Avenue - Southwest View

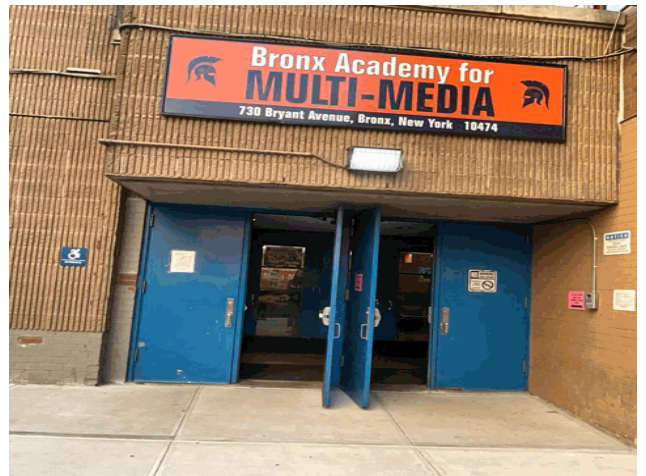
Main Entrance Photo

Facade A - Bryant Avenue

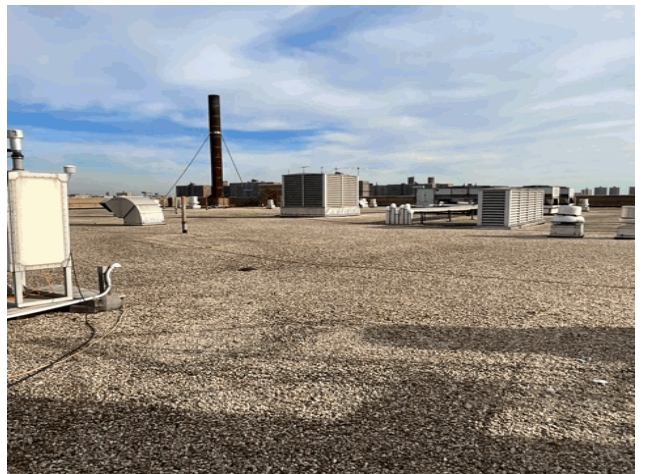
Roof Photo

Roof 1 - North view
