**NYC Department of Education
Building Condition Assessment Survey 2023-2024**

Architectural Inspection

Asset: P.S. 76 - BRONX, 900 ADEE AVENUE, BRONX, NY, 10469

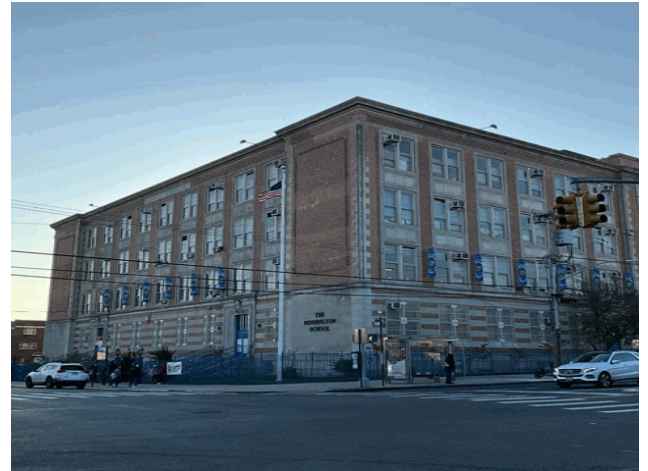
Corner of Adee Avenue and Radcliff Avenue - Southwest View

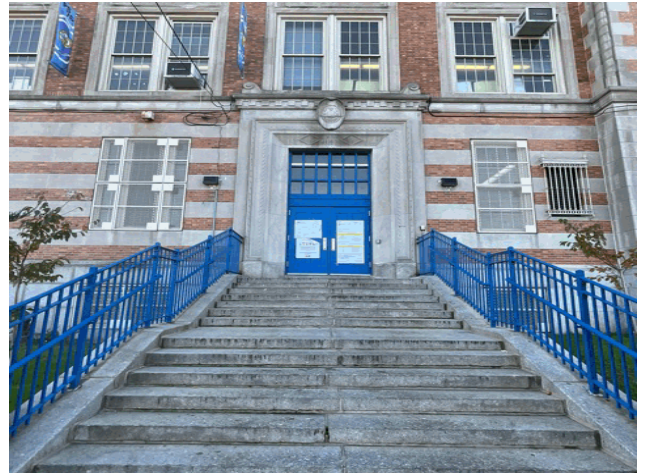
Facade A - Adee Avenue

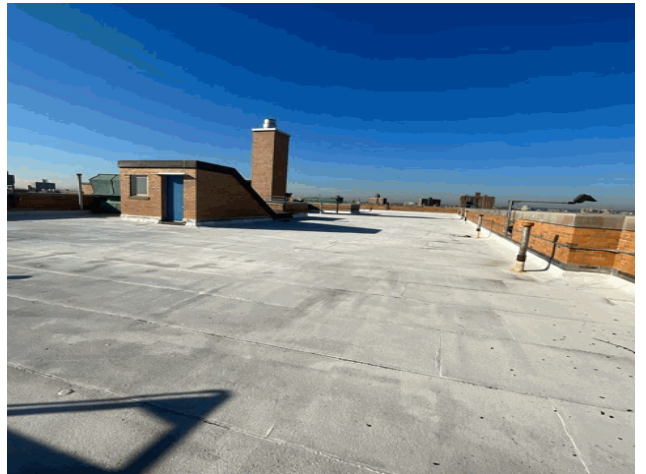
Roof1 - Southwest View
