**NYC Department of Education
Building Condition Assessment Survey 2023-2024**

Architectural Inspection

Asset: P.S. 88 - BRONX, 1340 SHERIDAN AVENUE, BRONX, NY, 10456

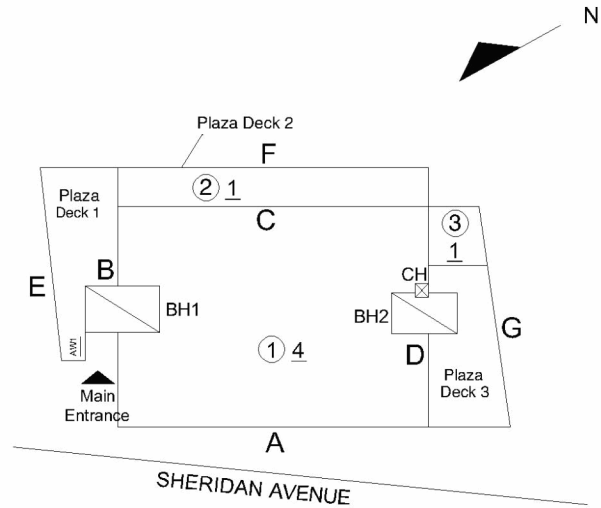
X088

Question	Response
Architectural	
EXTERIOR	Inspected
AREAWAY	Inspected
Instance on AW1	Inspected
Instance Condition	2- Between Good and Fair
Instance Quantity	1
Instance Quantity Uom	EACH
Deficiency	No deficiencies recorded
AWNINGS AND CANOPIES	Does not exist
CHIMNEY	Inspected
Material Type(s)	Masonry
Condition	2- Between Good and Fair
Deficiency	No deficiencies recorded
COPING	Inspected
Condition	3- Fair
Deficiency	STONE:CRACKED/BROKEN PIECES
Deficiency Location/Instance	
Deficiency Quantity	10
Quantity Uom	L.F.
Potential Action	REPLACE-IN-KIND
Urgency of Action	PRIORITY 4
Purpose of Action	LEVEL 2
