**NYC Department of Education
Building Condition Assessment Survey 2023-2024**

Architectural Inspection

Asset: P.S. 97 - BRONX, 2500 FISH AVENUE, BRONX, NY, 10469

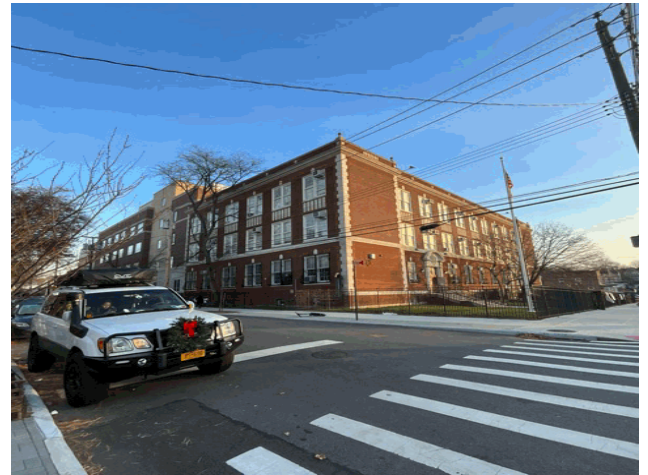
Corner of Fish Avenue and Mace Avenue - Southwest View

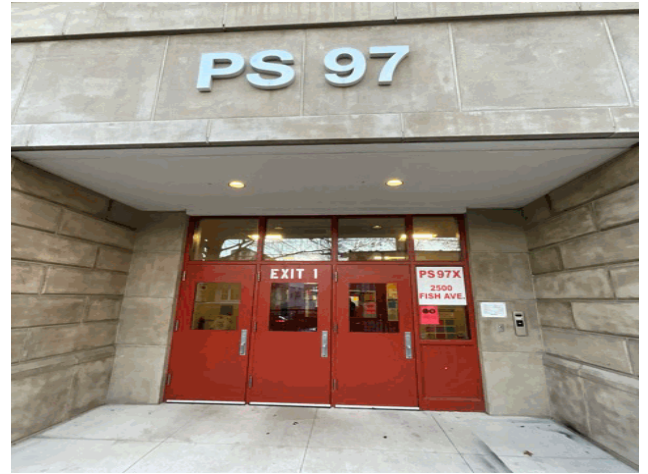
Facade A - Fish Avenue

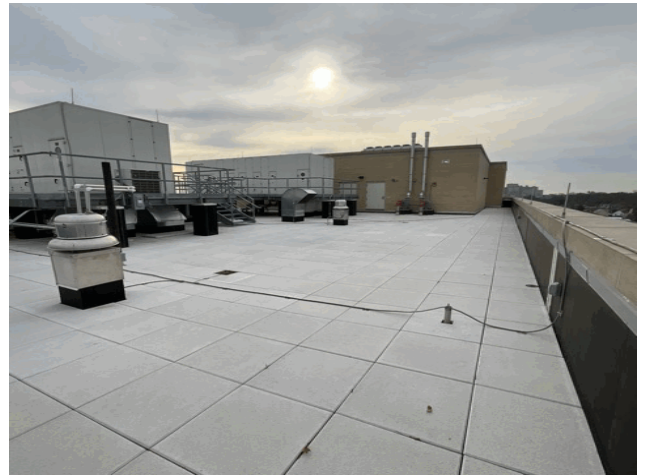
Roof 1 - South View
