**NYC Department of Education
Building Condition Assessment Survey 2023-2024**

Architectural Inspection

Asset: P.S. 109 - BRONX, 1771 POPHAM AVENUE, BRONX, NY, 10453

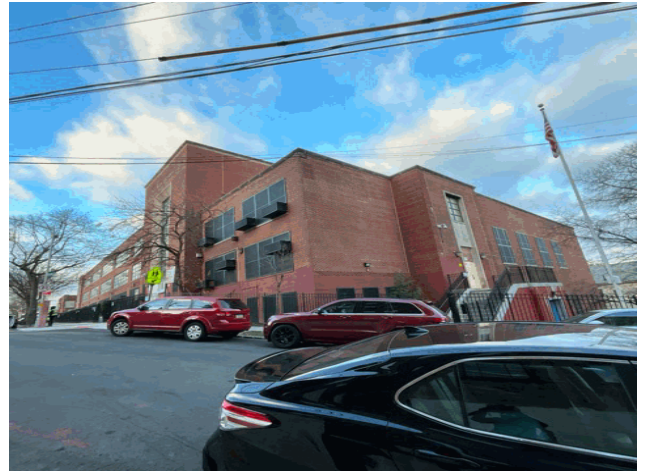
Corner of Popham Avenue and Palisades Place - Southwest view

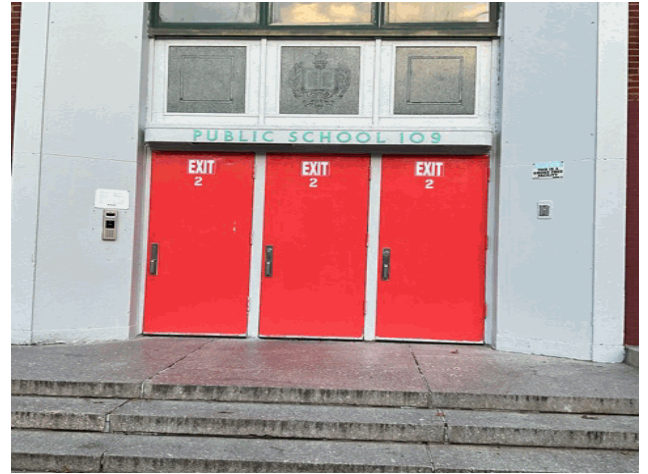
Facade A - Popham Avenue

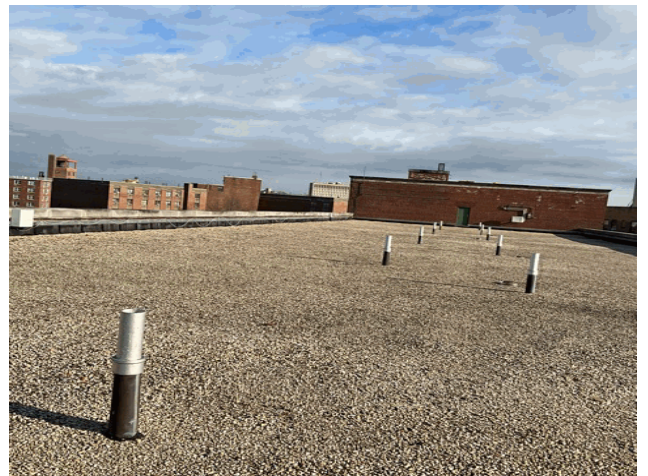
Roof 3 - Northeast View
