**NYC Department of Education
Building Condition Assessment Survey 2023-2024**

Architectural Inspection

X113

Asset: I.S. 113 - BRONX, 3710 BARNES AVENUE, BRONX, NY, 10467

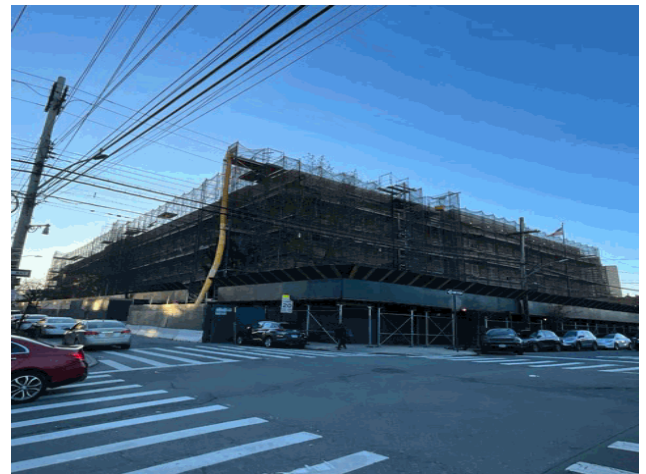
Corner of Barnes Avenue and East 217th Street - Northeast View

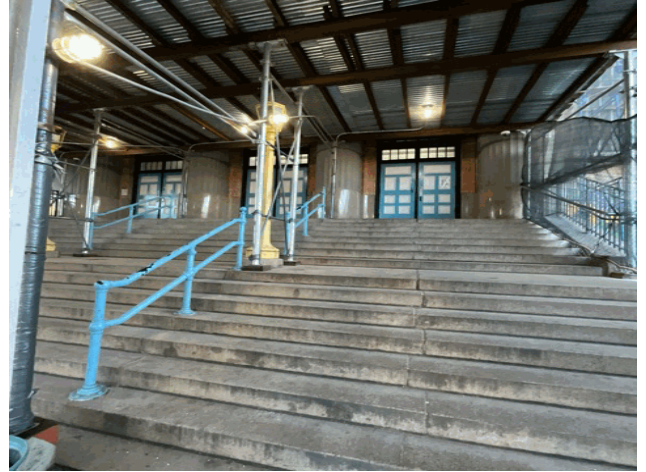
Facade A - Barnes Avenue

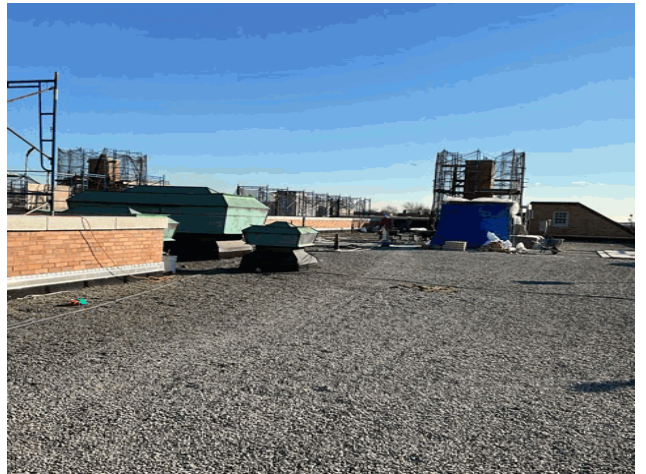
Roof 9 - View East
