**NYC Department of Education
Building Condition Assessment Survey 2023-2024**

Architectural Inspection

Asset: P.S. 119 - BRONX, 1075 PUGSLEY AVENUE, BRONX, NY, 10472

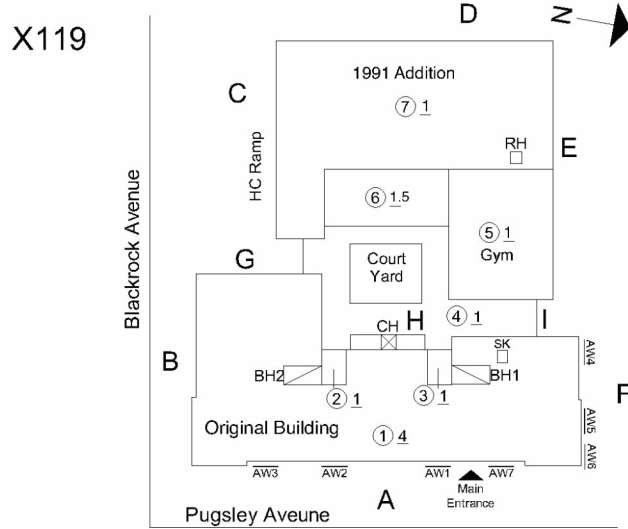
Question	Response
Architectural	
EXTERIOR	Inspected
AREAWAY	Inspected
Instance on AW1-AW7	Inaccessible
Instance Quantity	7
Instance Quantity Uom	EACH
AWNINGS AND CANOPIES	Does not exist
CHIMNEY	Inspected
Material Type(s)	Masonry
Condition	3- Fair
Deficiency	BRICK:DETERIORATED JOINTS
Deficiency Location/Instance

Deficiency Quantity	450
Quantity Uom	S.F.
Potential Action	REPOINT
Urgency of Action	PRIORITY 3
Purpose of Action	LEVEL 2
Deficiency Photo 1
