**NYC Department of Education
Building Condition Assessment Survey 2023-2024**

Architectural Inspection

Asset: I.S. 301 - BRONX, 890 CAULDWELL AVENUE, BRONX, NY, 10456

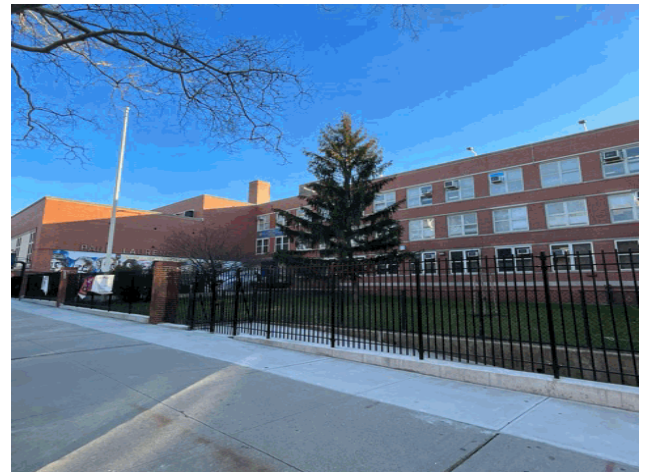
| Question | Answer |
|---|---|
| Facade Photo | |

Cauldwell Avenue - Northeast View

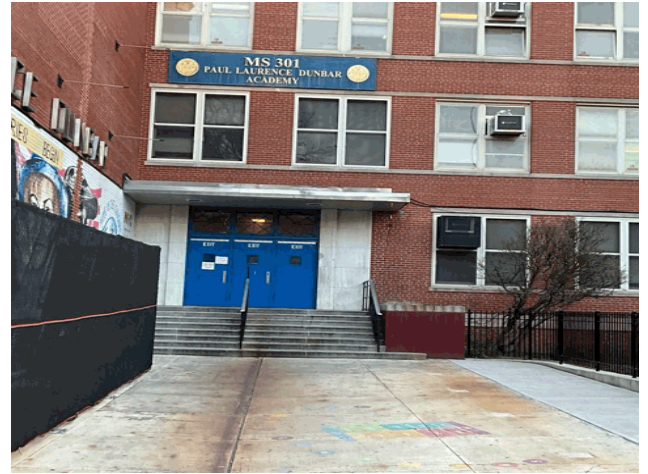
Main Entrance Photo

Facade A - Cauldwell Avenue

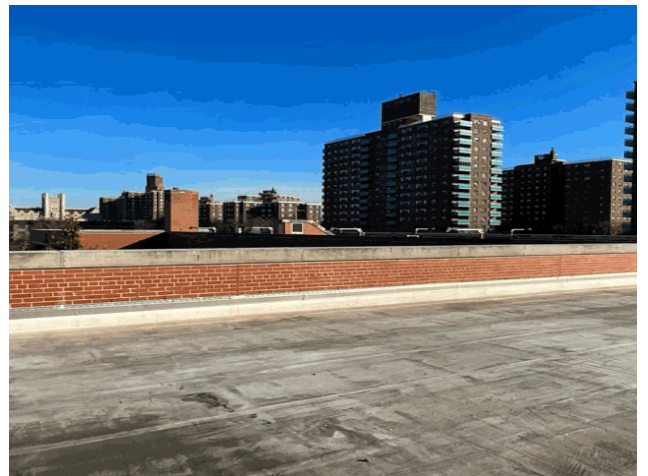
Roof Photo

Roof 1 - Northeast View
