**NYC Department of Education
Building Condition Assessment Survey 2023-2024**

Architectural Inspection

Asset: I.S. 135 - BRONX, 2441 WALLACE AVENUE, BRONX, NY, 10467

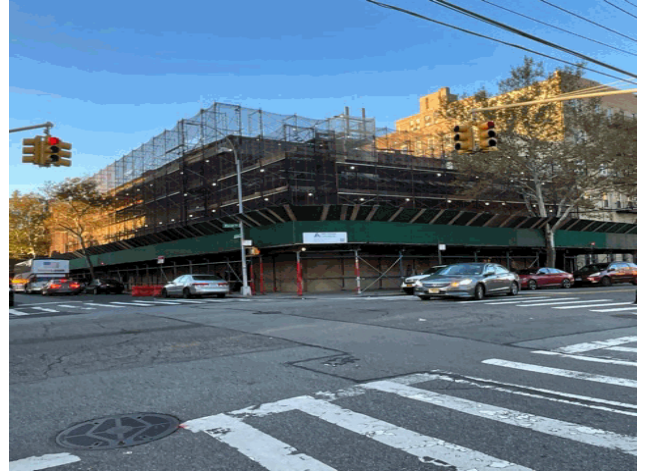
Corner of Mace Avenue and Wallace Avenue - Southeast View

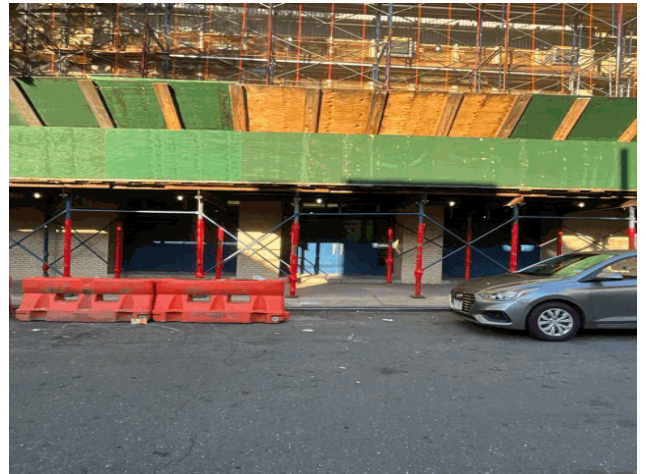
Facade A - Wallace Avenue

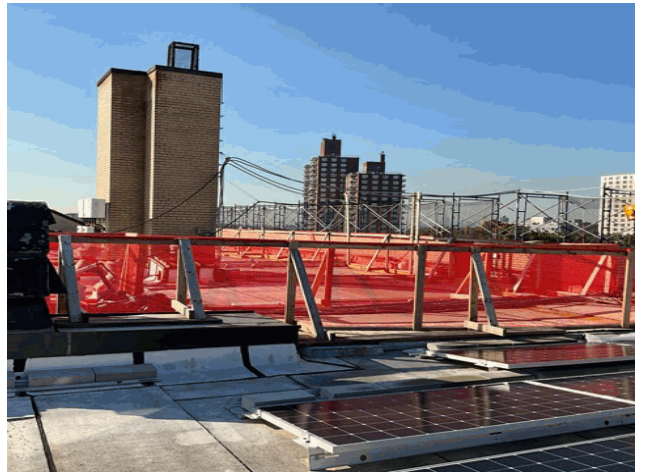
Roof 1 - South View
