**NYC Department of Education  
Building Condition Assessment Survey 2023-2024**

**Architectural Inspection**

**X160**

**Asset: P.S. 160 - BRONX, 4140 HUTCHINSON RIVER PARKWAY EAST, BRONX, NY, 10475**

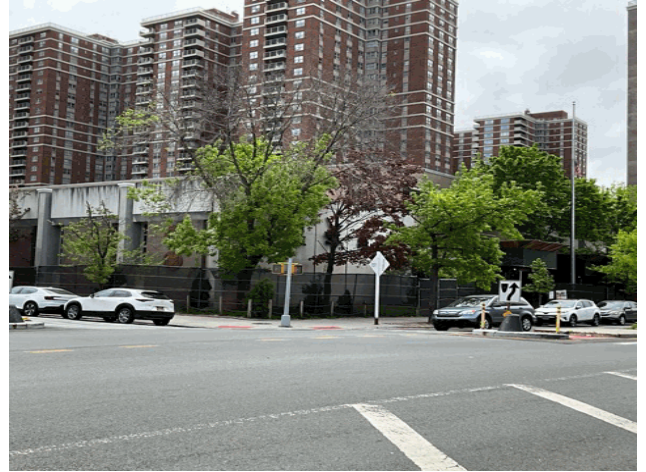
Facade Photo

The corner of Hutchinson River Parkway East and Einstein Loop South - South View

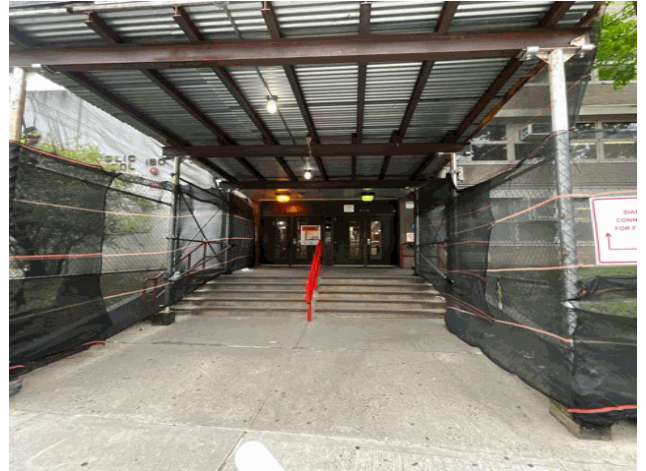
Main Entrance Photo

Facade A - Hutchinson River Parkway East

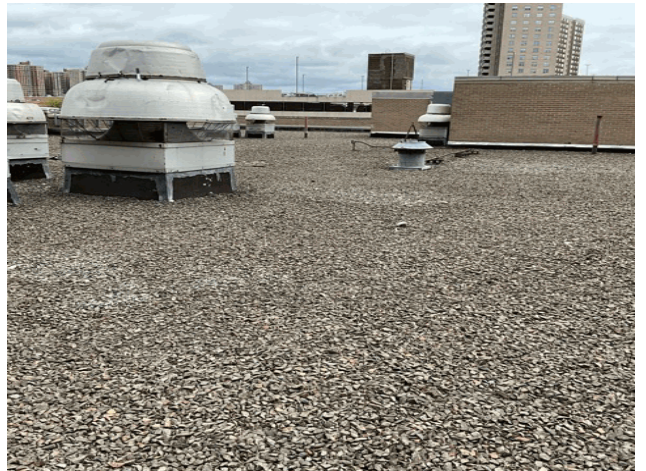
Roof Photo

Roof 7 - Northwest view
