**NYC Department of Education
Building Condition Assessment Survey 2023-2024**

Architectural Inspection

X166

Asset: I.S. 166 - BRONX, 250 EAST 164 STREET, BRONX, NY, 10456

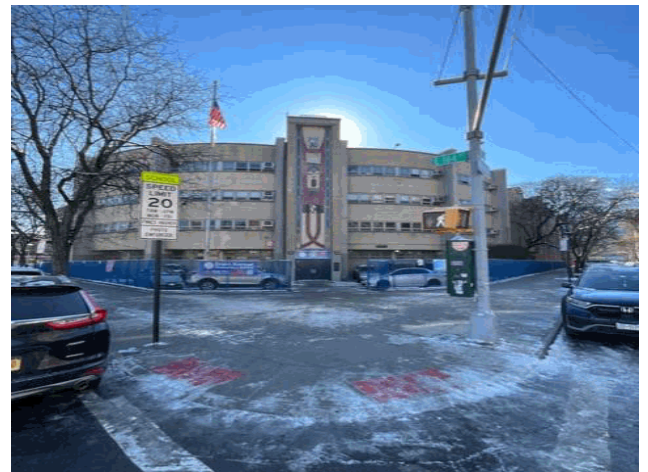
Corner of East 164th Street and Grant Avenue - South View

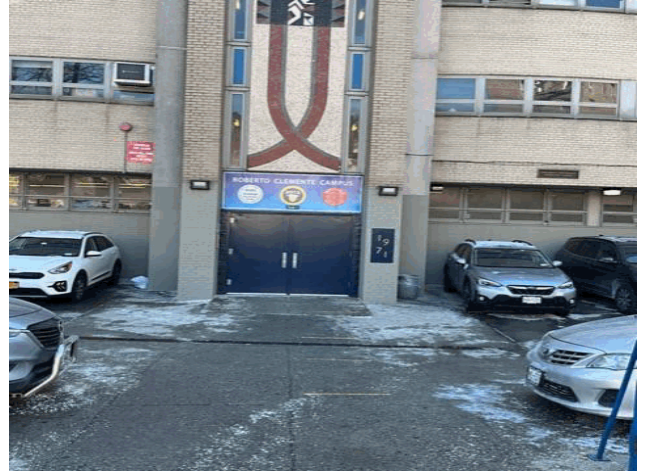
Facade A - East 164th Street

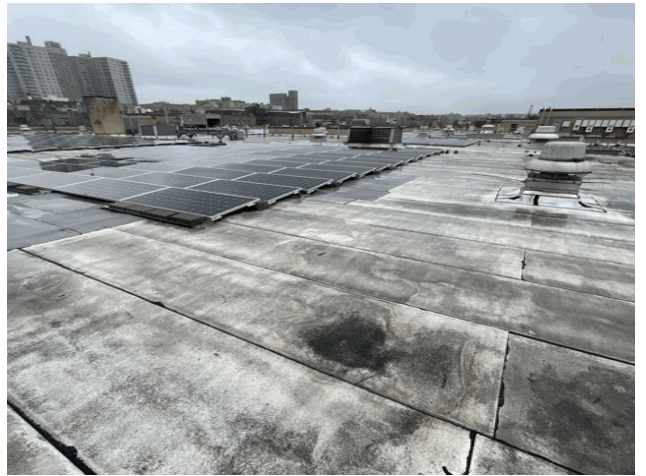
Roof 1 - North View
