**NYC Department of Education
Building Condition Assessment Survey 2023-2024**

Architectural Inspection

Asset: P.S. 236 - BRONX, 1871 WALTON AVENUE, BRONX, NY, 10453

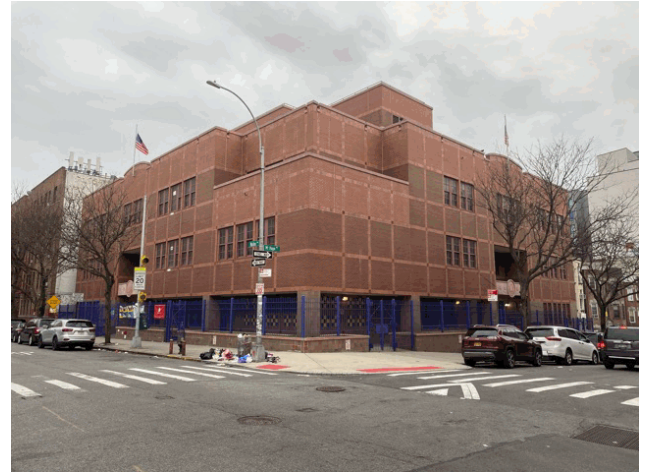
| Question | Answer |
|--|---|
| Facade Photo | |

Corner of Walton Avenue and Mt. Hope Place - Southwest View

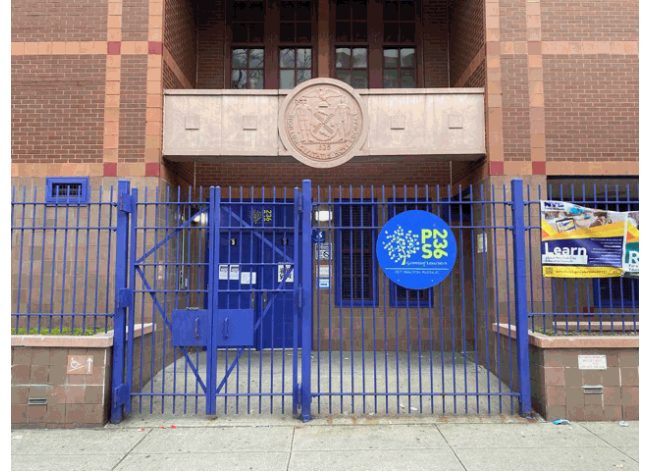
Main Entrance Photo

Facade A - Walton Avenue

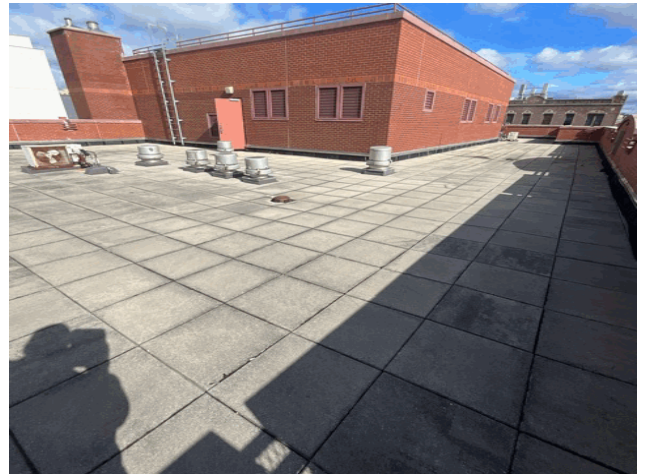
Roof Photo

Roof 1 - Northwest View
