NYC Department of Education
Building Condition Assessment Survey 2023-2024

Architectural Inspection

X174

Asset: I.S. 174 - BRONX, 456 WHITE PLAINS ROAD, BRONX, NY, 10473

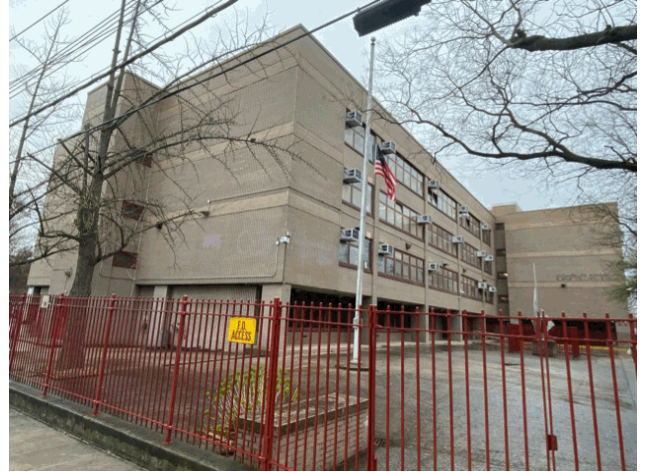
Facade Photo

Corner of White Plains Road and Lacombe Avenue - Southeast View

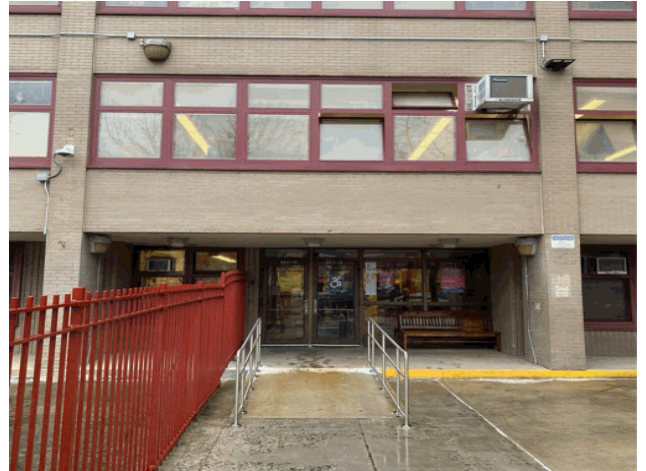
Main Entrance Photo

Facade A - White Plains Road

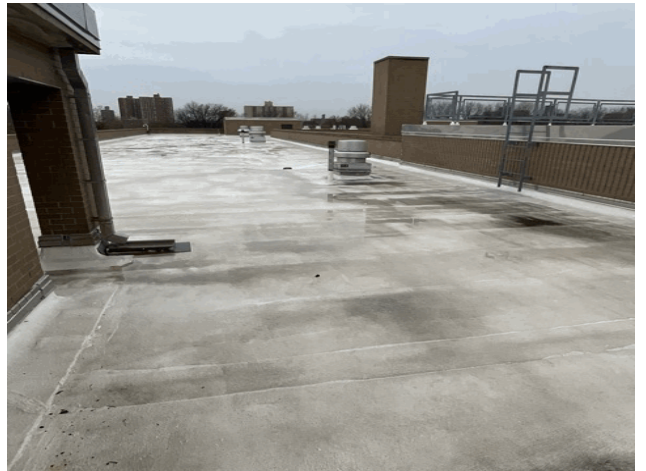
Roof Photo

Roof 1 - North View
