**NYC Department of Education
Building Condition Assessment Survey 2023-2024**

Architectural Inspection

X175

Asset: P.S. 175 - BRONX, 200 CITY ISLAND AVENUE, BRONX, NY, 10464

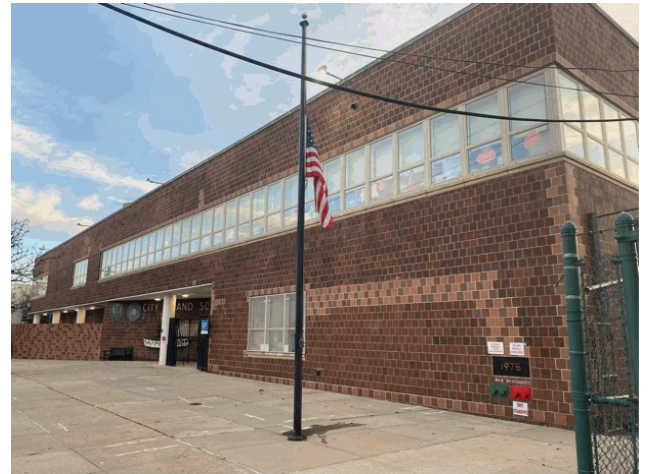
City Island Avenue - Northeast View

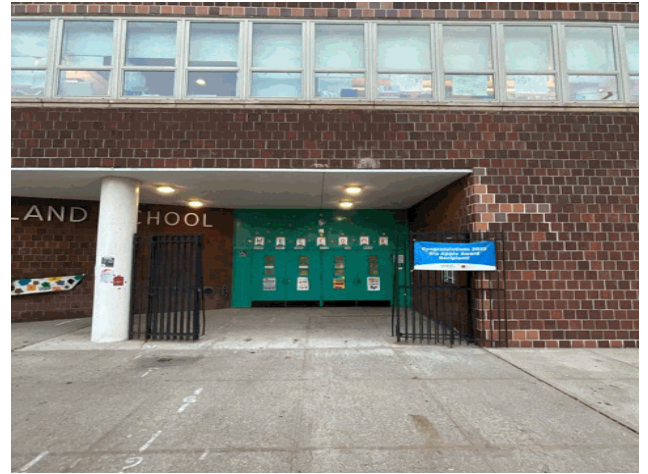
Facade A - City Island Avenue

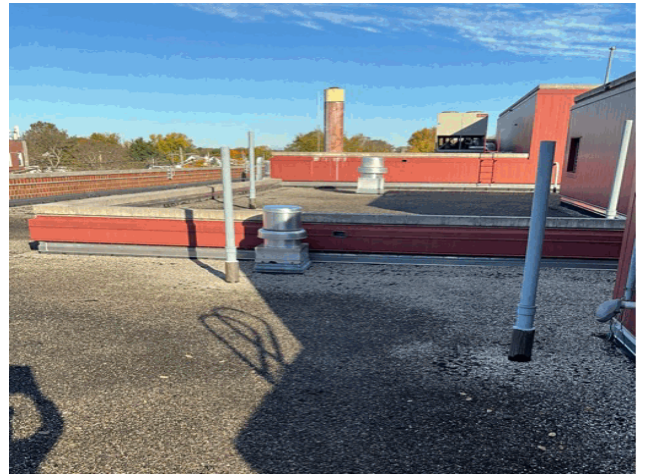
Roof 1 - South View
