**NYC Department of Education  
Building Condition Assessment Survey 2023-2024**

**Architectural Inspection**

**X184**

**Asset: I.S. 184 - BRONX, 778 FOREST AVENUE, BRONX, NY, 10456**

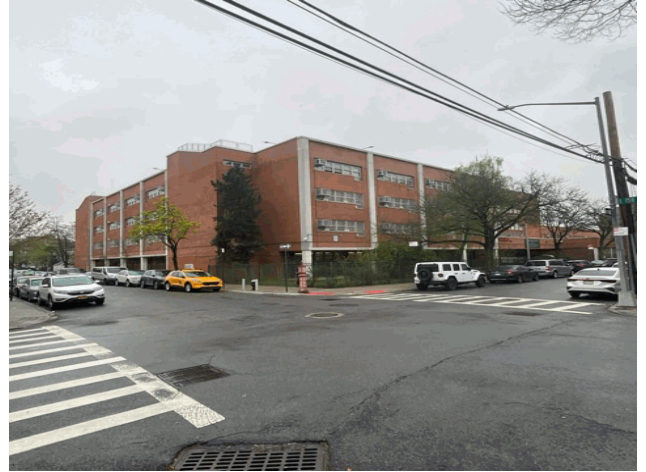
Corner of Forrest Avenue and East 158th Street - Southeast View

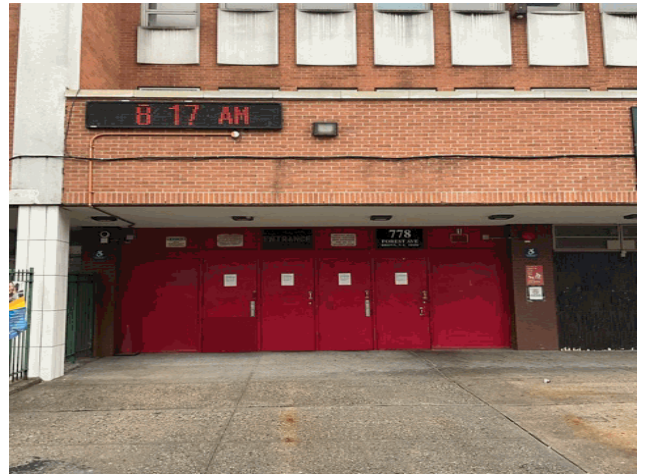
Facade A - Forrest Avenue

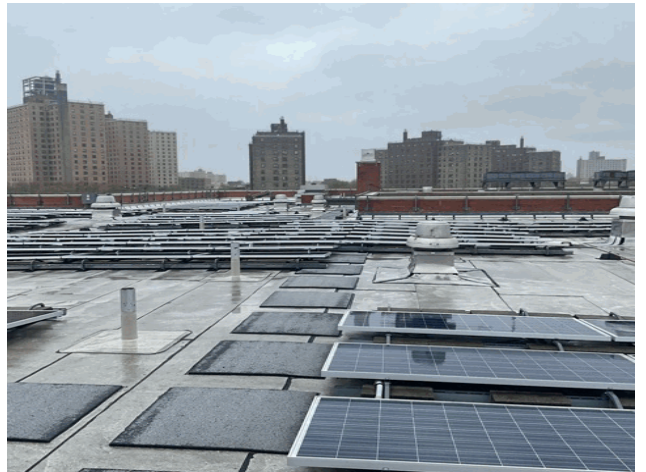
Roof 1 - South View
