**NYC Department of Education
Building Condition Assessment Survey 2023-2024**

Architectural Inspection

Asset: P.S. 198 - BRONX, 1180 TINTON AVENUE, BRONX, NY, 10456

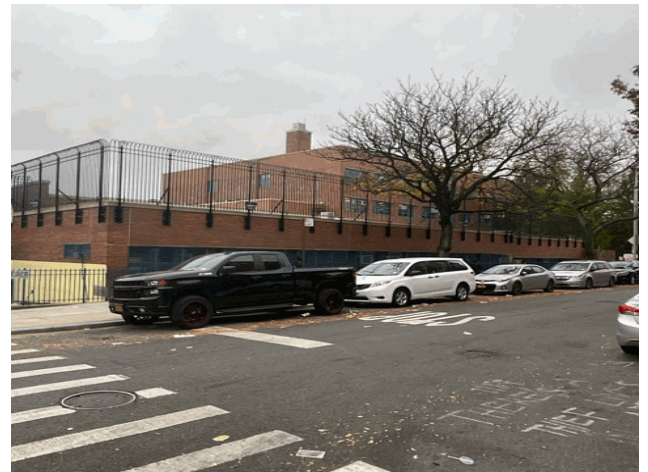
The corner of Tinton Avenue and East 168th Street - Southeast view

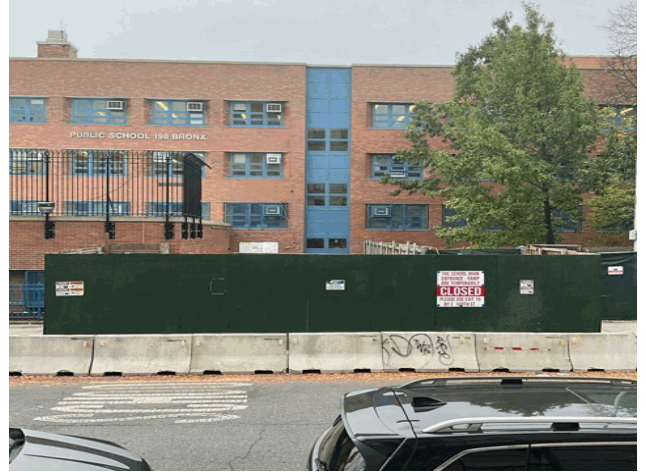
Facade A - Tinton Avenue

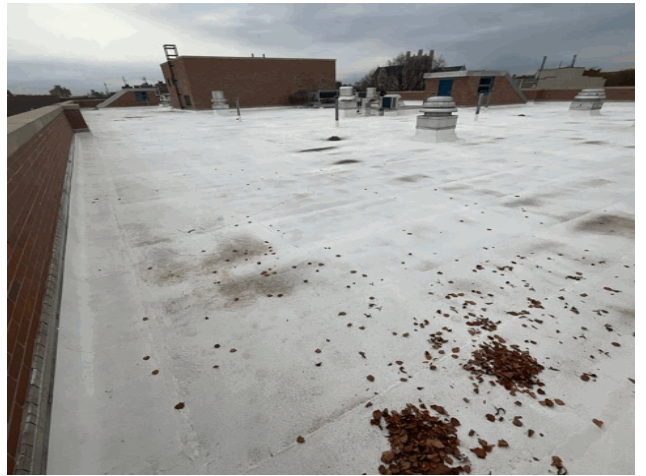
Roof 1 - Southwest view
