**NYC Department of Education
Building Condition Assessment Survey 2023-2024**

Architectural Inspection

Asset: I.S. 206B - BRONX, 2280 AQUEDUCT AVENUE, BRONX, NY, 10468

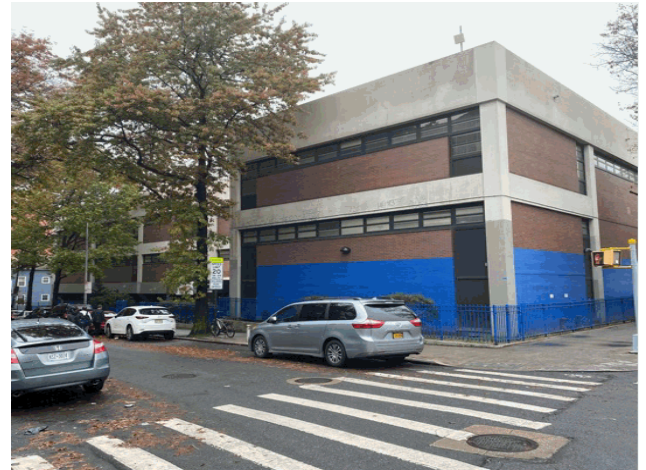
Corner of Aquaduct Ave and West 183rd Street - Northeast View

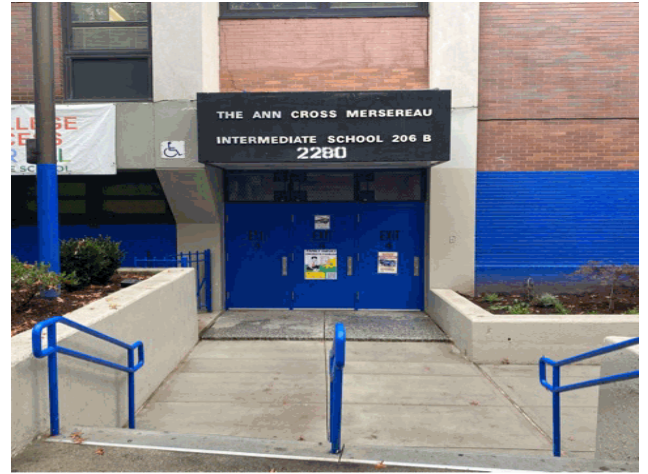
Facade A - Aqueduct Avenue

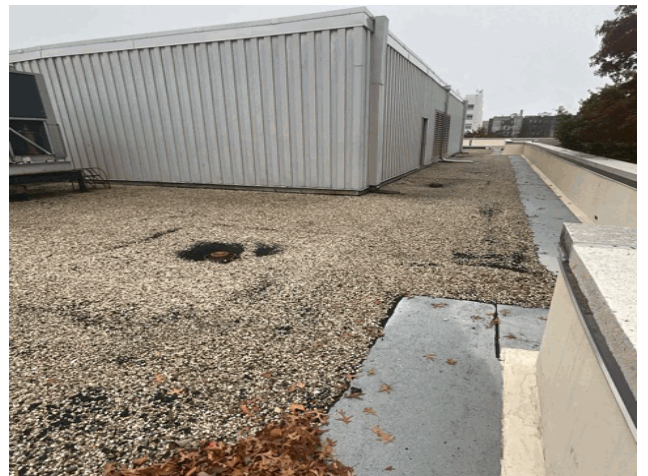
Roof 1 - South View
