**NYC Department of Education  
Building Condition Assessment Survey 2023-2024**

**Mechanical Inspection**

**X279**

**Asset:** P.S. 279 - BRONX, 2100 WALTON AVENUE, BRONX, NY, 10453

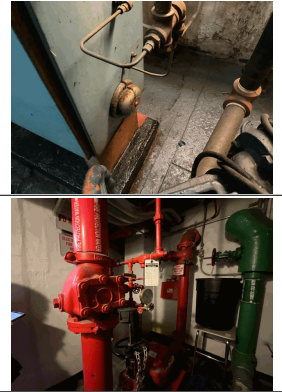
Yes	Defective Boiler Safety Auxiliary	Boiler Safety Control Alarm Bell is not audible	Burner/Burner Control Panel	Boiler Room @ Boiler #2	Angel Ortiz	Fireman
Yes	Defective Sprinkler/Standpipe System	Defective	Wet Sprinkler Alarm Valve Assembly	Basement - Gas/Water Meter Room B06A/B	Angel Ortiz	Fireman
