**NYC Department of Education  
Building Condition Assessment Survey 2023-2024**

**Architectural Inspection**

**X285**

**Asset:** HIGHBRIDGE ENVIRONMENTAL EDUCATION CAMPUS - BRONX, 200 WEST 167 STREET, BRONX, NY, 10452

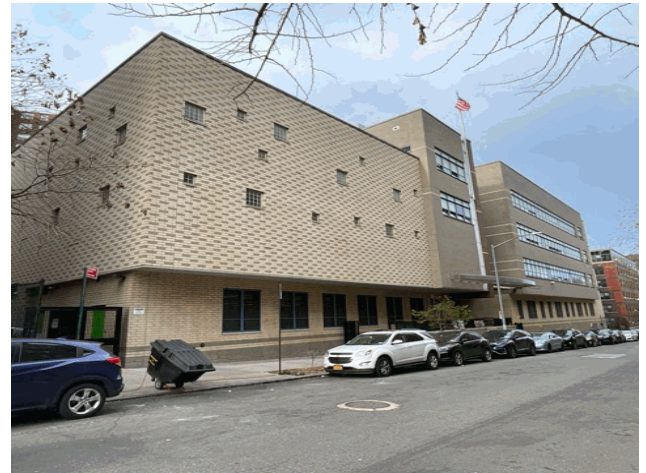
| Question | Answer |
|--|--|
| Facade Photo | |

Corner of West 167th Street and University Avenue - Northwest View

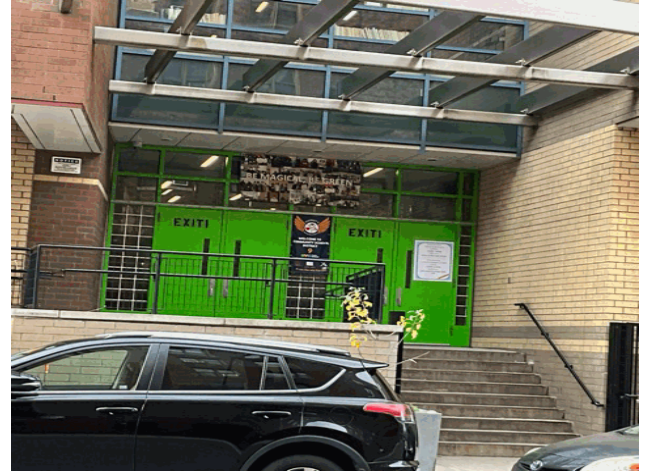
Main Entrance Photo

Facade A - West 167th Street

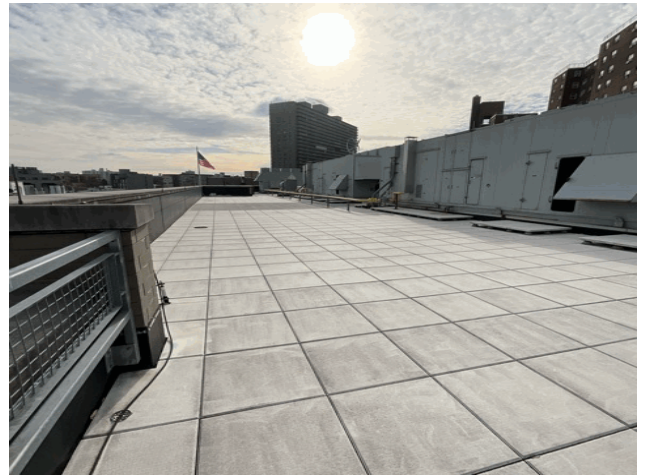
Roof Photo

Roof 1 - South View
