**NYC Department of Education
Building Condition Assessment Survey 2023-2024**

Architectural Inspection

X292

Asset: THE DOMINIC CASTORE EDUCATIONAL COMPLEX - BRONX, 800 LYDIG AVENUE, BRONX, NY, 10462

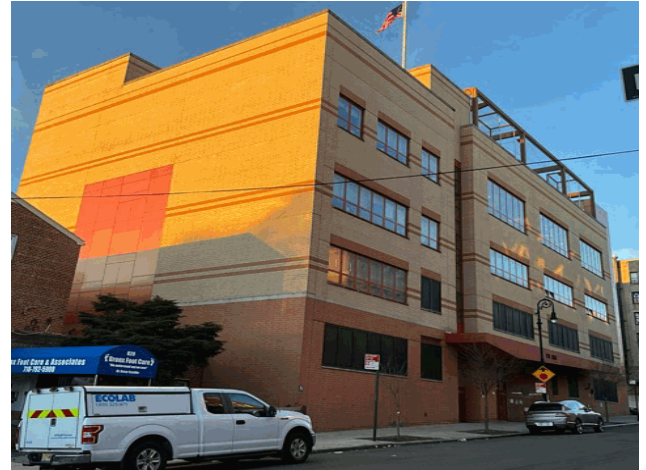
Lydig Avenue - Northeast View

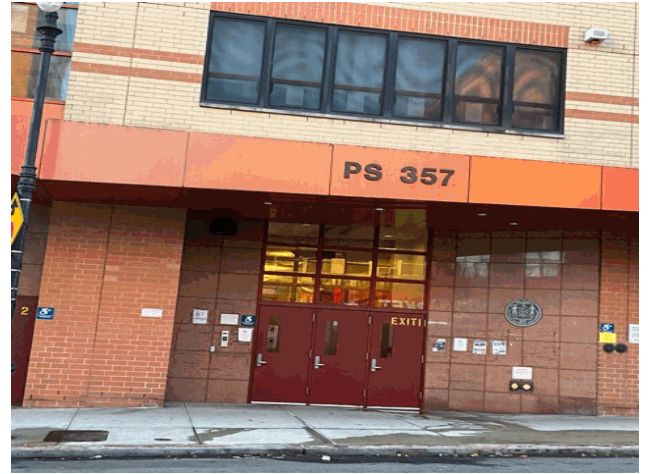
Facade A - Lydig Avenue

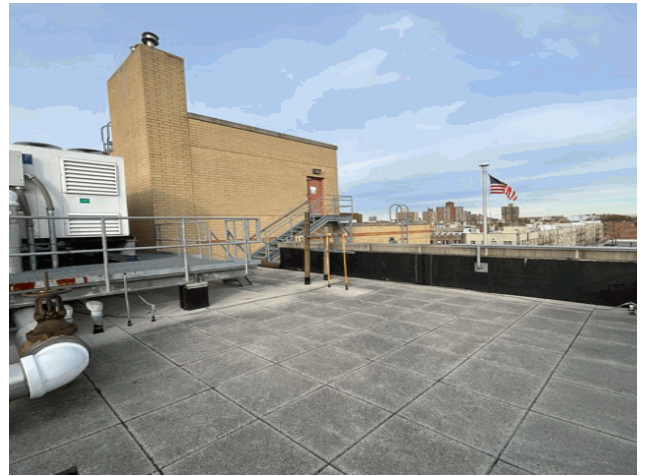
Roof 4 - West View
