NYC Department of Education
Building Condition Assessment Survey 2023-2024

Architectural Inspection

Asset: HERBERT H. LEHMAN HS - BRONX, 3000 EAST TREMONT AVENUE, BRONX, NY, 10461

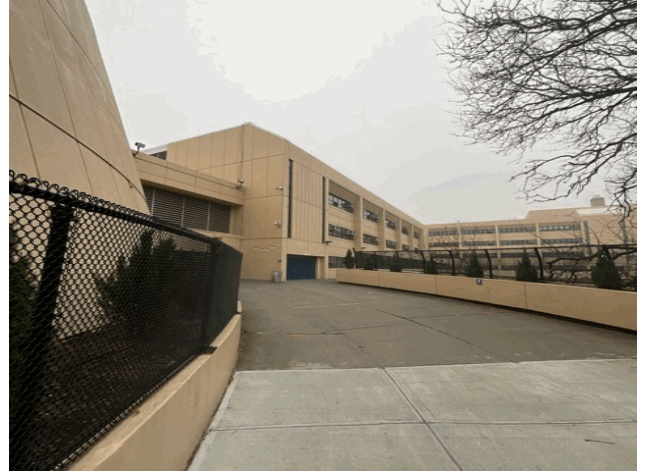
Corner of East Tremont Avenue and Hutchinson River Parkway - Southwest View

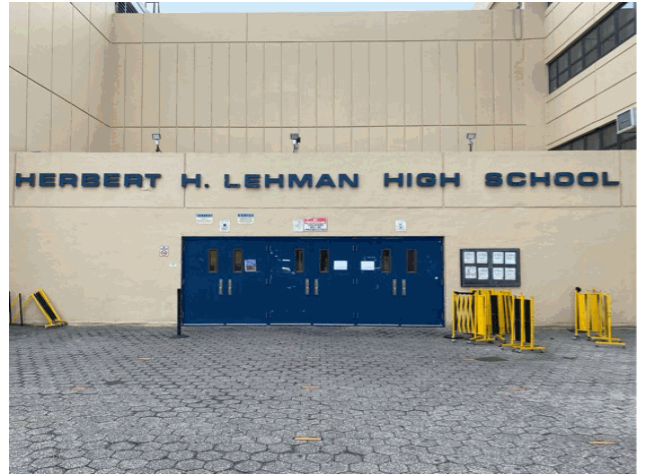
Facade A - East Tremont Avenue

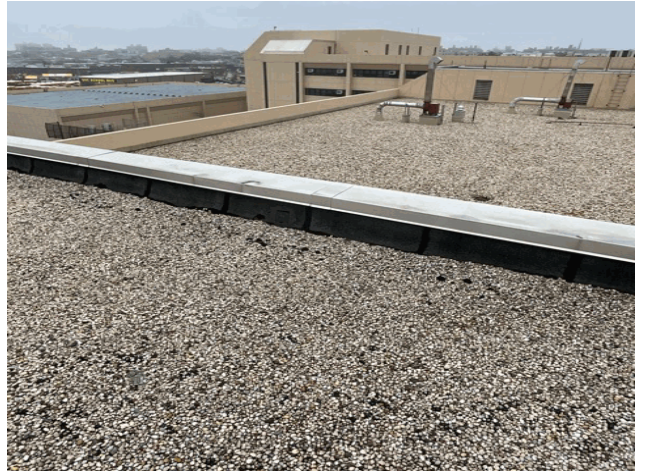
Roof 10 - Southwest View
