**NYC Department of Education
Building Condition Assessment Survey 2023-2024**

Architectural Inspection

X416

Asset: COLUMBUS HS AF - BRONX, 925 ASTOR AVENUE, BRONX, NY, 10469

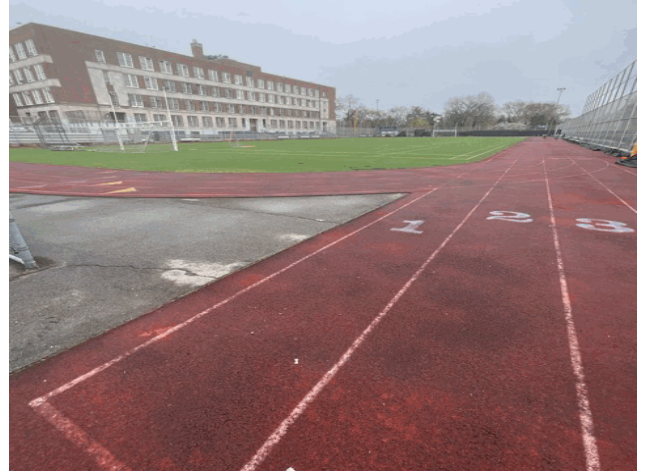
Facade Photo

Waring Avenue - Southeast View

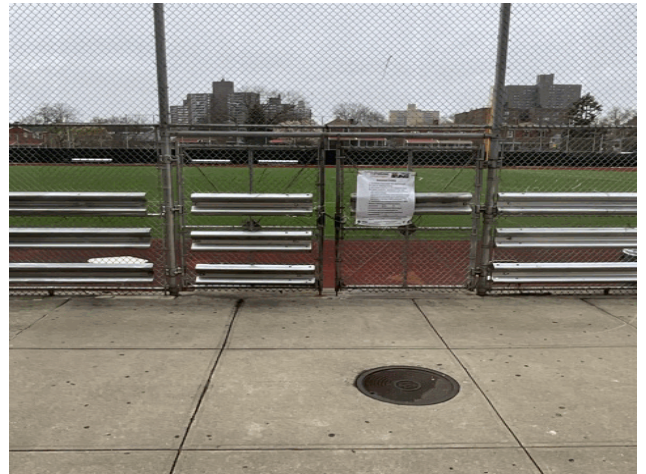
Main Entrance Photo

Main Entrance - West View from Driveway

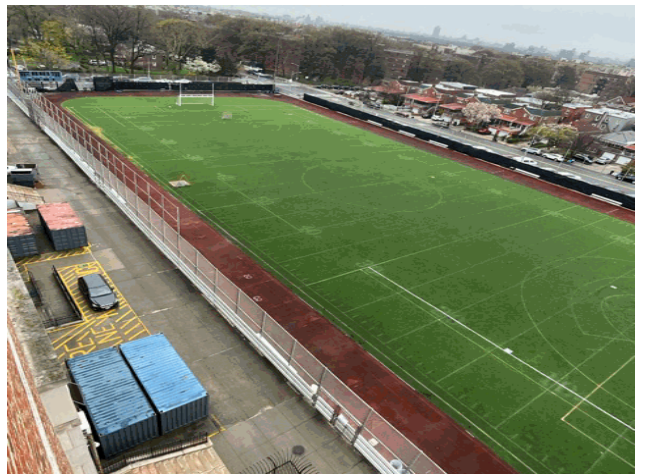
Roof Photo

Athletic Field - Southwest View from Main Asset X415
