Building Condition Assessment Survey 2023-2024

Architectural Inspection X456

Asset:	TRUMAN HS AF - BRONX, 750 BAYCHESTER AVENUE, BRONX, NY, 10475		
Inspection Id	Inspection Type	Time In	Last Edited
1542	ARCHITECTURAL - SENIOR	2023-12-08 07:00AM	2024-01-24 12:55PM
1549	ARCHITECTURAL - ASSOCIATE	2023-12-08 01:27PM	2024-05-06 04:06PM
seet Data

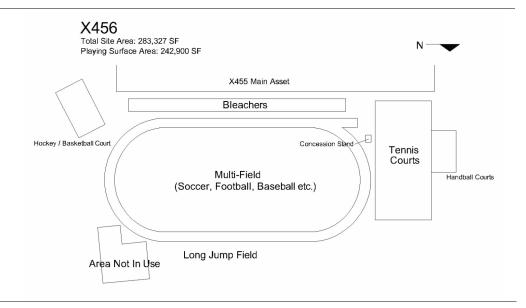
NATURAL TURF:DAMAGED/WORN OUT

Football and Soccer Field

Purpose of Action Deficiency Photo 1 S.F. REPLACE PRIORITY 4
