**NYC Department of Education
Building Condition Assessment Survey 2023-2024**

Architectural Inspection

X460

Asset: HS OF LAW, GOV'T & JUSTICE - BRONX, 244 EAST 163 STREET, BRONX, NY, 10451

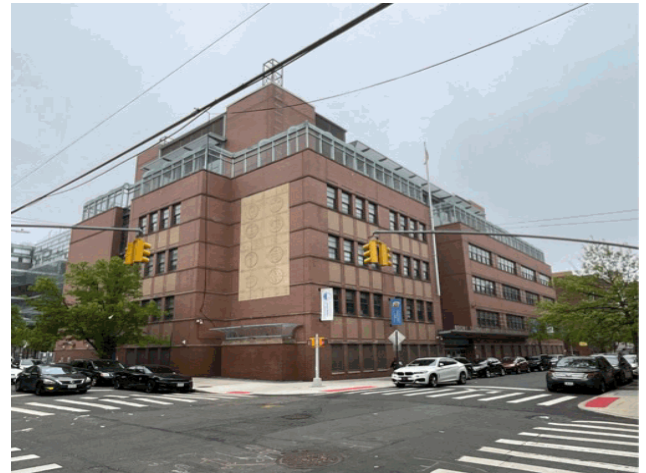
Corner of Grant Avenue and East 163rd Avenue - West View

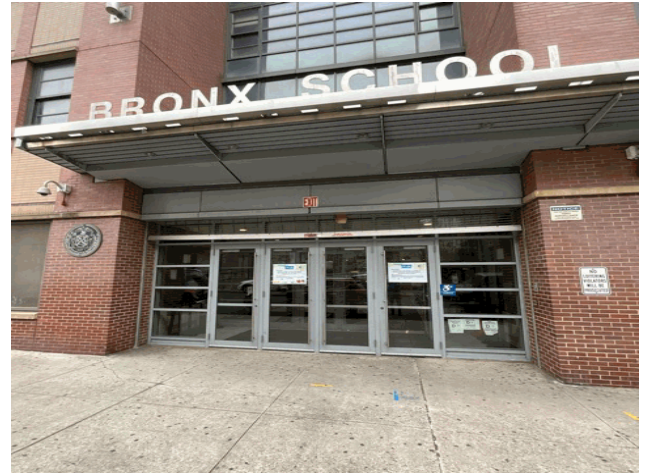
Facade A - East 163rd Street

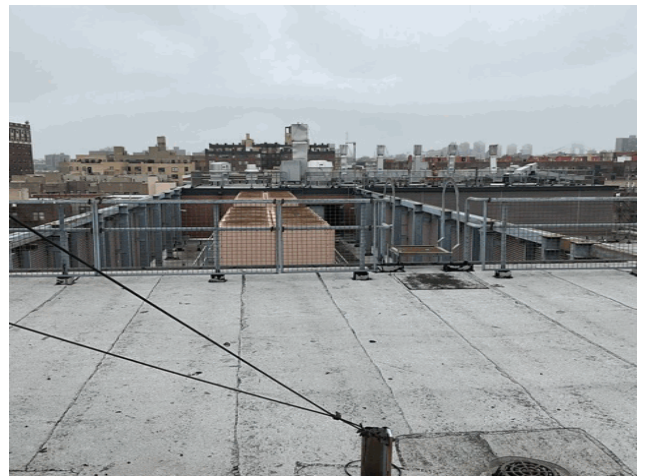
Roof 2 - Northwest View
