**NYC Department of Education  
Building Condition Assessment Survey 2023-2024**

**Architectural Inspection**

**X471**

**Asset:** SOUTH BRONX HS AF - BRONX, 701 ST ANNS AVENUE, BRONX, NY, 10455

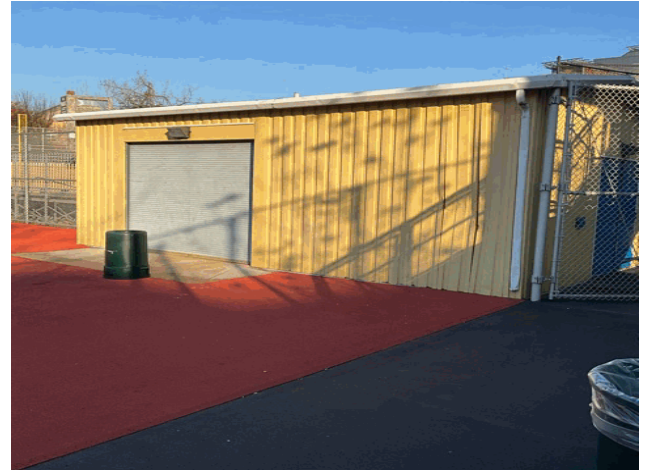
Facade F - Northwest View

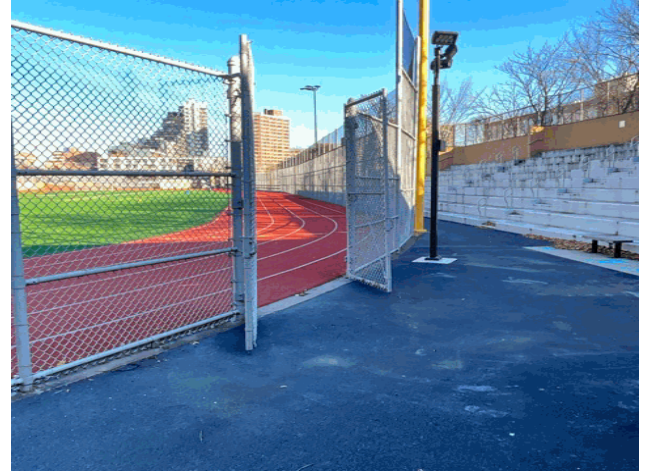
Facade A - Northeast View

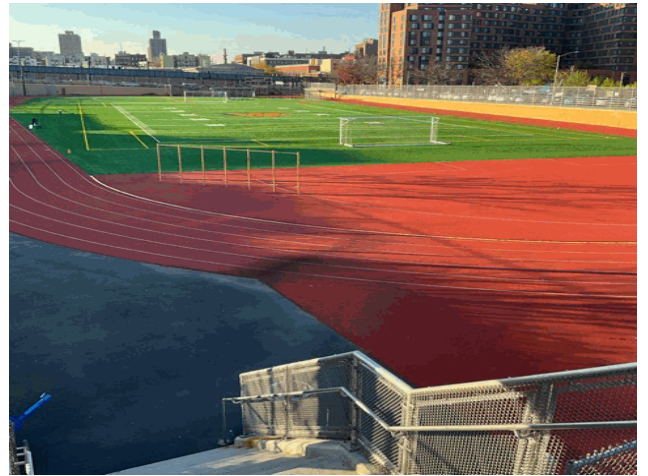
Athletic Field - Southwest View
