Building Condition Assessment Survey 2023-2024

Architectural Inspection

Asset:	3K CENTER @ 1107 EAST GUN HILL ROAD - BRONX,	1107 EAST GUN HILL ROAD, BRONX, N	Y, 10469
Inspection Id	Inspection Type	Time In	Last Edited
201	ARCHITECTURAL - ASSOCIATE	2023-10-16 12:00PM	A 2023-11-19 11:56PM
203	ARCHITECTURAL - SENIOR	2023-10-16 11:46A	M 2024-06-12 09:41PM
set Data

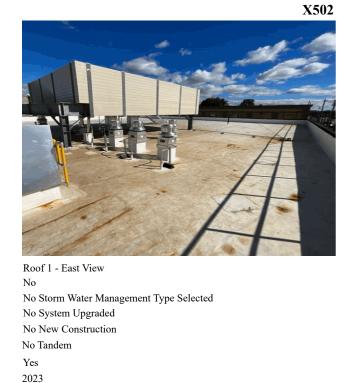
estion	Response	
XTERIOR	*	
ROOF		
ROOFING		
ROOFING		
Replacement Uom	S.F.	
Instance on Single Ply, Fully Adhered Roof:Roof 1	Inspected	
Instance Roof Photo		
	Roof 1	
Instance Condition	1- Good	
Instance Quantity	9,000	
Instance Quantity Uom	S.F.	
Does the roof have major mechanical equipment sitting on Dunnage Steel less than 18" above the Roofing?	No	
Does this Roof Instance have a Sustainable Roof System?	Yes	
Sustainable Roof System Type	White Roof	
Sustainable Roof System Location (Roof Number)	Roof 1	
Do solar panels exist on these roofs?	No	
Is/Are the roof(s) suitable for Solar Panel installation?	<u>No</u> 2023	
Source of Installation Year	Custodial Staff	
Deficiency	No deficiencies recorded	
ROOFING DRAINS	Inspected	
	2- Between Good and Fair	
Condition	No deficiencies recorded	
Deficiency		
SPECIALTIES	Inspected	
BULKHEAD/PENTHOUSE	Does not exist	
CUPOLA/ SPIRES/ TOWERS	Does not exist	
DORMER	Does not exist
