**NYC Department of Education
Building Condition Assessment Survey 2023-2024**

Architectural Inspection

Asset: P.S. 69 MINISCHOOL - BRONX, 560 THIERIOT AVENUE, BRONX, NY, 10472

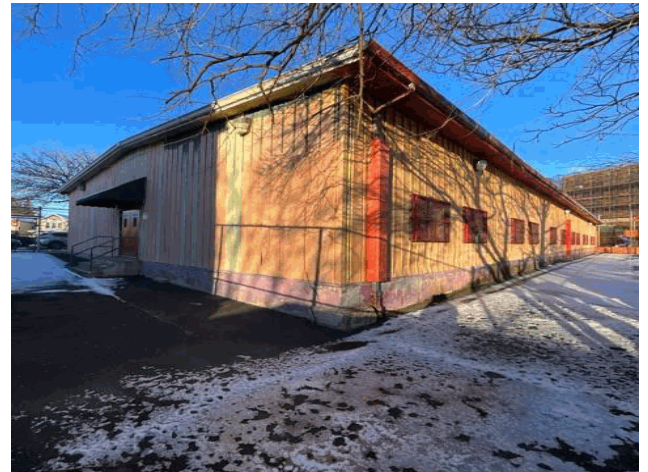
Facades B and C - Northwest view

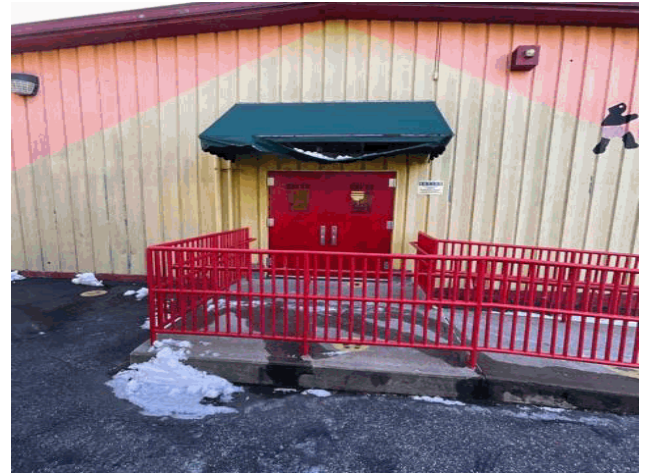
Facade A - Thieriot Avenue
