**NYC Department of Education
Building Condition Assessment Survey 2023-2024**

Architectural Inspection

X873

Asset: P.S. 73 MINISCHOOL - BRONX, 1020 ANDERSON AVENUE, BRONX, NY, 10452

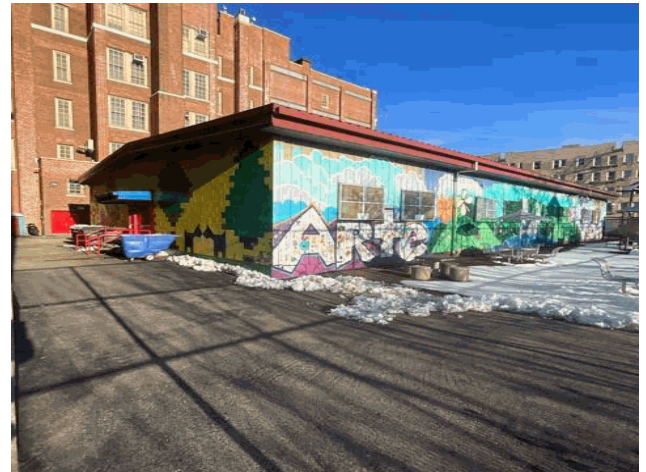
Facades C and D - Northwest View

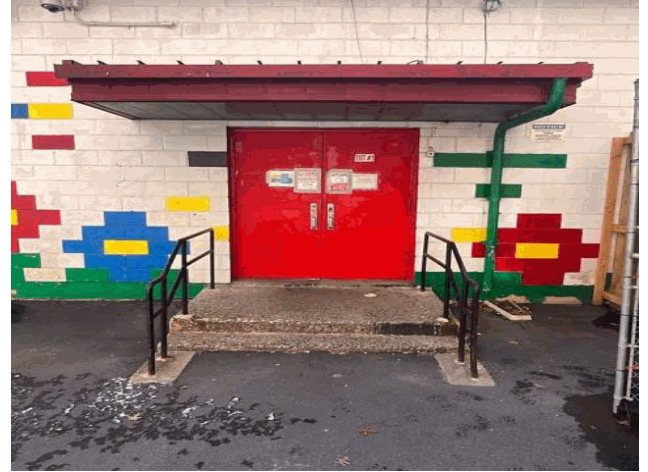
Facade A - Facing Main Asset

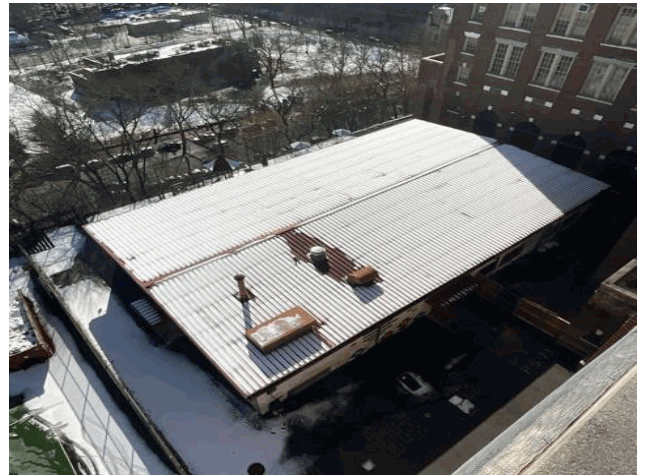
Roof 1 - South Viewed from Main Asset X073
