**NYC Department of Education
Building Condition Assessment Survey 2023-2024**

Architectural Inspection

X878

Asset: FANNIE LOU HAMER FREEDOM HS - BRONX, 1021 JENNINGS STREET, BRONX, NY, 10460

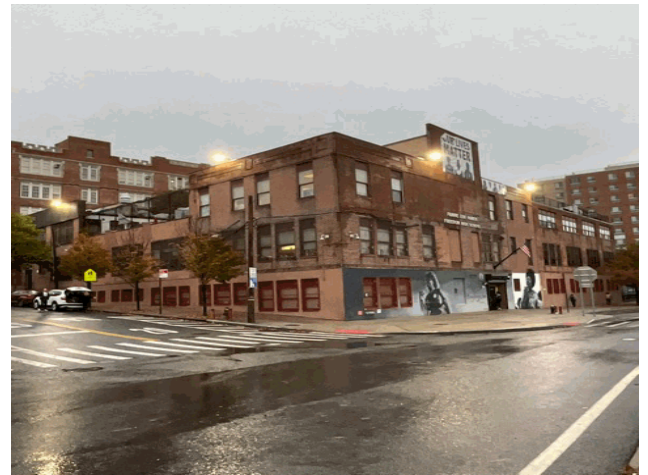
Corner of Jennings Street and West Farms Road - Southeast View

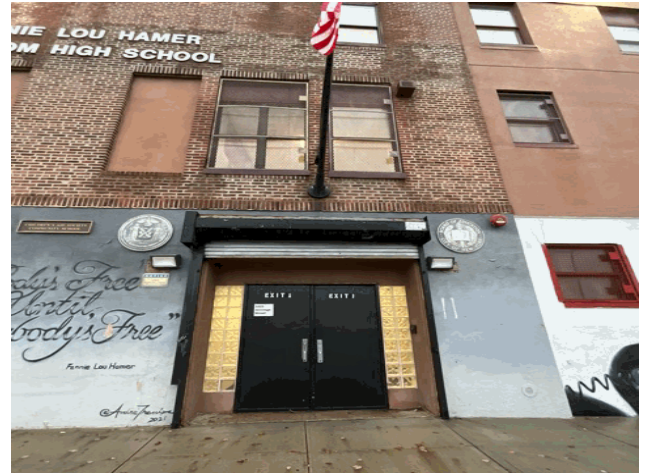
Facade A - West Farms Road

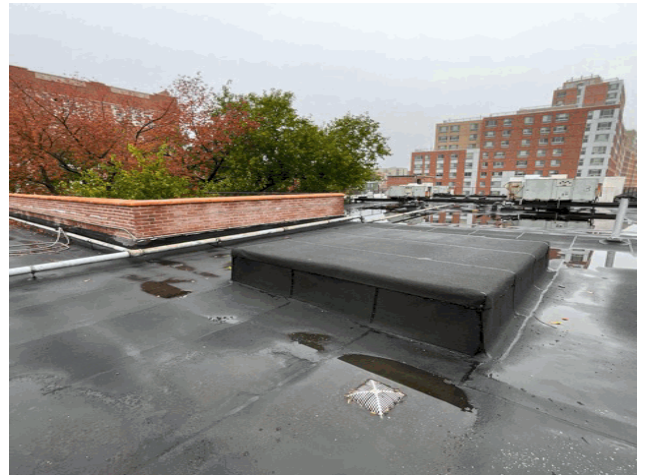
Roof 1 - North View
