**NYC Department of Education
Building Condition Assessment Survey 2023-2024**

Architectural Inspection

X880

Asset: P.S. 69 ANNEX - BRONX, 639 THERIOT AVENUE, BRONX, NY, 10472

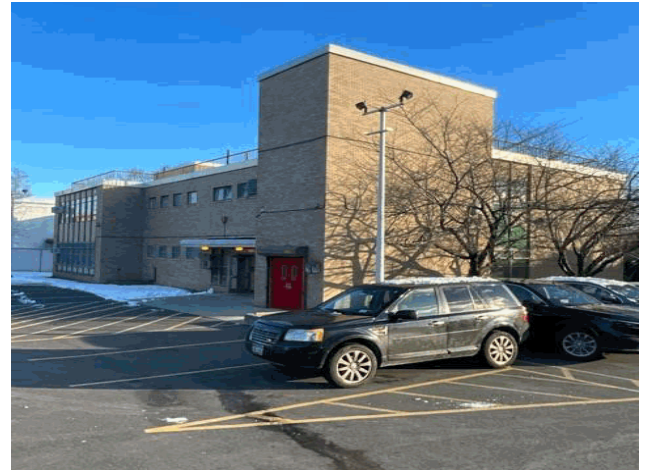
Facade A and D - North View

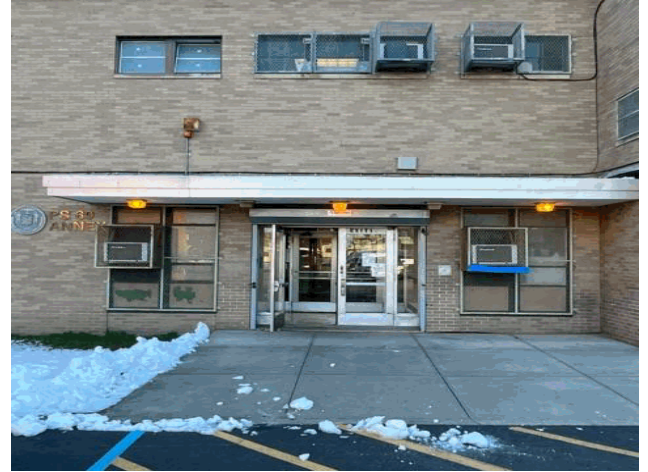
Facade A - Schoolyard

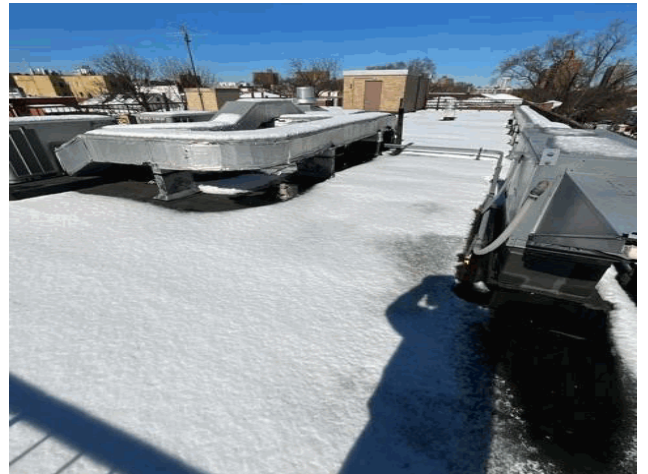
Roof 1 - North View
