**NYC Department of Education
Building Condition Assessment Survey 2023-2024**

Architectural Inspection

X890

Asset: P.S. 90 MINISCHOOL - BRONX, 1116 SHERIDAN AVENUE, BRONX, NY, 10456

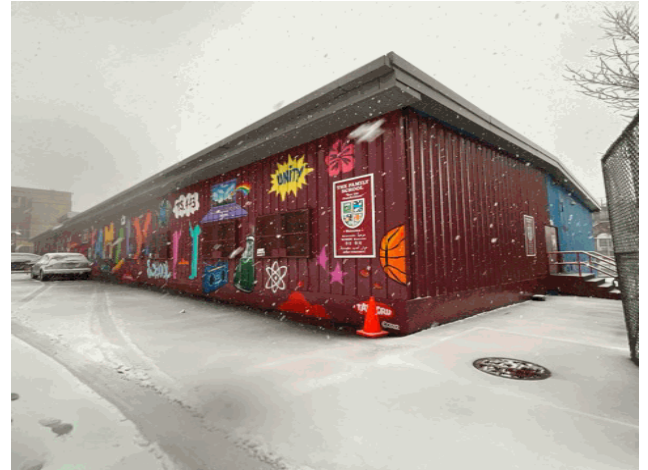
Facade A and D - Northeast View

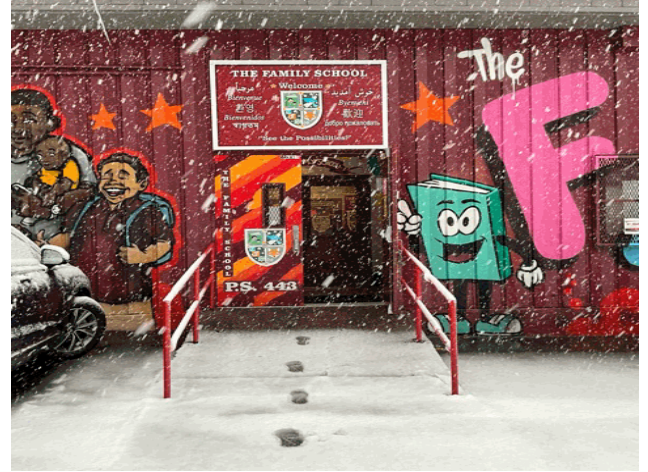
Facade A - View from Main Asset (X090)

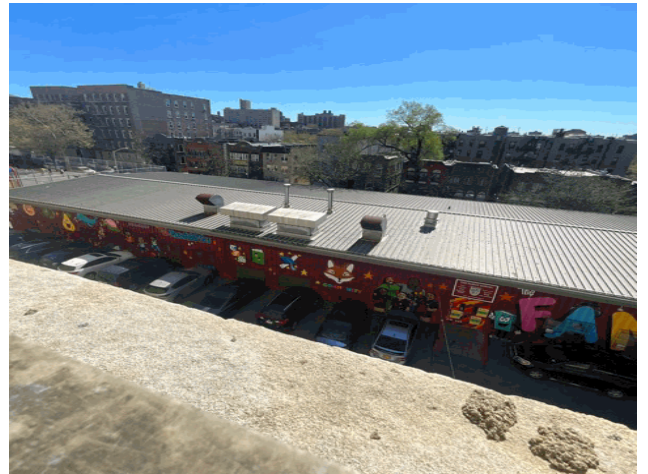
Roof 1 - East View from Main Asset X090
