**NYC Department of Education
Building Condition Assessment Survey 2023-2024**

Architectural Inspection

Asset: P.S. 93 MINISCHOOL - BRONX, 1535 STORY AVENUE, BRONX, NY, 10473

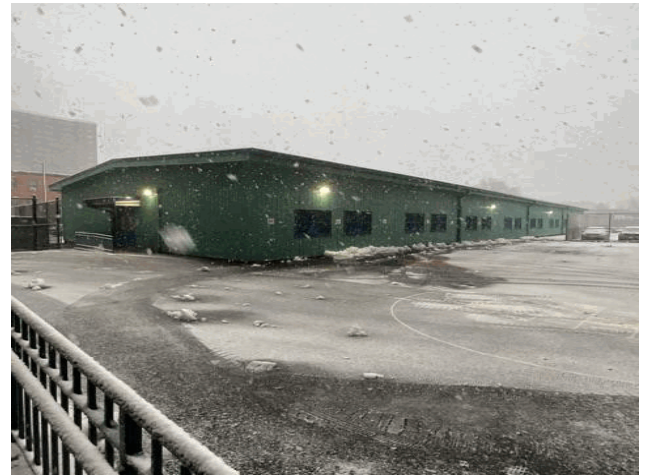
Facade A and D - Northwest View

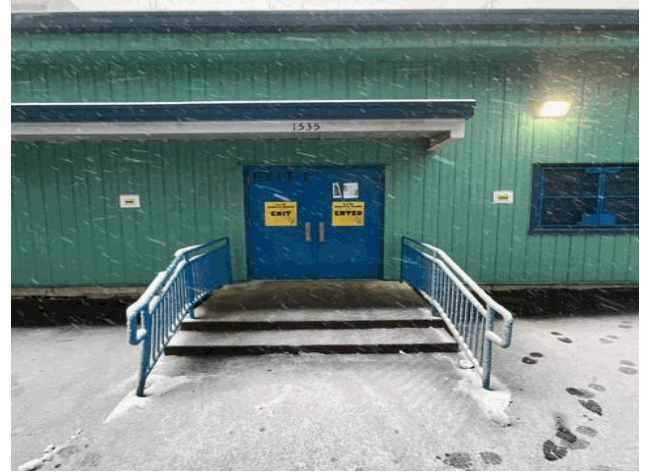
Facade A - Elder Avenue

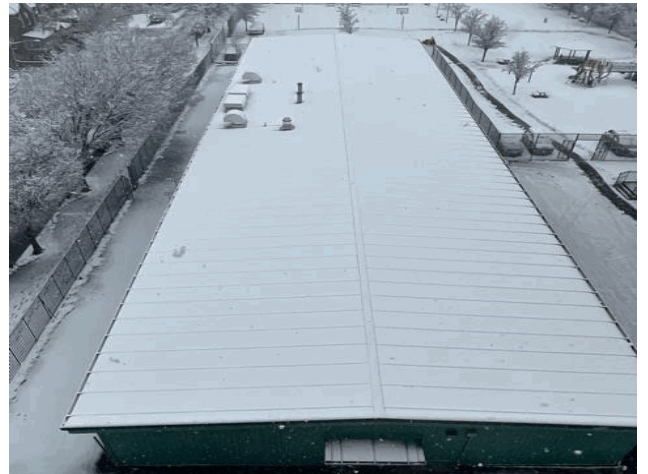
Roof 1 - North View
