**NYC Department of Education  
Building Condition Assessment Survey 2023-2024**

**Architectural Inspection**

**X918**

**Asset: P.S. 68 TEMP. C.R. BLDG. - BRONX, 4011 MONTICELLO AVENUE, BRONX, NY, 10466**

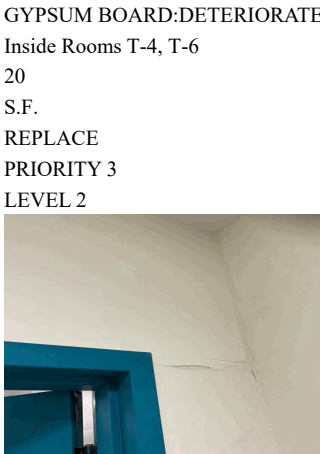
Inside Room T-4
Deficiency Photo 2	No photo recorded
Violations	No violations recorded
<b>LIFE SAFETY</b>	Inspected
<b>F.D. HOLDING AREA</b>	Does not exist
<b>STEEL STAIRS</b>	Does not exist
<b>SITE</b>	Not required

Inside Room T-4
Deficiency Photo 2	No photo recorded
Violations	No violations recorded
Deficiency	GYPSUM BOARD:DETERIORATED
Deficiency Location/Instance	Inside Rooms T-4, T-6
Deficiency Quantity	20
Quantity Uom	S.F.
Potential Action	REPLACE
Urgency of Action	PRIORITY 3
Purpose of Action	LEVEL 2
Deficiency Photo 1
