**NYC Department of Education
Building Condition Assessment Survey 2023-2024**

Architectural Inspection

Asset: P.S. 121 TEMP. C.R. BLDG. - BRONX, 2750 THROOP AVENUE, BRONX, NY, 10469

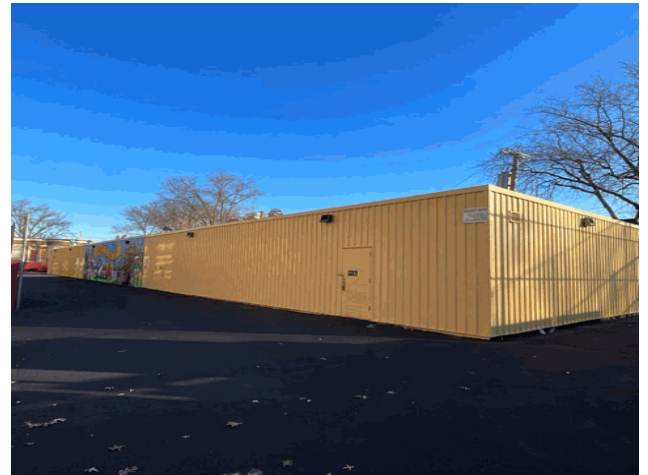
Facade A and D - Northeast view

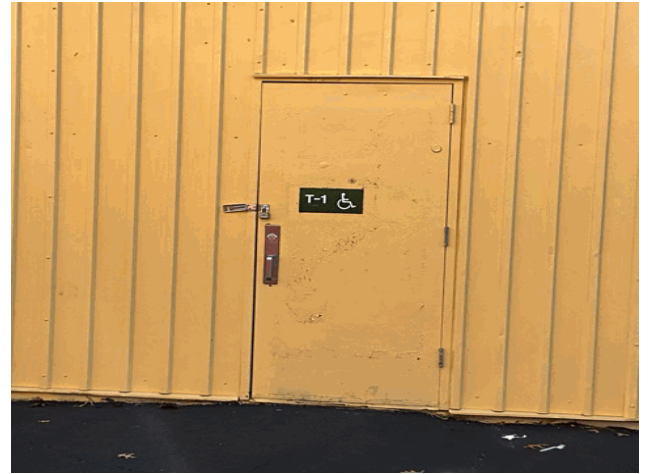
Facade A - Unit T1

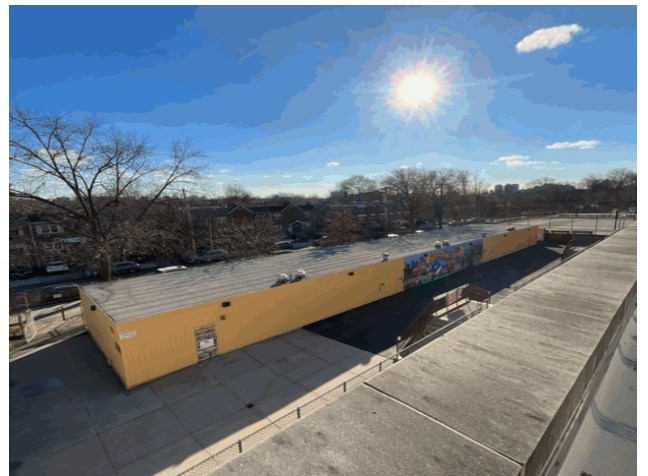
Roof 1 - South View from Main Asset X121
