**NYC Department of Education
Building Condition Assessment Survey 2023-2024**

Architectural Inspection

X932

Asset: I.S. 118 TEMP. C.R. BLDG. - BRONX, 577 EAST 179 STREET, BRONX, NY, 10457

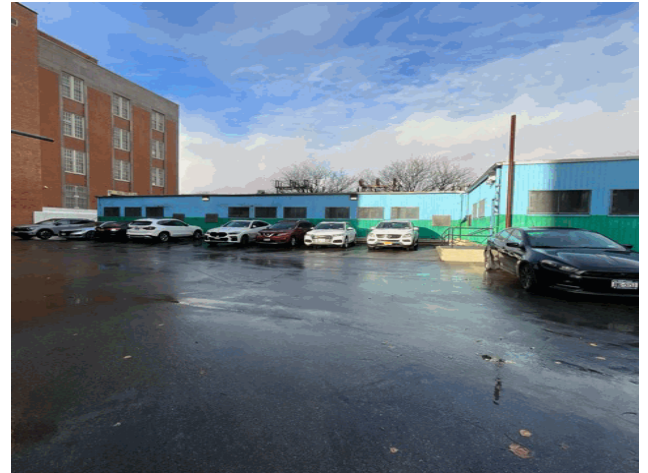
Facade D, E and F - North View

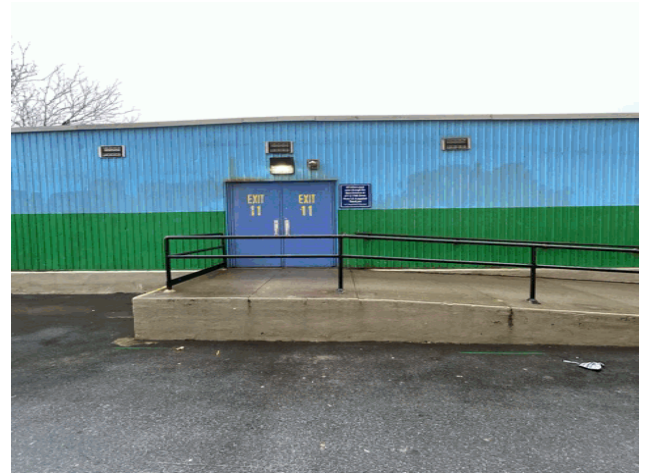
Facade A - Schooyard

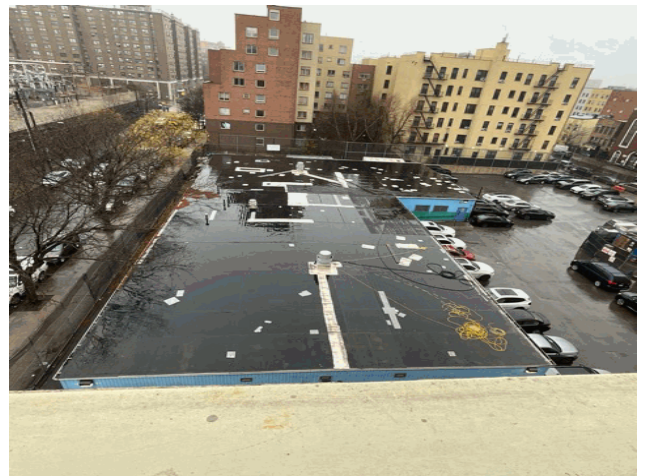
Roof 1 - Northwest View from Main Asset X118
