**NYC Department of Education  
Building Condition Assessment Survey 2023-2024**

**Architectural Inspection**

**X951**

**Asset: P.S.15 ANNEX (PLAY YARD) - BRONX, 2195 ANDREWS AVENUE, BRONX, NY, 10453**

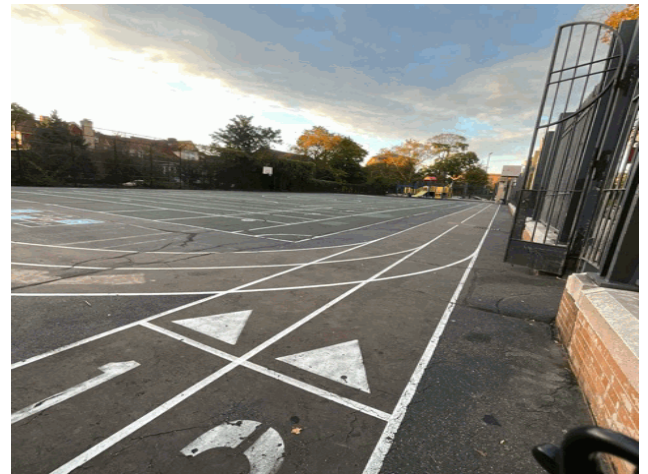
Andrew's Avenue - South view

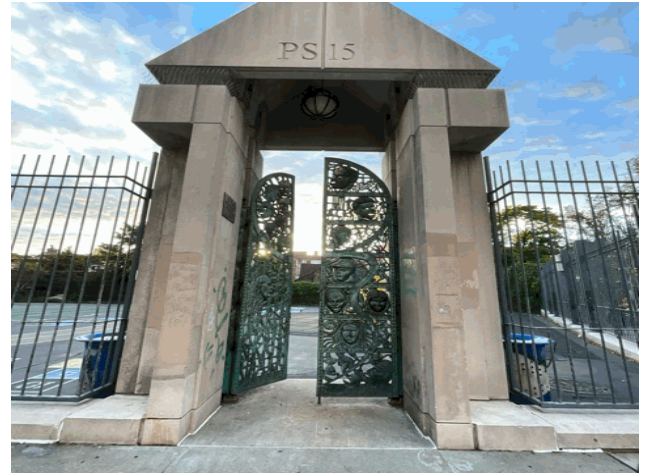
Facade A - Andrew's Avenue

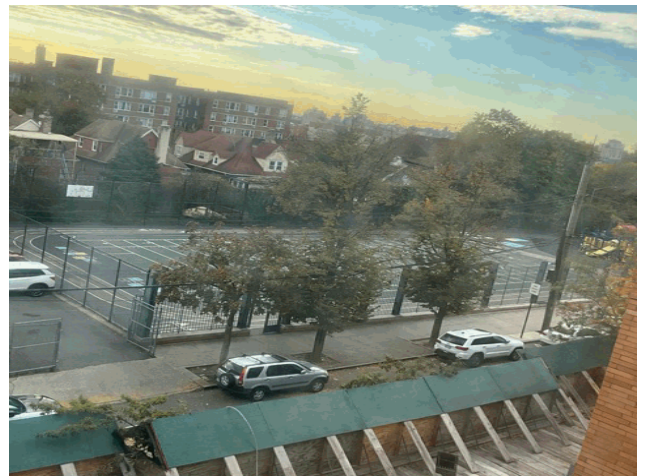
Play Yard - Southeast View from Main Asset X015
