**NYC Department of Education
Building Condition Assessment Survey 2023-2024**

Architectural Inspection

X953

Asset: AUXILIARY SERVICES HS - BRONX, 3450 EAST TREMONT AVENUE, BRONX, NY, 10465

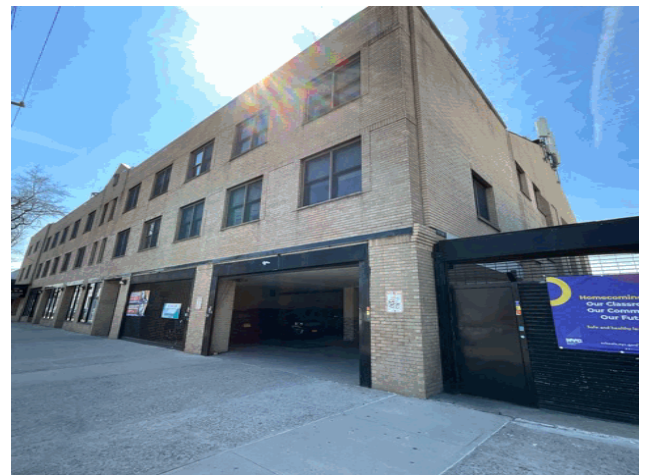
East Tremont Avenue - Northeast View

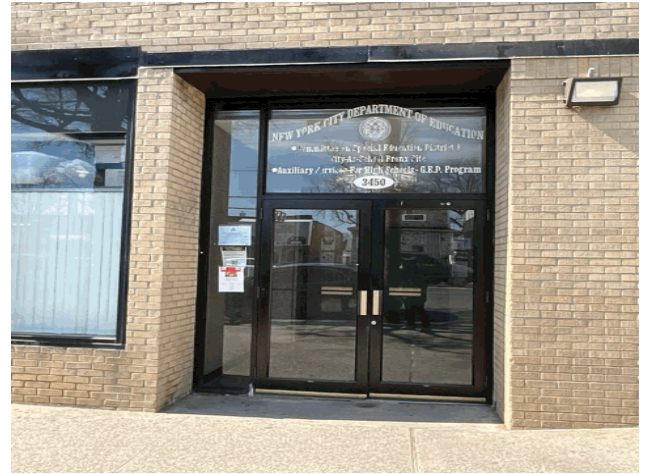
Facade A - East Tremont Avenue

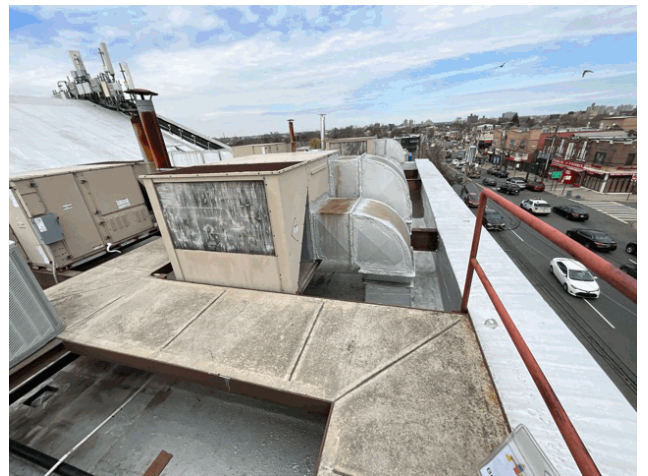
Roof 1 - Northwest View
