**NYC Department of Education
Building Condition Assessment Survey 2023-2024**

Architectural Inspection

X961

Asset: MORRIS HS TRANSPORTABLE - BRONX, 1110 BOSTON ROAD, BRONX, NY, 10456

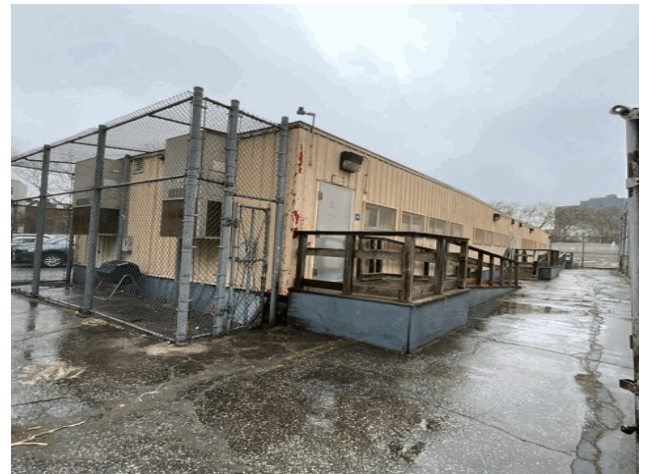
Facade F and E - Northwest View

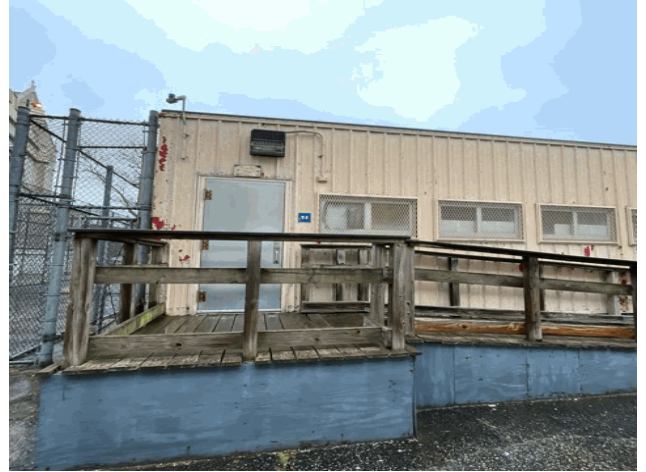
T1 - Facade A

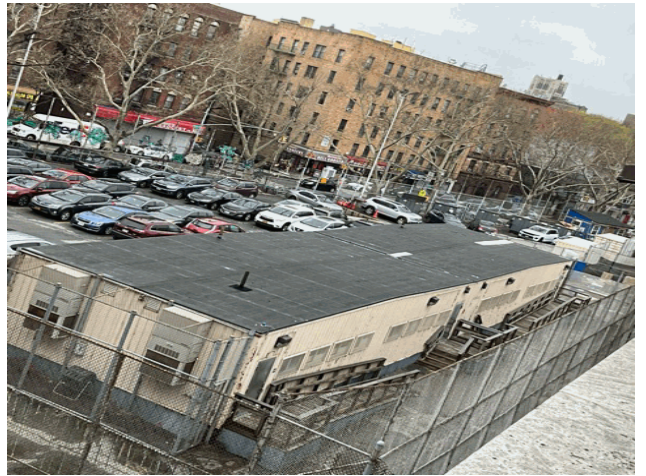
Roof 2 - North View from Main Asset X400
