**NYC Department of Education  
Building Condition Assessment Survey 2023-2024**

**Architectural Inspection**

**X988**

**Asset:** LAFAYETTE ACADEMIES - BRONX, 1231 LAFAYETTE AVENUE, BRONX, NY, 10474

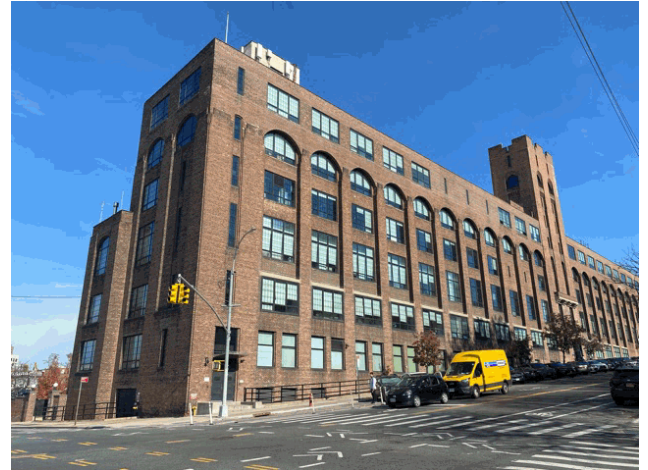
The corner of Lafayette Avenue and Tiffany Street - North view

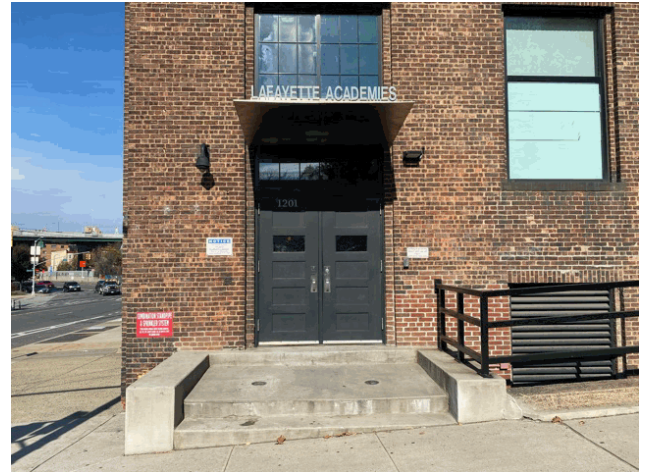
Facade A - Lafayette Avenue
