ENVIRONMENTAL STEWARDSHIP SUMMARY REPORT

FOR THE CONSTRUCTION, OPERATION, AND MAINTENANCE OF TACTICAL INFRASTRUCTURE PEDESTRIAN FENCE SEGMENTS K-2 THROUGH K-5 U.S. Border Patrol El Paso Sector, Texas

U.S. Department of Homeland Security
U.S. Customs and Border Protection
U.S. Border Patrol

July 2012

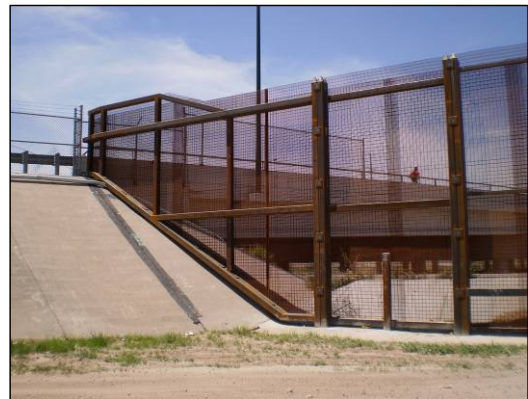
As approved by the CR process, the fence is cantilevered above the surface of the Zaragoza Bridge abutment on both sides of the bridge (Photograph 3-1). The K-2A TI is depicted in Figures 3-2a through 3-2d.

Photograph 3-1. Zaragoza POE Cantilevered Fenced Segment.

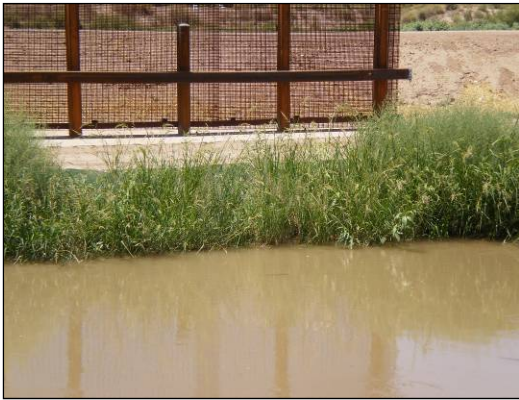
Instead of shotcrete, the contractor installed a geo-textile fabric on the south canal bank to stabilize the fill and prevent bank erosion (Photograph 3-2). No bank failures or erosion spots along the south canal bank were observed during the survey, and the stabilization method appears to be working as planned. Vegetation has become established within the geo-textile fabric along the south canal bank to further stabilize the fill. Some erosion and caving were observed along the north bank of the canal in this segment, but it does not appear to be the result of fence installation (Photograph 3-3). No staging areas were observed north of the levee in K-2C, and it is assumed that the contractor used the private lot staging area for K-2B.

Photograph 3-2. Geo-Textile Canal Bank Stabilization.

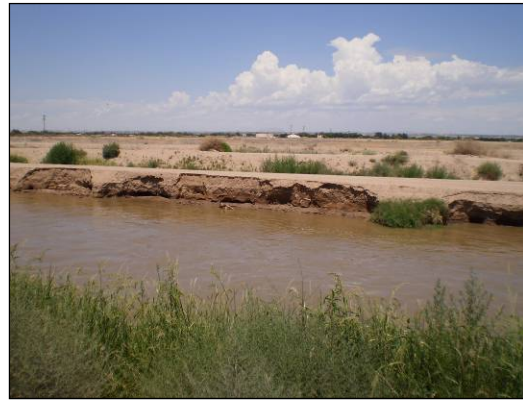
Photograph 3-3. Canal Bank Erosion and Caving.

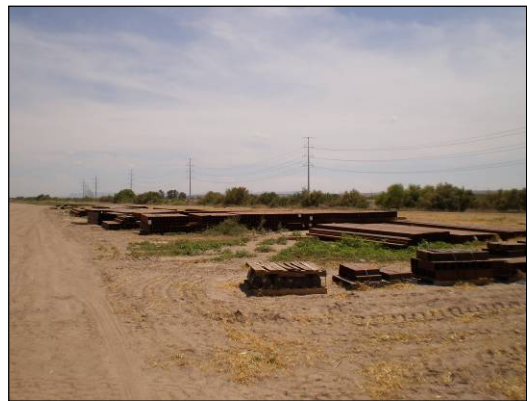
A 0.03-mile (161-foot) gap was left in the fence at the proposed Doubles Crossing bridge location, but the bridge was not installed. A sliding pedestrian gate was installed just west of the Doubles Crossing location at a canal headgate. A 0.085-mile (448-foot) gap was left in the fence at the proposed Walcott Road Crossover, but no bridge was installed at this location, either. A 0.057-mile (300-foot) gap was left in the fence at the Tellez headgate, and a 0.045-mile (240-foot) gap was left in the fence at the Lopez Road Bridge location. A 7.44-acre staging area was measured on the vega at the Lopez Road fence gap, and considerable fence parts and other supplies were still in the staging area at the time of the post-construction survey (Photograph 3-4).

Photograph 3-4. Vega Staging Area in Segment K-2C.

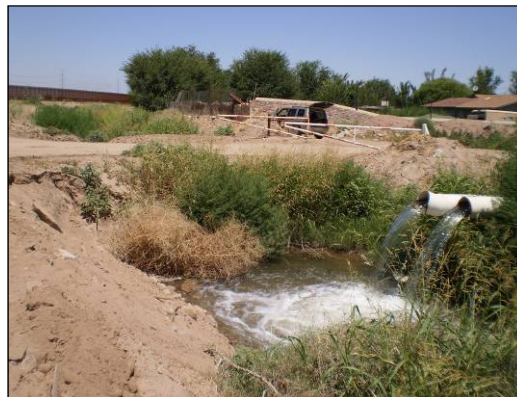
Photograph 3-5. Pompas Waste Canal Culvert Crossing.

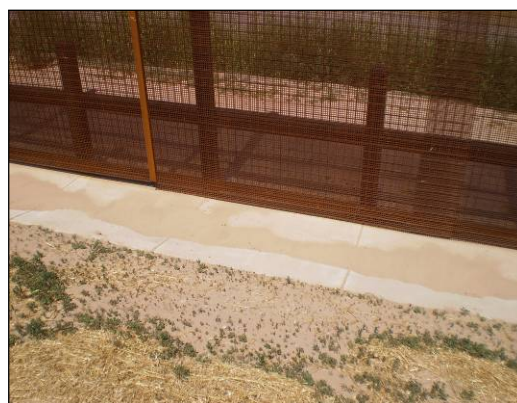
Photograph 3-6. Lack of Animal Pass-Through Gap at the Base of the Fence.

The small animal pass-through gap at the base of the installed fence was not built uniformly along the wire mesh segments of PV-1 fence. Better quality control will be utilized for future fence installation projects to ensure better adherence to required biological BMPs. CBP is implementing a Comprehensive Tactical Infrastructure Maintenance and Repair (CTIMR) program to ensure the TI and related areas are maintained and repaired as needed.

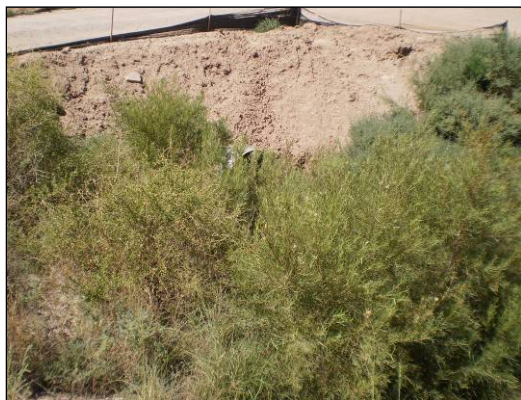
Photograph 3-7. TJ's Crossing Temporary Culvert Installed.

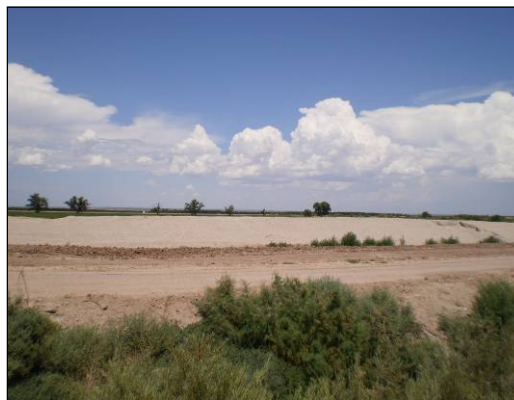
Photograph 3-8. Gravel Pile on Staging Area at TJ's Crossing.

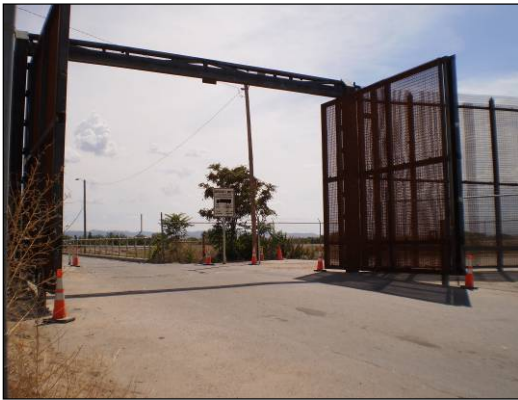
Photograph 3-9. Fabens POE Swinging Vehicle Gate Installed.

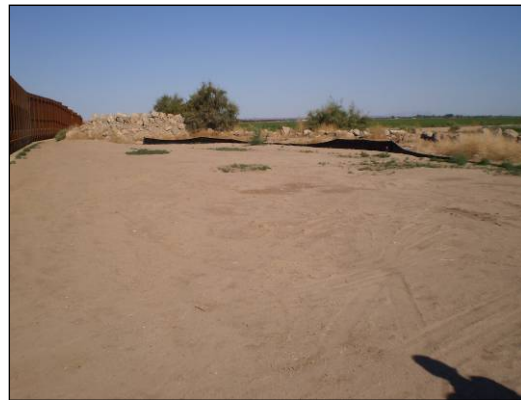
Photograph 3-10. Staging Area at the Fabens Waste Channel.

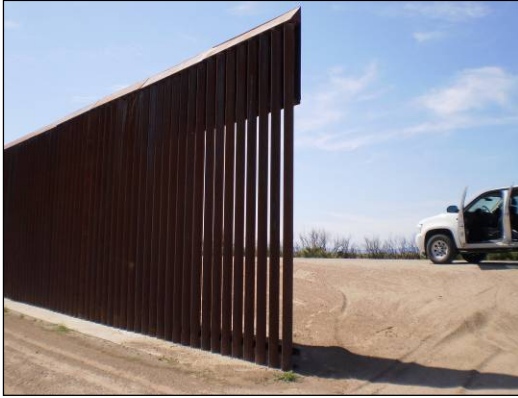
The K-5 fence design, as mentioned previously, was changed to PV-1 bollard fence (Photograph 3-11). The levee and the vega near the levee in K-5 have been disturbed and consist of rutted bare dirt (Photograph 3-12). No restoration, in the form of smoothing, hay cover, or revegetation, was in place at the time of the post-construction survey, reportedly at the request of USIBWC. The width of levee and vega disturbance is typically about 70 feet and does not vary appreciably from the previously disturbed width in the adjacent proposed K-4 segment, which was not built. No impacts were measured in the vega along the K-5 corridor.

Photograph 3-11. Bollard Fence Installed in Segment K-5, West End.

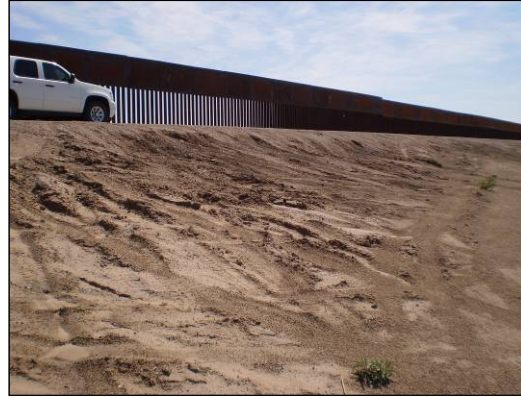
Photograph 3-12. Rutted Levee and Vega at the West End of Segment K-5.

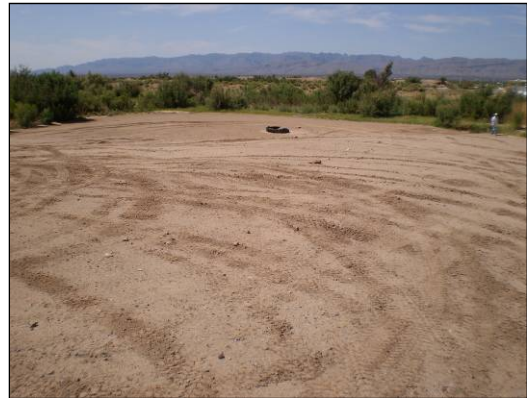
Photograph 3-13. Fort Hancock POE Staging Area.

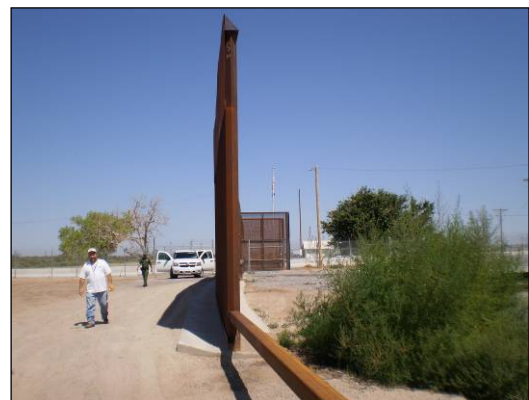
A 0.166-mile (877-foot) gap in the fence exists from a point just west of the river access canal near the POE to a point where the levee separates from the irrigation canal. This gap corresponds to an approved CR, which specified construction of a modified PV-3 floating fence to be placed across the river access canal and bridge (Photograph 3-14). The floating fence segment has not been built. The remainder of K-5 was built along the north toe of the levee as described in the ESP. Four additional sliding vehicle gates were installed in the remainder of K-5.

Photograph 3-14. Fort Hancock POE Fence Gap.

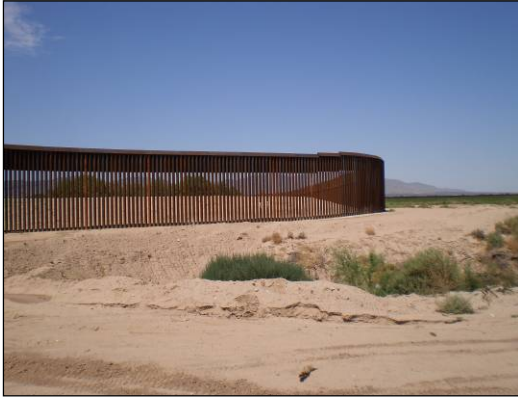
Segment K-5 ends at the head of the Diablo Arroyo, and the fence curves around and over the irrigation canal culvert in the levee (Photograph 3-15). The access road for K-5 begins at the east end of the fence and follows a preexisting gravel and dirt road north to State Route 20 (SR-20). The Esperanza Water District maintenance yard on SR-20 near the north end of the access road was

Photograph 3-15. East End of Segment K-5.

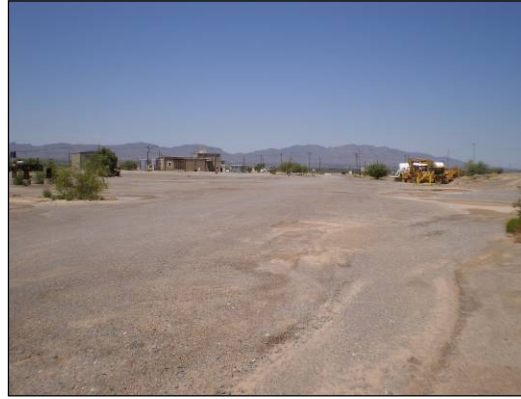
used for staging (Photograph 3-16), but no area boundary was measured because the entire area is previously disturbed and partially paved. This staging area was not approved in a CR.

Photograph 3-16. Esperanza Water District Staging Area.
