U.S. Customs and Border Protection (CBP) proposed to replace existing landing mat fence with bollard-style fencing, construct a 20-foot-wide construction road paralleling the new fence, and install a 20-foot-wide swing gate at the railroad crossing at the DeConcini Port of Entry (POE) for the U.S. Border Patrol (USBP) Nogales Station. All proposed construction was planned to occur within the Roosevelt Reservation within and near the city of Nogales, Arizona (Figure 1).

The purpose of this letter report is to summarize the fence replacement, road construction, and gate installation, and assess the final design and footprint of the new tactical infrastructure (TI). This letter will serve as the Environmental Stewardship Summary Report (ESSR) to compare the final completed action to the originally planned installation of TI, as proposed in the November 2011 *Final Environmental Stewardship Plan for the Proposed Nogales Fence Replacement Project, U.S. Border Patrol Tucson Sector, Nogales Station, Arizona*. The TI proposed in the Environmental Stewardship Plan (ESP) was constructed between March 25, 2011, and July 29, 2011.

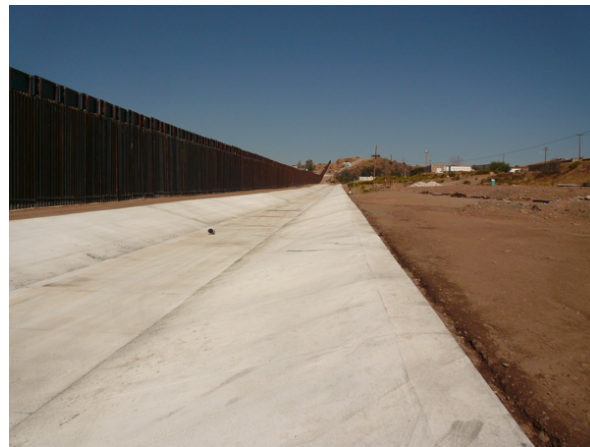
A low-water crossing and drainage gate system were installed immediately west of the Maricopa POE; these improvements accounted for the greatest increase in impacts not evaluated in the ESP. An area immediately north of the new border road, west of the low-water crossing near the Maricopa POE was also lined with concrete (Photograph 1). The concrete-lined drain impacted a total of 1.15 acres. In addition, road improvements to the existing border road were conducted including grading, filling to reduce incline grade, and laying

Photograph 1. Overview of the concrete-lined drain, west of Maricopa POE.

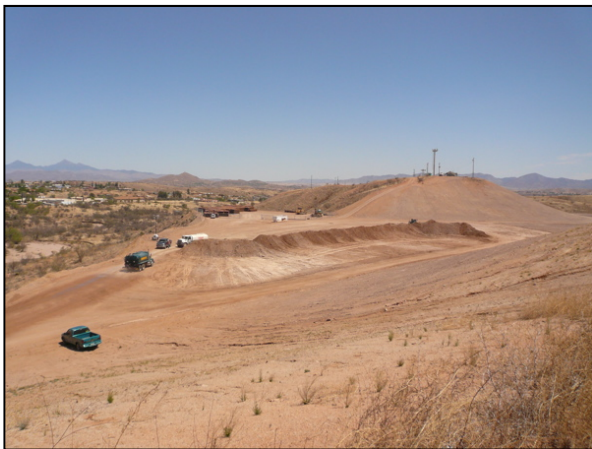
The ESP anticipated the use of two previously disturbed staging areas: one near the west side of the Mariposa POE (see Figure 3) and one east of the project corridor along the easternmost access road (see Figure 13). Two additional previously disturbed staging areas were utilized during the construction phase. The first additional staging area used was immediately east of the Mariposa POE (Photograph 2 and Figure 4). The area was previously disturbed and devoid of vegetation. The second additional staging area was an industrial leased space north of the Mariposa POE on Arizona Highway 189, which was used to store construction equipment and as a fabrication yard for fence panels (Photograph 3).

Photograph 2. Overview of staging area east of Mariposa POE.

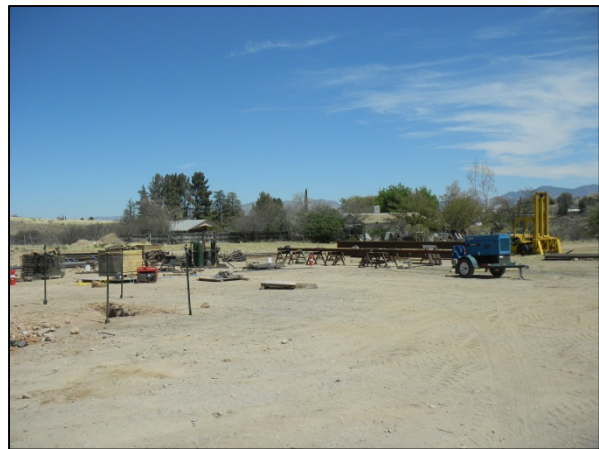
Photograph 3. Overview of leased staging area north of Mariposa POE.

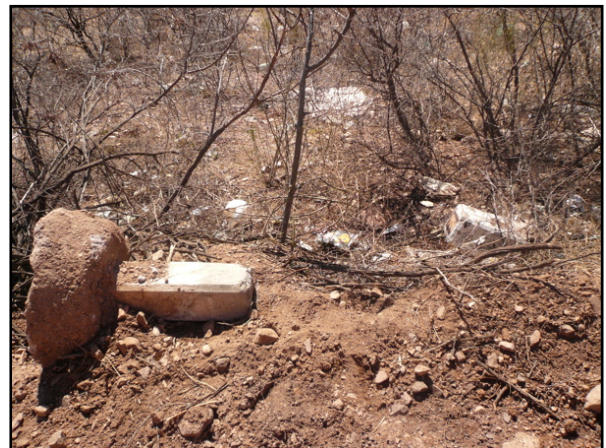
A small border marker (International Boundary and Water Commission [IBWC] 123) was found damaged when a portion of the legacy fence was removed west of the Mariposa POE (Photograph 4). Due to the location of the legacy fence, the small border marker had been approximately 50 feet south of the landing mat fence and was not accessible from the United States' side of the legacy landing mat fence; therefore, the

Photograph 4. Broken Border Marker IBWC 123, west of Mariposa POE.

construction activities associated with this project did not damage the marker. Gates were installed along the project corridor adjacent to border monuments, which are approximately 4 feet south of the fence. This will provide the U.S. Section, IBWC with access and space to repair and maintain the monuments. No new cultural resources were discovered in the project corridor.

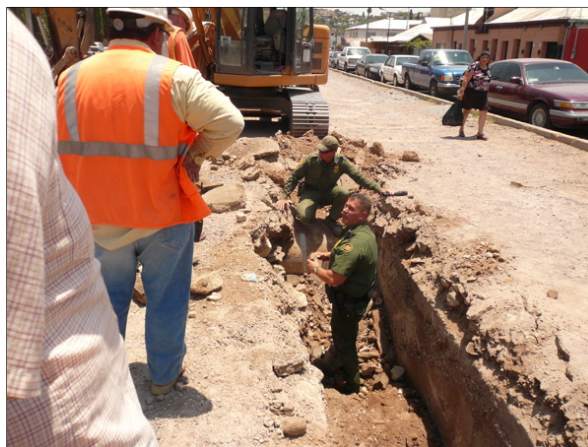
Four clandestine tunnels were identified while excavating the footer for the new bollard fence. As the tunnels were discovered, agents from the USBP Nogales Station were notified (Photograph 5). The agents secured the tunnel and noted its location. The construction crew sealed the tunnels with concrete once the USBP finished their investigation.

Photograph 5. USBP agents inspecting a clandestine tunnel near West International Street, west of the DeConcini POE.

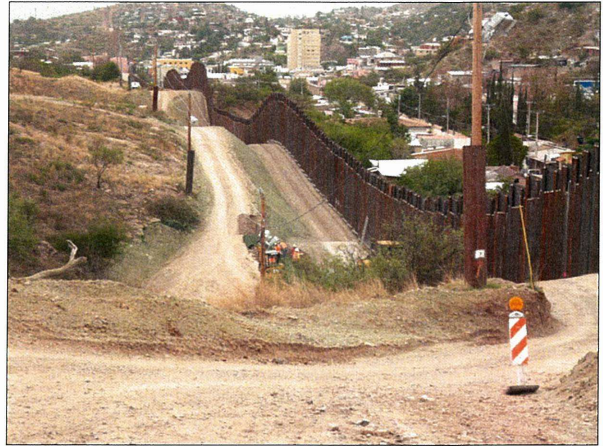
The post-construction survey identified one additional issue that requires consideration. Large areas of exposed soil and erosion problems were noted along the border road and access roads. Although erosion control techniques were part of the design of the project (i.e., concrete road

improvements on hillsides, riprap, and hydromulch [Photograph 6]), due to the rough terrain, the entire project corridor will require monitoring and maintenance, especially following rain events.

Photograph 6. Green hydromulch on hillside between elevated legacy road and new construction road, west of the DeConcini POE.
