# PROPERTY INSPECTION REPORT

**1234 Some Place**  
**Anytown IN 46033**

**Tuesday, 5/14/2013**

**Full Home Inspection**

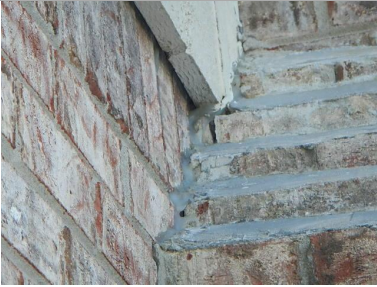
**1**

- Item: **Brick Chimney**
- Location: **North Side Of Home**
- Condition: **Movement In The Brick Chimney Away From The Home**
- Action: **Evaluate And Repair Chimney Movement By Qualified Contractor As Soon As Possible**

- The Fireplace On The Interior Is Also Showing Signs Of Movement - See Interior Pages

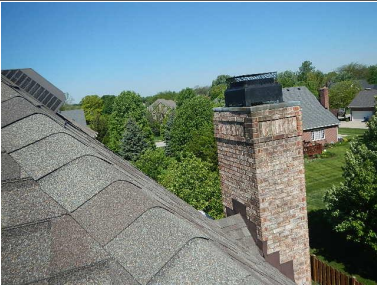
**2**

- Item: **Brick Chimney**
- Location: **North End Of Roof**
- Condition: **Chimney Is Too Low - Does Not Meet The 3' X 2' X 10' Rule**
- Action: **Evaluate And Repair Height Of Chimney By Qualified Contractor As Soon As Possible**

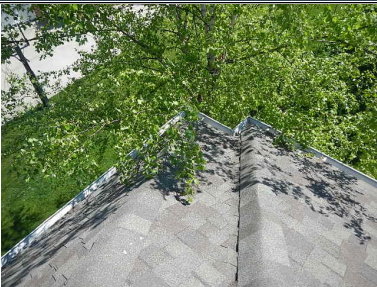
**3**

- Item: **Fiberglass Shingles**
- Location: **N E Corner Of Roof**
- Condition: **Tree Limbs Improperly Touching The Roofing**
- Action: **Trim Tree Limbs To Prevent Damage**

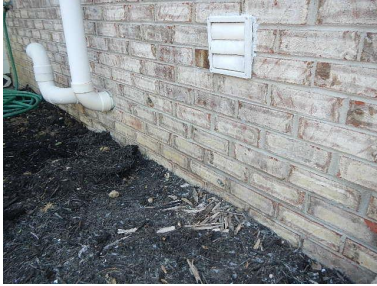
1

- Item: **Brick Veneer**
- Location: **All Sides**
- Condition: **Missing Weep Holes**
- Action: **Evaluate And Repair Missing Weep Holes By Qualified Contractor To Perform Their Intended Function Properly**

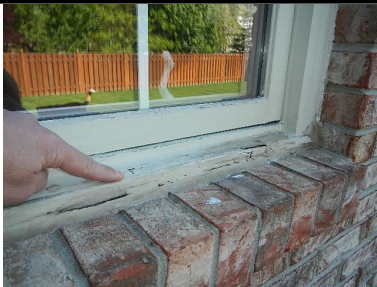
2

- Item: **Windows**
- Location: **Kitchen Window**
- Condition: **Serious Wood Rot**
- Action: **Evaluate And Repair Or Replace Rotted Wood By Qualified Contractor Prior To Closing**

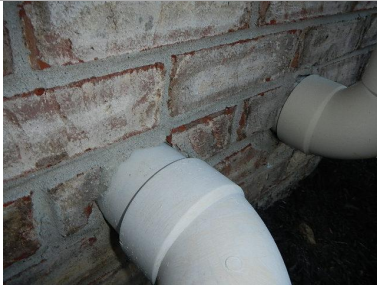
3

- Item: **Brick Veneer**
- Location: **Rear Exterior Wall**
- Condition: **Missing Caulking Around Furnace Exhaust Pipes**
- Action: **Evaluate And Repair Or Replace Missing Caulking To Prevent Leakage**

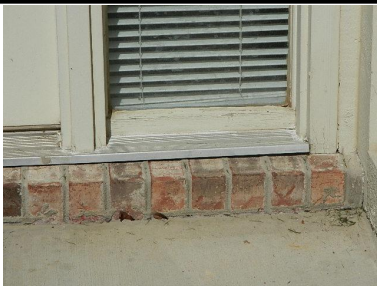
4

- Item: **Doors**
- Location: **Front Entry Door**
- Condition: **Threshold Is Pulled Up North Of The Door (at Side Light Of Door)**
- Action: **Evaluate And Repair Front Door Threshold Soon**

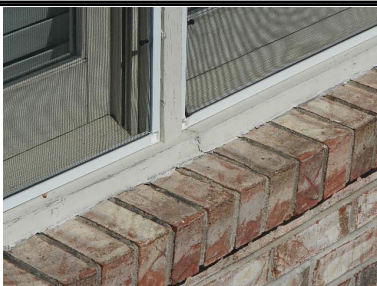
5

- Item: **Windows**
- Location: **Master Bedroom Window**
- Condition: **Evidence Of Deteriorated Finger Jointed Sill Boards**
- Action: **Evaluate And Repair Finger Jointed Wood Sill By Qualified Contractor Soon - This Will Likely Need Further Attention In The Future**

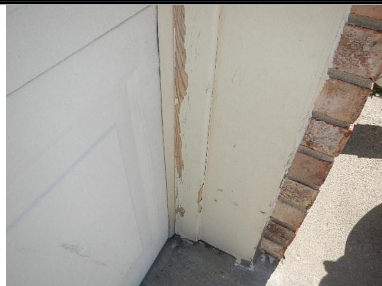
6

- Item: Wood Trim
- Location: All Sides
- Condition: Peeling Paint On The Wood Trim And Windows
- Action: Scrape And Paint All Wood Trim To Prevent Deterioration

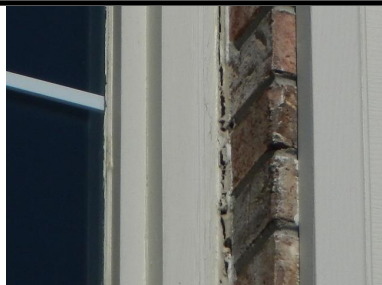
7

- Item: Windows
- Location: Front Window Over The Entry Door
- Condition: Loose, Missing Or Cracked Caulking
- Action: Evaluate And Repair Or Replace Caulking In The Near Future To Prevent Leakage And Deterioration

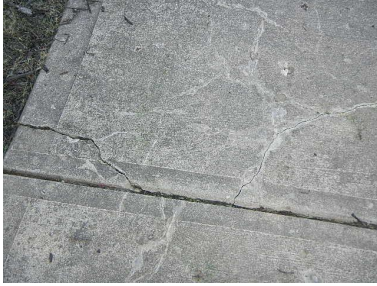
1

- Item: **Walkways**
- Location: **Front Concrete Walkway**
- Condition: **Cracked And Settled Walkway**
- Action: **Monitor And Maintain As The House Ages**

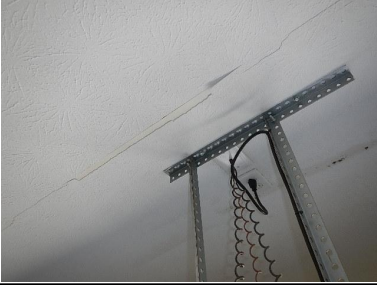
**1**

- Item: Ceiling
- Location: Garage Ceiling
- Condition: Several Minor Cracks
- Action: Evaluate And Repair Cracks In The Near Future

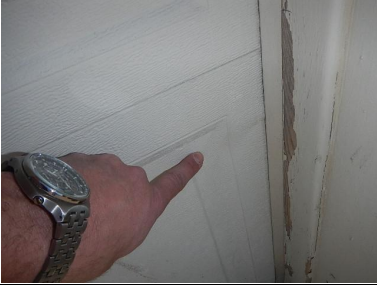
**2**

- Item: Overhead Door
- Location: East Overhead Door
- Condition: Minor Damage To Door - Small Dent
- Action: Monitor And Maintain As The House Ages - This Does Not Appear To Be A Problem At The Time Of The Inspection

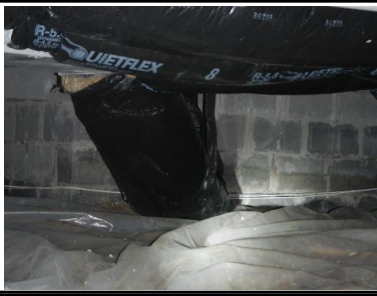
<b>1</b>

<ul style="list-style-type: none"> <li>- <b>Item:</b> Ductwork</li> <li>- <b>Location:</b> Crawl Space</li> <li>- <b>Condition:</b> Loose/ Unsupported Ductwork</li> <li>- <b>Action:</b> Evaluate And Repair Or Replace Loose Ductwork In Crawl Space By Qualified Contractor As Soon As Possible To Prevent Further Damage</li> </ul>
----------	--	---

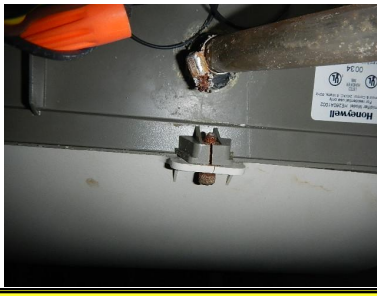
<b>2</b>

<ul style="list-style-type: none"> <li>- <b>Item:</b> Humidifier</li> <li>- <b>Location:</b> Basement Furnace</li> <li>- <b>Condition:</b> Inoperative Humidifier - Unit Is Rusted Shut, Unable To Inspect Interior</li> <li>- <b>Action:</b> Evaluate And Repair Or Replace Humidifier By Qualified Contractor As Soon As Possible</li> </ul>
----------	---	--

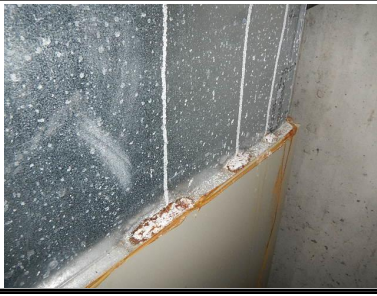
<b>3</b>

<ul style="list-style-type: none"> <li>- <b>Item:</b> Heating General Condition</li> <li>- <b>Location:</b> Furnace Plenum</li> <li>- <b>Condition:</b> Minor Rusting On The Plenum</li> <li>- <b>Action:</b> Monitor And Maintain As The House Ages</li> </ul>
----------	---	---

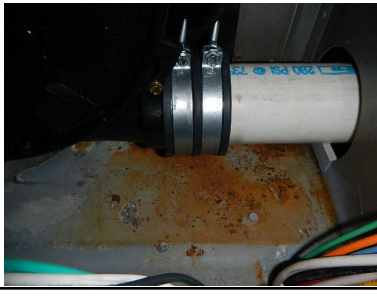
<b>4</b>

<ul style="list-style-type: none"> <li>- <b>Item:</b> Heating General Condition</li> <li>- <b>Location:</b> Interior Of The Furnace</li> <li>- <b>Condition:</b> Past Leakage At The Inducer Fan Area</li> <li>- <b>Action:</b> Monitor And Maintain As The House Ages</li> </ul>
----------	---	---

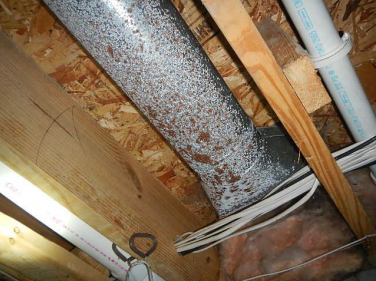
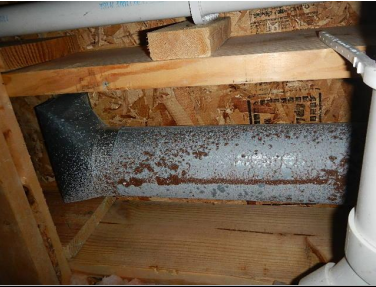
**5**

- **Item:** Ductwork  
- **Location:** Basement Near Crawl Space Access  
- **Condition:** Minor Rusting On The Metal Ductwork  
- **Action:** Monitor And Maintain As The House Ages

- **Item:** Ductwork  
- **Additional Photo Of:** Minor Rusting On The Metal Ductwork

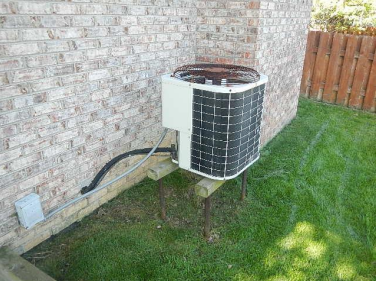
**7**

- **Item:** A / C General Condition  
**The Cooling Equipment Is Existing Beyond Its Expected Useful Life And Should Be Monitored And Maintained Regularly. This Equipment May Need Replacement Soon**

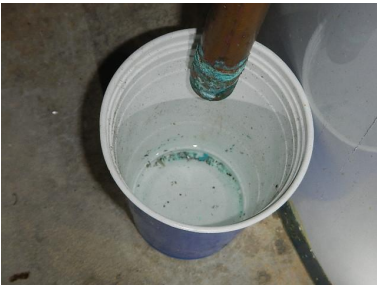
**2**

- Item: W H Relief Valve
- Location: Side Of The Water Heater
- Condition: Evidence Of Leakage At Relief Valve
- Action: Evaluate And Repair Or Replace Relief Valve By Qualified Contractor As Soon As Possible

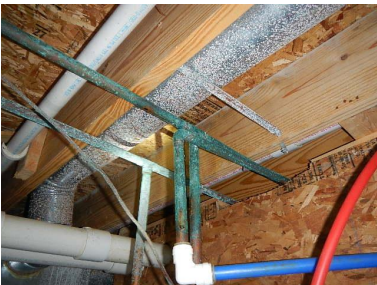
**3**

- Item: Water Supply
- Location: Basement Near The Crawl Space Access
- Condition: Minor Corrosion Observed On The Pipes
- Action: Monitor And Maintain As The House Ages

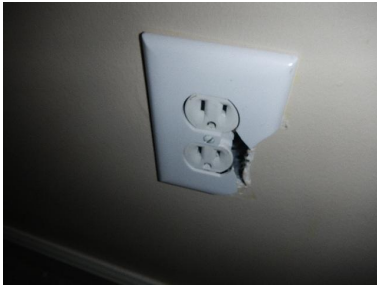
1

- Item: **Lights & Outlets**
- Location: **West Wall Of Finished Basement**
- Condition: **Damaged Outlet Cover Plate**
- Action: **Replace Damaged Cover Plate As Soon As Possible For Safety Reasons**

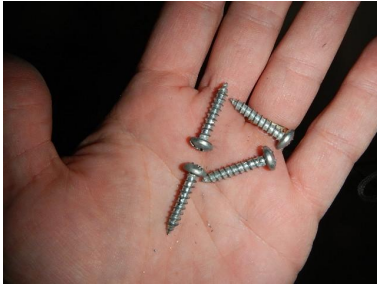
2

- Item: **Panel Cover**
- Location: **Main Panel Cover**
- Condition: **Improper Screws - Should Not Be Pointed Screws**
- Action: **Evaluate And Repair Or Replace Improper Screws On Cover Of Main Panel As Soon As Possible**

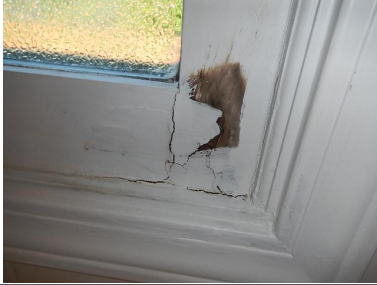
1

- Item: **Windows**
- Location: **Master Bathroom Window Above The Tub**
- Condition: **Serious Wood Rot On Frame And Sash**
- Action: **Evaluate And Repair Or Replace Master Bathroom Window By Qualified Contractor As Soon As Possible**

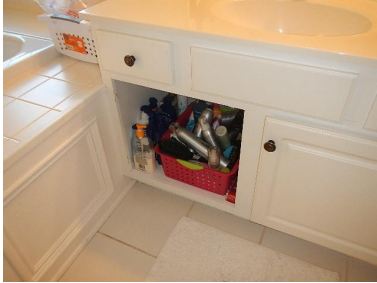
2

- Item: **Cabinets & Counters**
- Location: **Master Bathroom**
- Condition: **Missing Cabinet Door Right Of The Master Tub**
- Action: **Evaluate And Repair Or Replace Missing Cabinet Door In The Near Future**

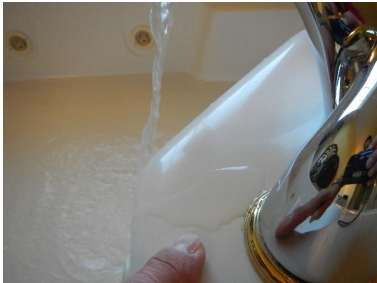
3

- Item: **Tub & Shower Faucets**
- Location: **Master Bath Tub Cold Water Faucet**
- Condition: **Active Leaking At Base Of Cold Faucet Handle**
- Action: **Evaluate And Repair Cold Water Faucet On Tub By Qualified Contractor In The Near Future**

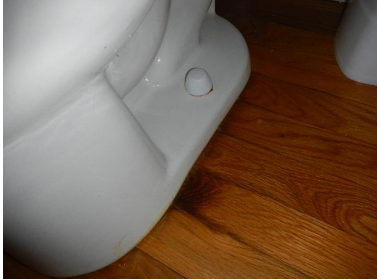
4

- Item: **Toilets**
- Location: **Main Floor Full Bath**
- Condition: **Past Leakage At Base Of Toilet**
- Action: **Monitor And Maintain As The House Ages**

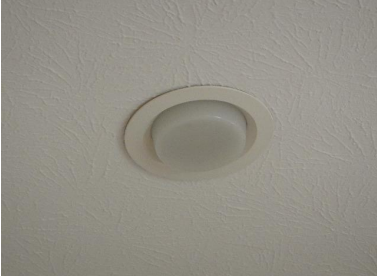
<b>5</b>

<ul style="list-style-type: none"> <li>- <b>Item:</b> Lights &amp; Outlets</li> <li>- <b>Location:</b> Master Bath Light Over Shower</li> <li>- <b>Condition:</b> Inoperative Light Fixtures - Bulb Burned Out?</li> <li>- <b>Action:</b> Service ( Light Bulb? )</li> </ul>
----------	---	--

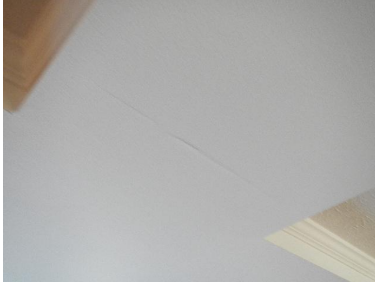
1

- **Item:** Walls & Ceiling
- **Location:** Family Room Ceiling
- **Condition:** Damaged Drywall - Small Crack In Ceiling
- **Action:** Evaluate And Repair Crack In Ceiling Of Family Room In The Near Future

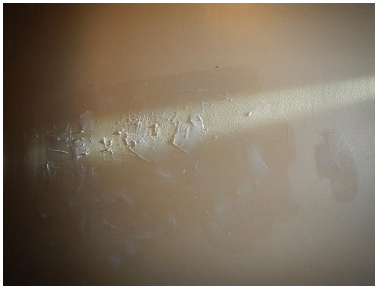
2

- **Item:** Walls & Ceiling
- **Location:** Basement North Of The T V Screen Area
- **Condition:** Damaged Drywall From Dart Board
- **Action:** Evaluate And Repair Damaged Drywall In The Near Future

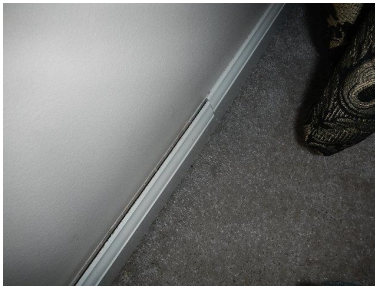
3

- **Item:** Walls & Ceiling
- **Location:** Basement East Wall
- **Condition:** Loose Baseboard Trim
- **Action:** Secure Baseboard Trim In The Near Future

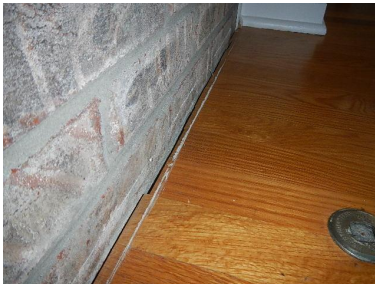
4

- **Item:** Floors
- **Location:** Family Room Fireplace
- **Condition:** Missing Trim Along Front Of Hearth
- **Action:** Install Trim If Desired

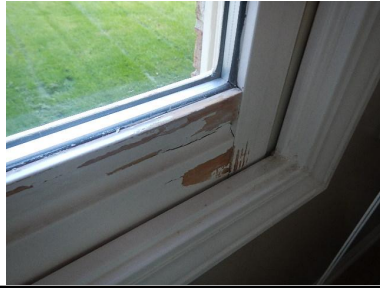
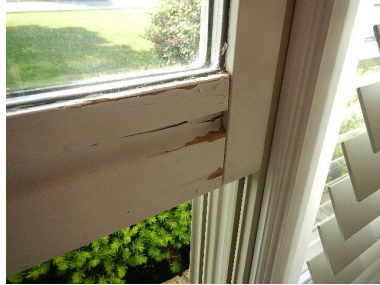
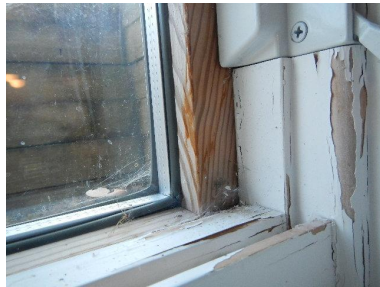
5

- **Item:** Windows
- **Location:** Most Windows Throughout Home
- **Condition:** Evidence Of Peeling Paint
- **Action:** Scrape And Paint All Wood Windows As Soon As Possible To Prevent Deterioration

- **Item:** Windows
- **Additional Photo Of:** Peeling Paint

- **Item:** Windows
- **Additional Photo Of:** Evidence Of Peeling Paint

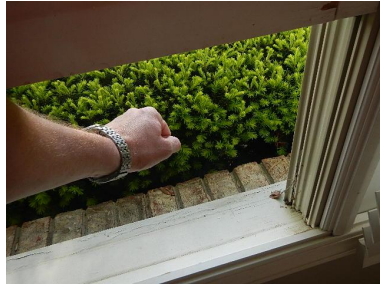
7

- **Item:** Windows
- **Location:** Throughout House
- **Condition:** Missing/ Non-installed Screens In Windows
- **Action:** Locate & Install Screens If Desired

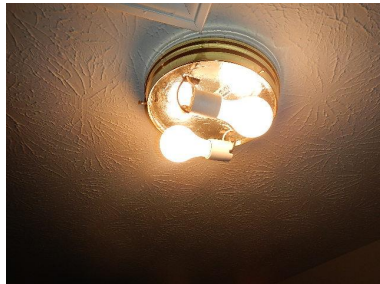
9

- **Item:** Lights & Outlets
- **Location:** Master Bedroom Closet
- **Condition:** Missing Globe On Light Fixture In Closet
- **Action:** Replace Globe In The Near Future

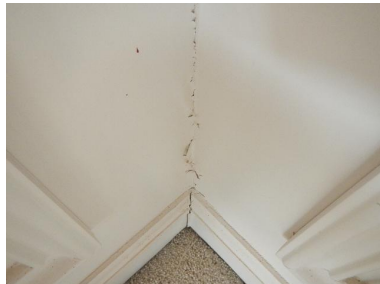
10

- **Item:** Walls & Ceiling
  - **Location:** S W Corner Of Dining Room
  - **Condition:** Minor Settlement Crack
  - **Action:** Monitor And Maintain As The House Ages
- The Crack In This Area Could Be Repaired As Well.

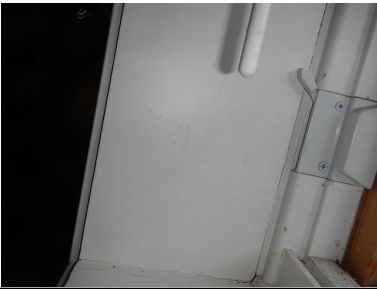
**11**

- **Item:** Windows
- **Location:** Basement East Window
- **Condition:** Past Signs Of Moisture On The Window Sill
- **Action:** Monitor And Maintain As The House Ages

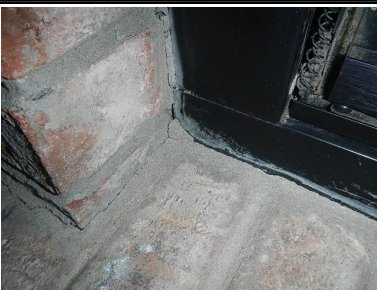
**12**

- **Item:** Fireplace
- **Location:** Family Room Fireplace Hearth
- **Condition:** Hearth Has Cracked And Settled Slightly Where It Meets The Fireplace
- **Action:** Monitor And Maintain As The House Ages

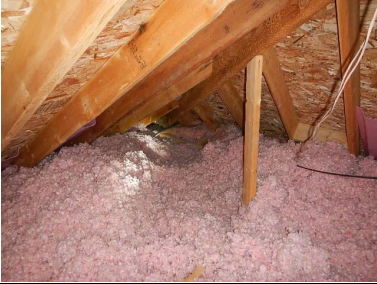
<b>1</b>

<p><b>ACCESSIBILITY</b></p> <ul style="list-style-type: none"> <li>- Item: Accessibility</li> <li>- Location: Upper Attic</li> <li>- Condition: Evidence Of Past Animal Activity At Northwest Corner Of Attic</li> <li>- Action: Monitor</li> </ul>
<b>2</b>

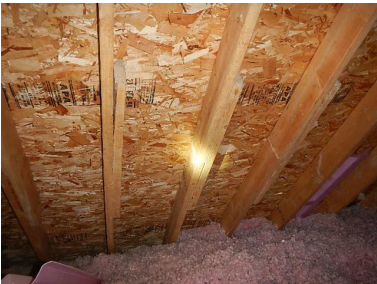
<p><b>WOOD RAFTERS</b></p> <ul style="list-style-type: none"> <li>- Item: Wood Rafters</li> <li>- Location: Garage Attic</li> <li>- Condition: Several Repaired Rafters In The Garage Attic</li> <li>- Action: Monitor And Maintain As The House Ages</li> </ul>

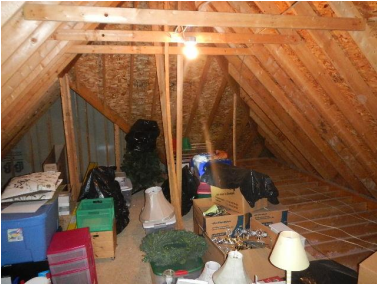
<b>3</b>

<p><b>ACCESSIBILITY</b></p> <ul style="list-style-type: none"> <li>- Item: Accessibility</li> <li>- Condition: Limited Access Due To Stored Items Above The Garage</li> </ul>
<b>4</b>

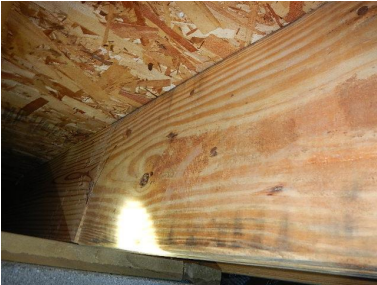
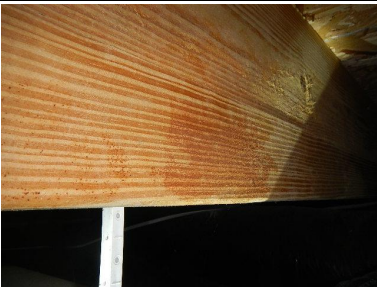
<b>1</b>

<ul style="list-style-type: none"> <li>- Item: <i>Floor Framing</i></li> <li>- Location: <i>Throughout Crawl Space Floor Joists</i></li> <li>- Condition: <i>Evidence Of Moderate Mold Growth On Floor Joist</i></li> <li>- Action: <i>Evaluate And Repair/ Treat All Mold Growth By Qualified Contractor Prior To Closing</i></li> </ul>
<b>2</b>

<ul style="list-style-type: none"> <li>- Item: <i>Floor Framing</i></li> <li>- Additional Photo Of: <i>Evidence Of Moderate Mold Growth</i></li> </ul>
<b>3</b>

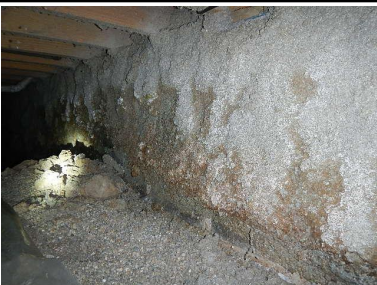
<ul style="list-style-type: none"> <li>- Item: <i>Insulation</i></li> <li>- Location: <i>Crawl Space</i></li> <li>- Condition: <i>Cellulose Insulation In Crawl Is Deteriorated And Wet</i></li> <li>- Action: <i>Evaluate And Repair Or Replace Crawl Space Foundation Insulation By Qualified Contractor As Soon As Possible</i></li> </ul>

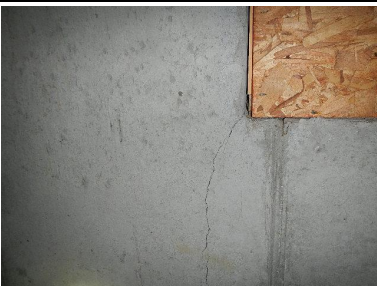
<b>4</b>

<ul style="list-style-type: none"> <li>- Item: <i>Foundation Walls</i></li> <li>- Location: <i>South Basement Foundation Wall</i></li> <li>- Condition: <i>Evidence Of Minor Settlement Crack</i></li> <li>- Action: <i>Monitor As The House Ages - This Does Not Appear To Be A Serious Problem At The Time Of The Inspection - This Could Need Corrective Action If The Problem Continues</i></li> </ul>
----------	---	--

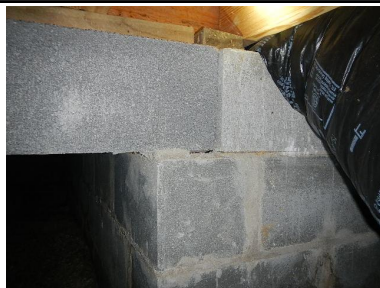
5

- Item: **Foundation Walls**
- Location: **East Side Of Crawl Space Foundation Wall Near Garage Floor Area**
- Condition: **Evidence Of Settling**
- Action: **Monitor As The House Ages - This Does Not Appear To Be A Serious Problem At The Time Of The Inspection - This Could Need Corrective Action If The Problem Continues**

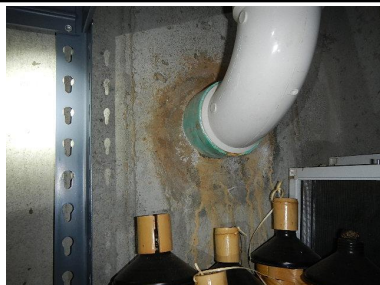
6

- Item: **Municipal Sewer**
- Location: **S E Wall Of The Basement**
- Condition: **Past Leakage Around The Main Sewer Line As It Exits The Foundation Wall**
- Action: **Monitor As The House Ages**

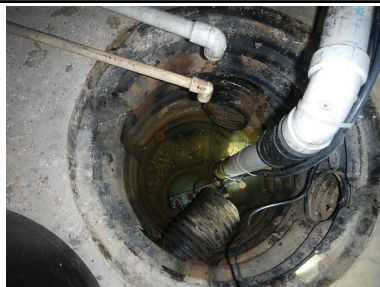
7

- Item: **Sump Pump**
- Location: **Basement Sump Pump**
- Condition: **We Suggest Adding A Backup Sump Pump As An Improvement To The Home Due To The Basement Being Finished.**
