FONTENELLE DAM, RIRIE DAM, AND TETON DAM – AN EXAMINATION OF THE INFLUENCE OF ORGANIZATIONAL CULTURE ON DECISION-MAKING

Fontenelle Dam, near Fontenelle, Wyoming, built by the Bureau of Reclamation between 1960 and 1964, had a serious incident in 1965 that nearly caused a breach of the structure that could have released more than 300,000 acre-feet of water. Teton Dam, near Rexburg, Idaho, built by the Bureau of Reclamation between 1972 and 1976, failed in 1976 releasing more than 250,000 acre-feet of water and causing 11 fatalities. Ririe Dam, also near Rexburg Idaho, was built in geologic conditions similar to Teton by the Walla Walla District of the Corps of Engineers between 1970 and 1976 – was subsequently transferred to Reclamation – and has performed well over its life. The dams are all located within 150 miles of each other. The story of why Teton Dam failed is more complex than the technical details surrounding its construction and destruction. The Teton disaster is a story of engineering judgment, communication, decision-making, economics, organization, culture, and individual and organizational hubris. To tell this story, one needs to examine the organizational cultures i

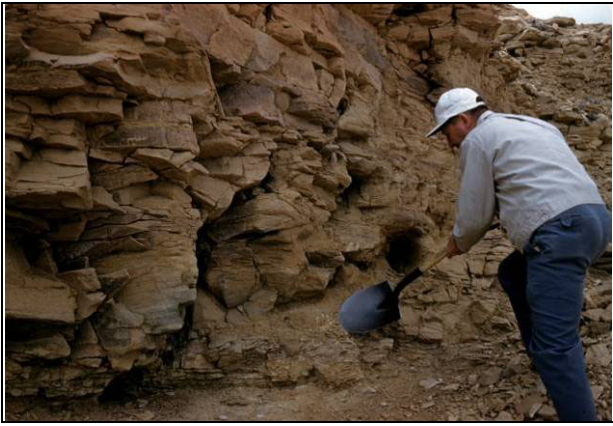
Figure 2A. A photo from right abutment site exploration in the 1950's showing the fractured nature of the foundation.

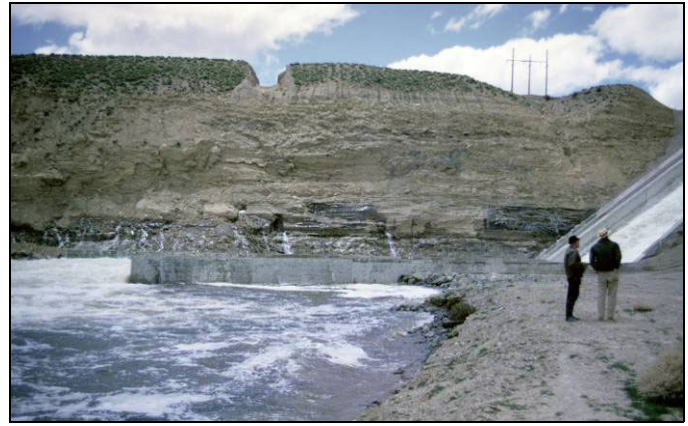
Figure 2B. A photo of the abutment downstream of the spillway. The seepage pattern illustrates the permeability and layering in the foundation.

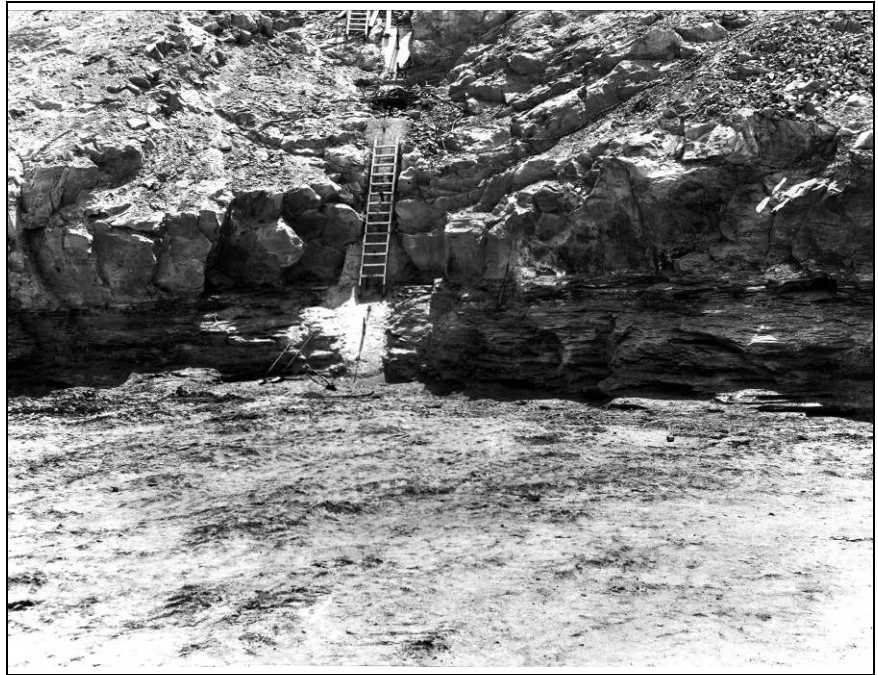
Figure 4B. A photo showing embankment construction along the right abutment. Note the steepness of the foundation and the narrowness of the grout cap under the ladder.

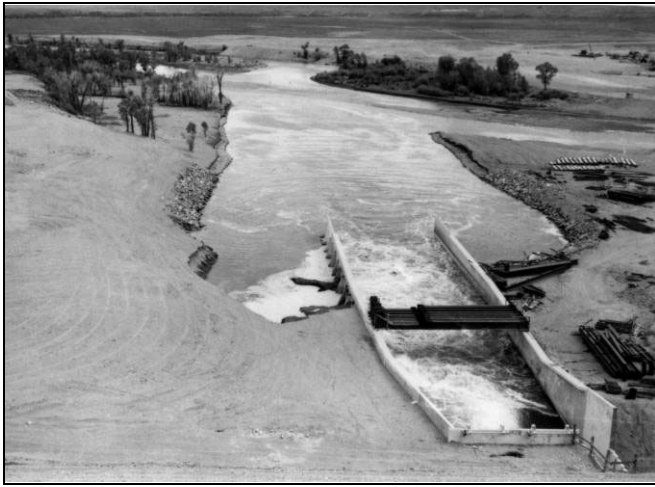
- A partial failure of the backfill behind the river outlet stilling basin on May 27, 1964. Divers found 1,800 yd³ of material in the stilling basin. Concentrated seepage was discovered exiting the shale.

Figure 6A. Failure of the backfill on the left side of the river outlet stilling basin, May 30, 1964

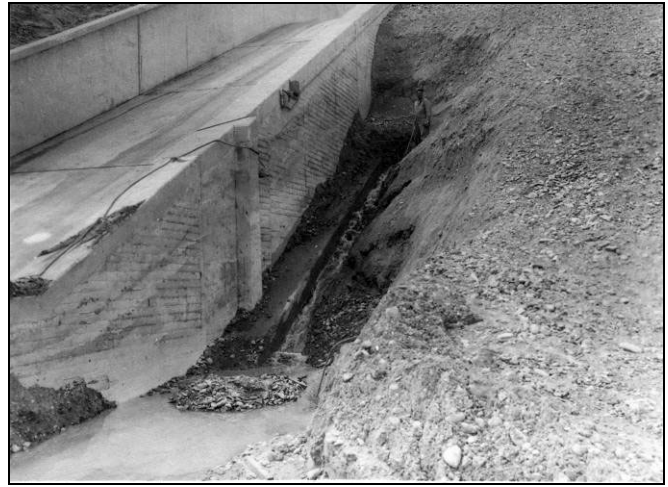
Figure 6B. Seepage emerging from the shale formation along the left side of the spillway chute, May 21, 1965.

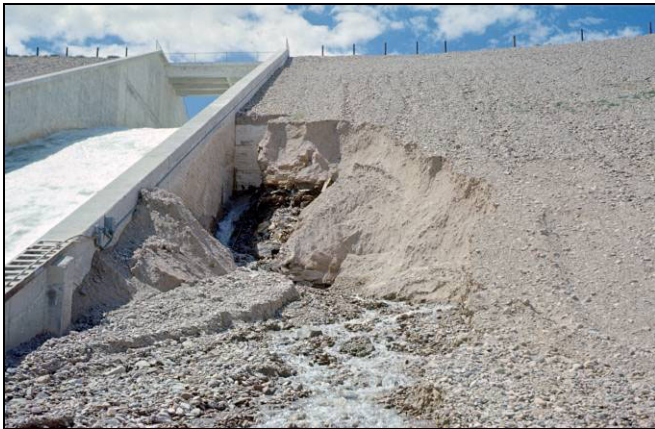
Figure 7A. Seepage emerging from the shale formation along the left side of the spillway chute, July 28, 1965.

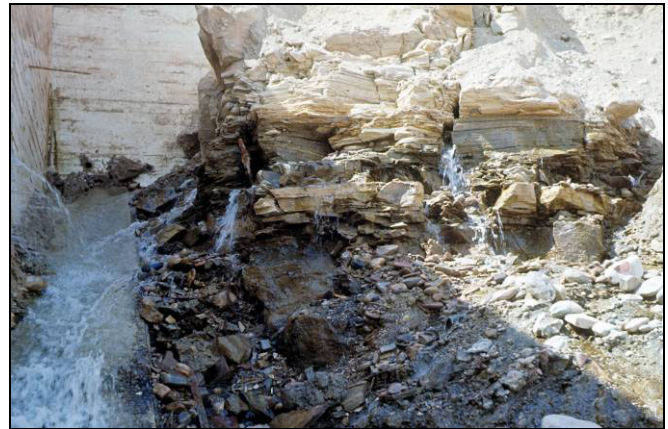
Figure 7B. Seepage emerging from the shale formation along the left side of the spillway chute, July 28, 1965.

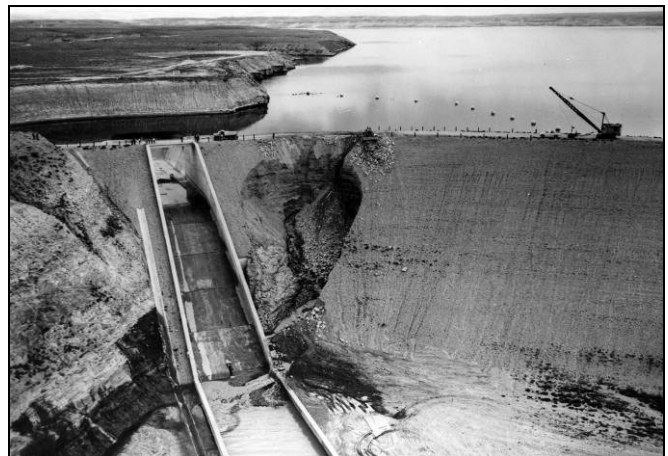
A major disaster was averted in September 1965 (Figure 8) when Reclamation opened the river outlet works and the two canal outlet works at Fontenelle in an effort to lower the reservoir as rapidly as possible. So serious was the situation that equipment and formwork were washed out of the river outlet works, which was under construction to repair scour damage to the concrete stilling basin. Fortunately, the reservoir has a significant release capacity, and the pool dropped nearly 4 feet per day until the erosion waned and then stopped. The reservoir volume at the time of the incident was approximately 300,000 acre-feet, and dam failure would have released a tremendous amount of water. While the reservoir was down, the eroded portion of the embankment was replaced and the foundation was grouted extensively through 1967.

Figure 8B. A wider photo of the large unstable area on the left side of spillway chute, September 17, 1965.

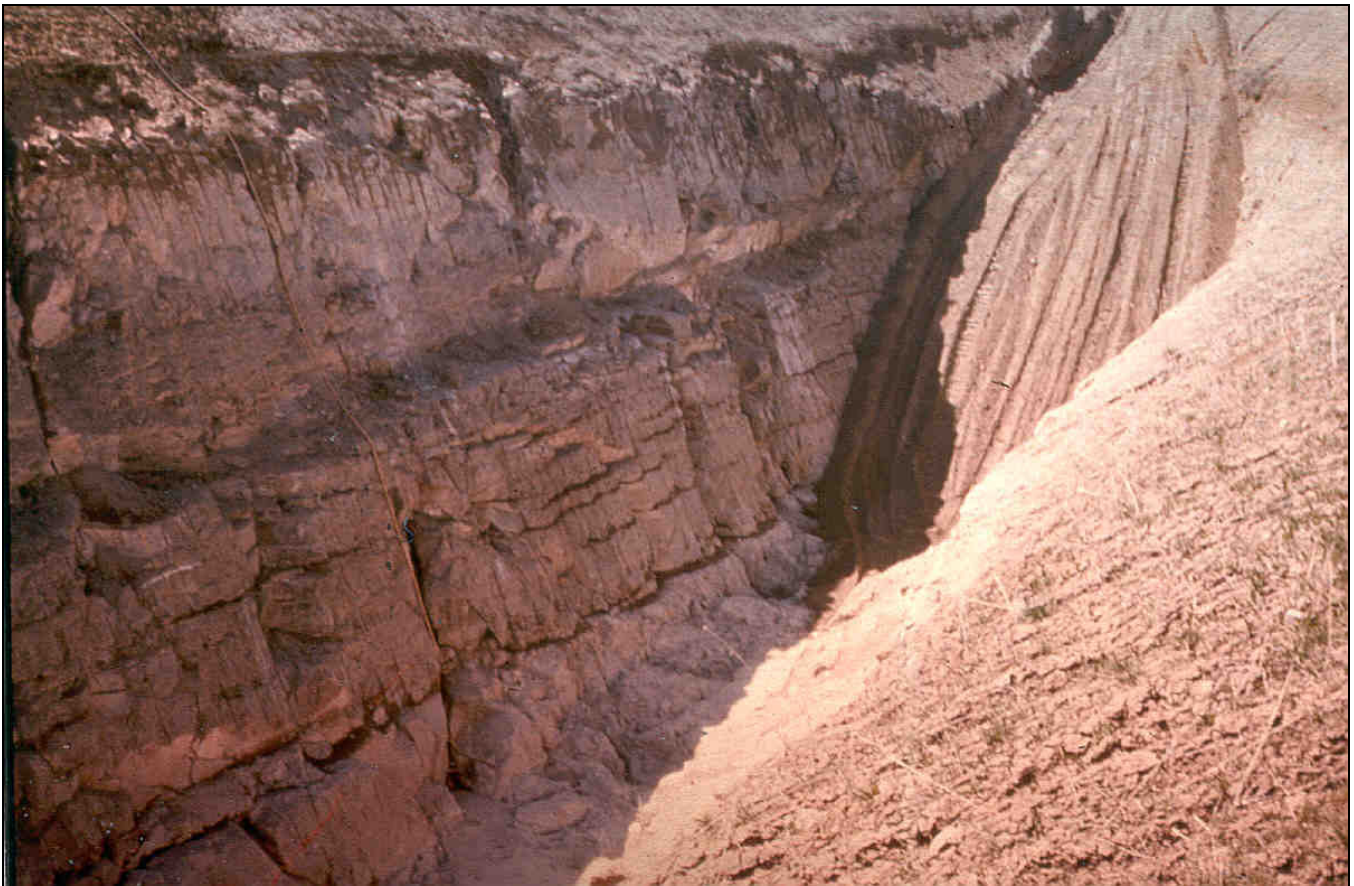
Continuous high-angle joints in the right abutment have been traced for lengths of as much as 200 feet, but most are between 20 and 100 feet long. The aperture of most high-angle joints is less than one-half inch, but many joints are as much as several inches wide and some are several feet wide. Examples of the jointing can be seen in Figures 16 and 17.

Figure 16. A view of the right abutment key trench showing the jointed nature of the foundation
