FEMA DR-GA-1033

INTERAGENCY HAZARD MITIGATION TEAM

FLOODING IN GEORGIA FROM TROPICAL STORM ALBERTO

PREPARED BY THE
BUILDING AND DAM
PERFORMANCE ASSESSMENT TEAM

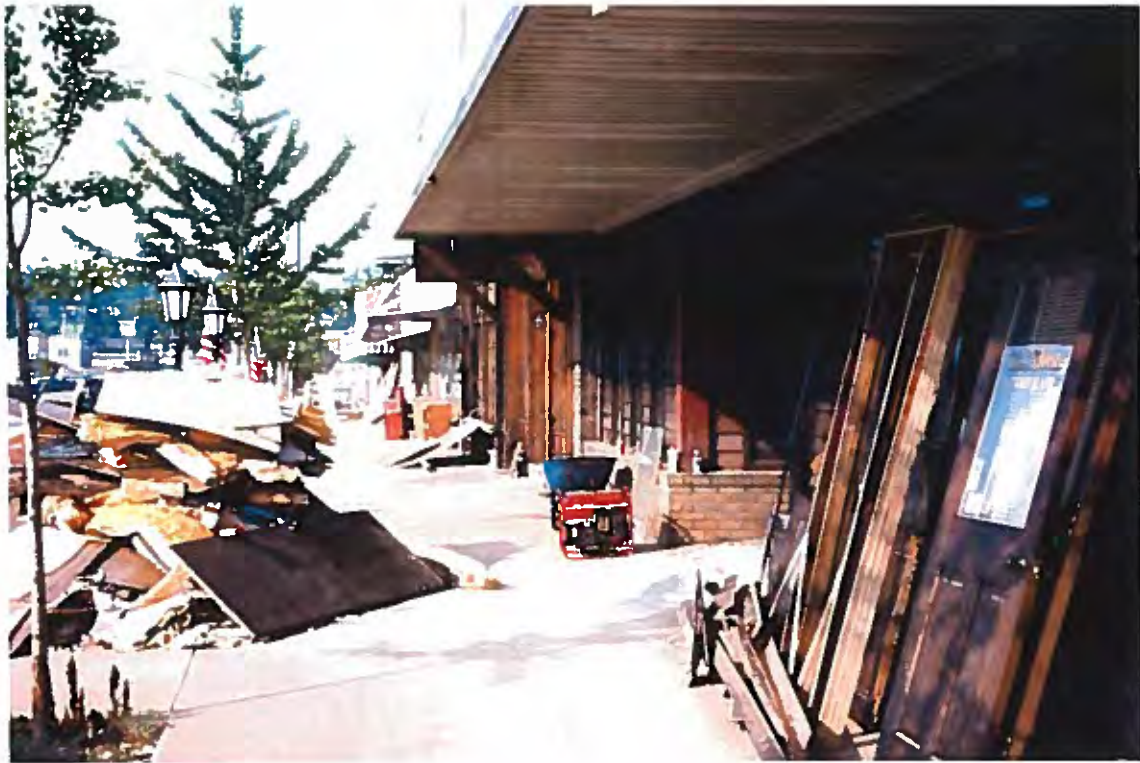
1. Robert's Law Office. Flooding caused extensive damage to timber subflooring and flooring.

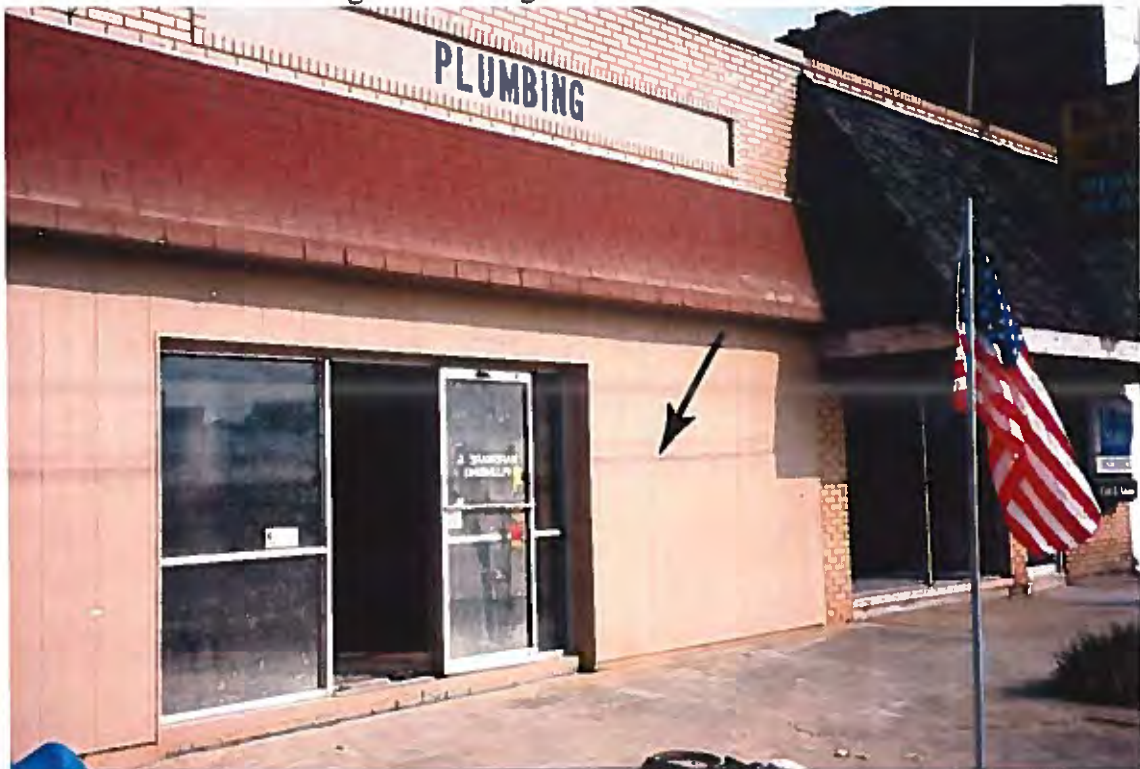
2. Looking toward Flint River along S. Dooly Street.
Damaged furnishings.

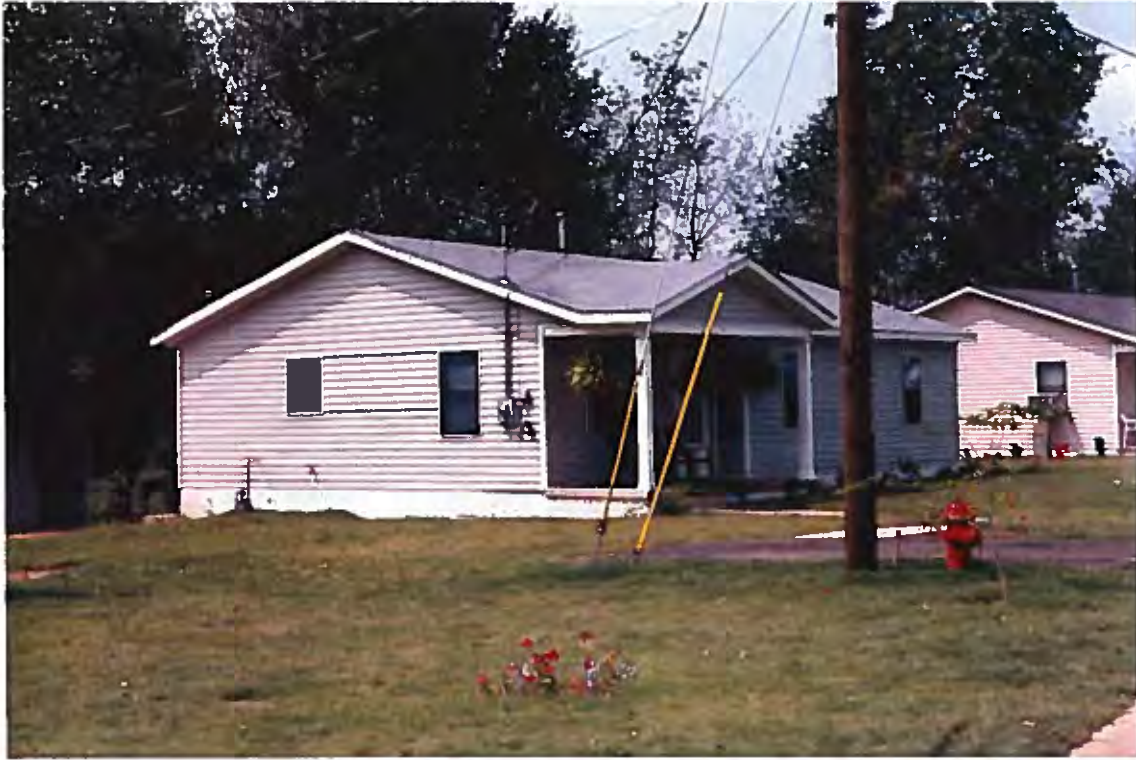
1. Success story. House built adjacent to but far enough away from creek.

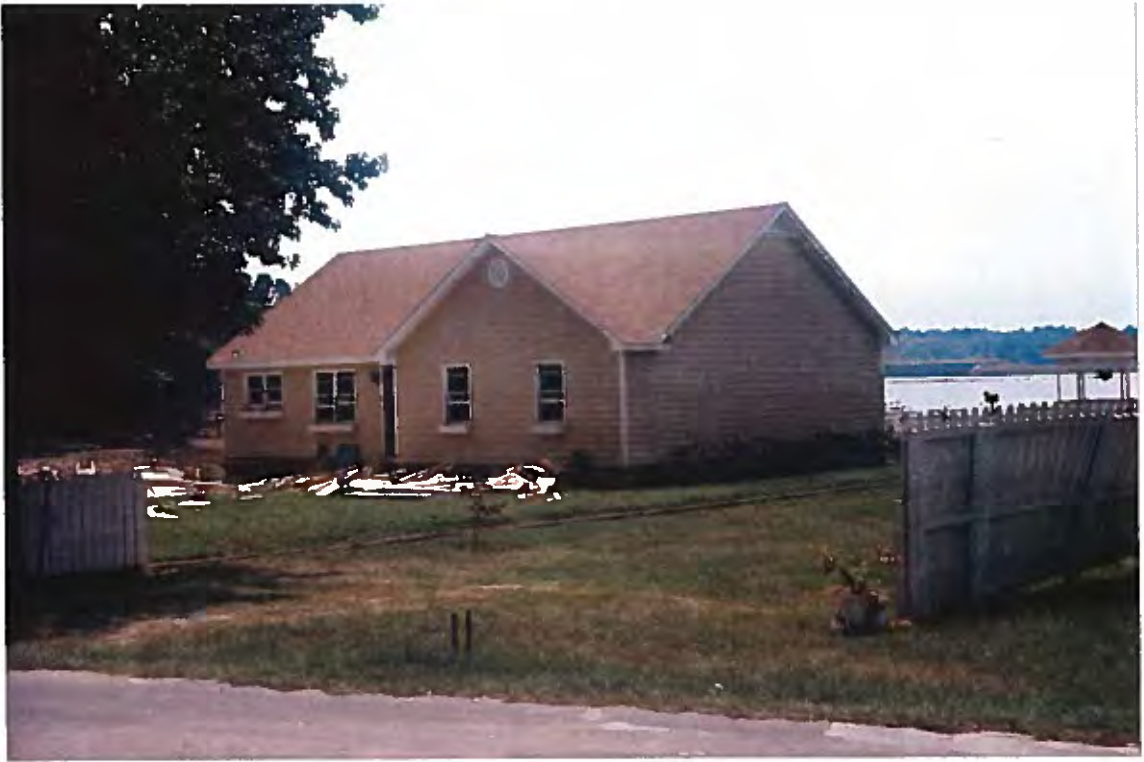
1. House on Lake Blackshear damaged by high water.
Interior goods and furnishings damaged by floodwaters.

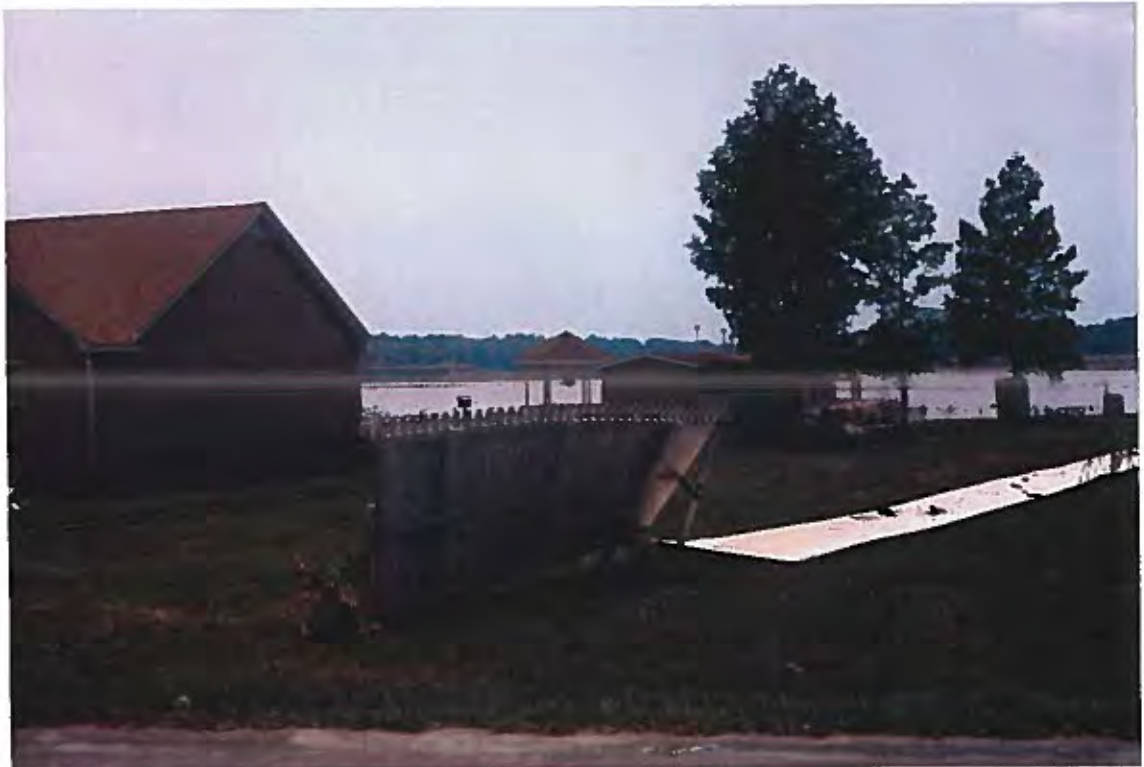
2. House on Lake Blackshear. Fence damaged by floodwaters.

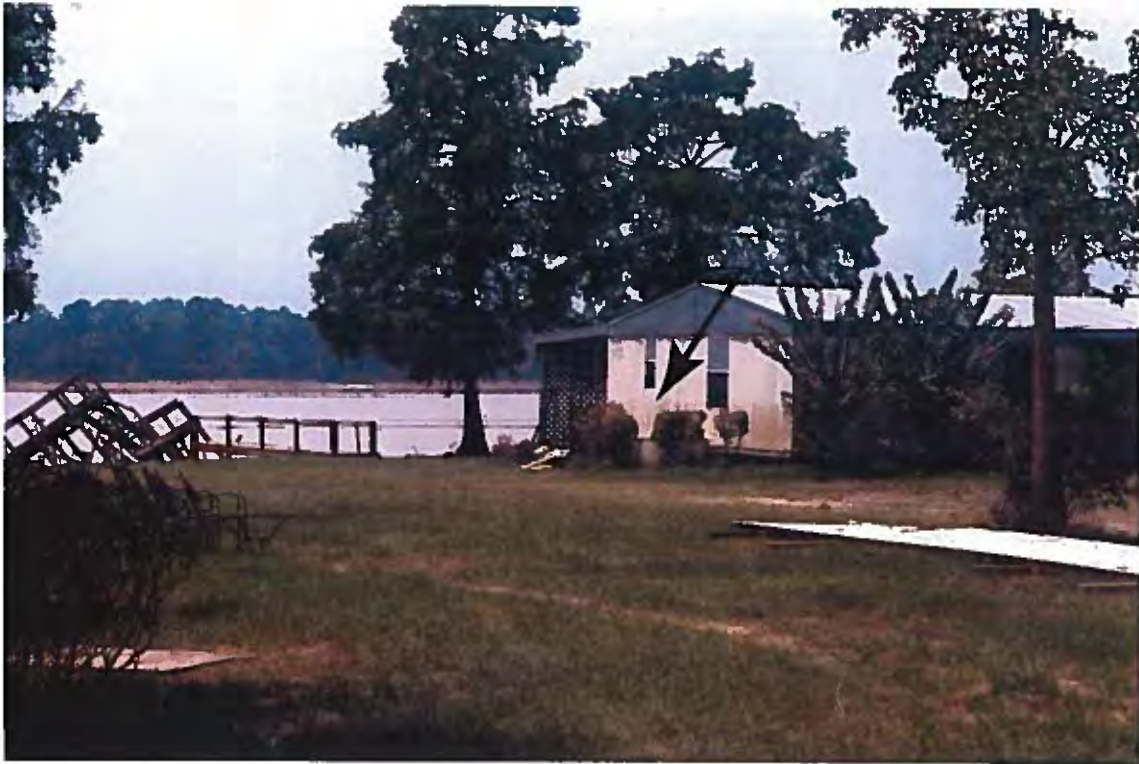
3. House on Lake Blackshear damaged by high water.
High water mark indicted by arrow.

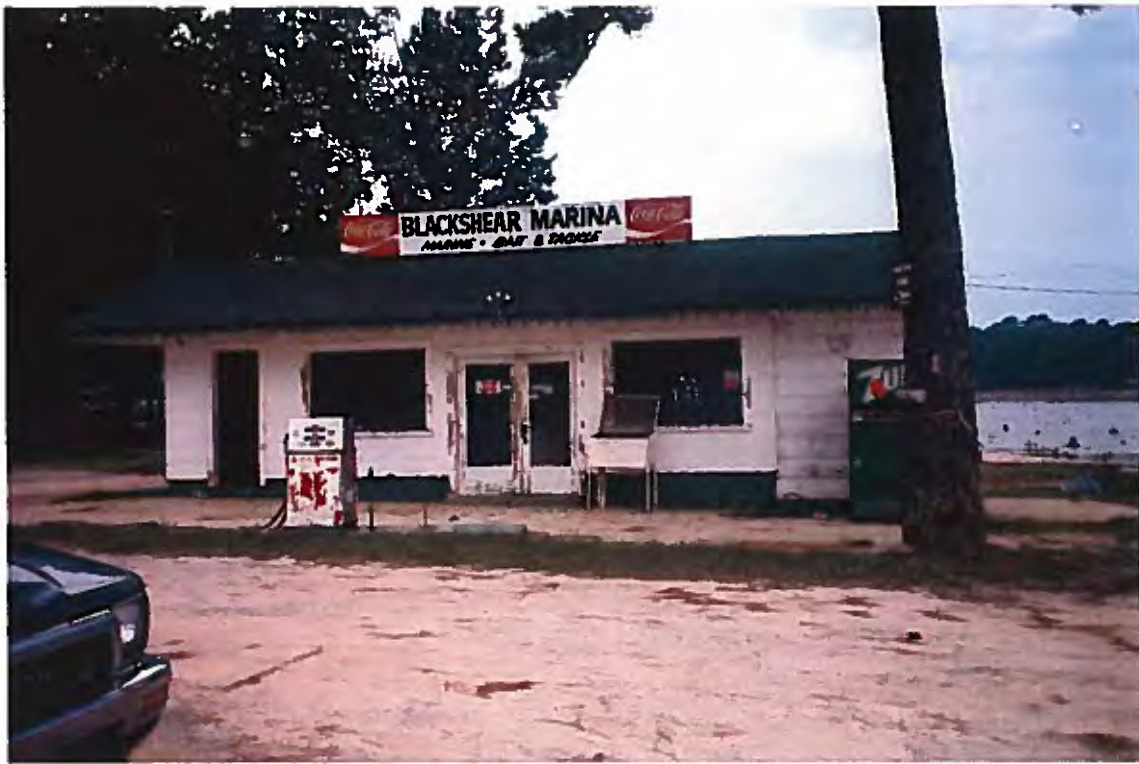
9. Blackshear Marina at State Route 300. Interior goods and furnishings damaged by floodwaters.

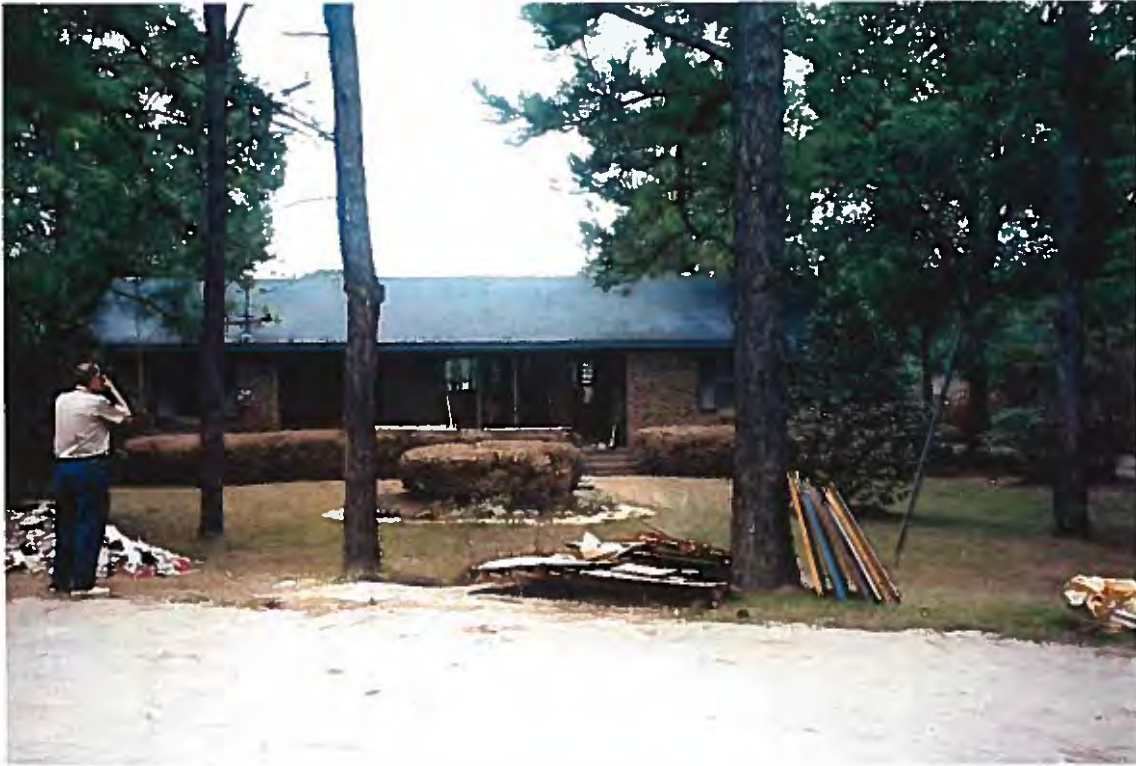
3. Cowart House on E. Parks Avenue under repair. Interior goods and furnishings damaged by floodwaters.

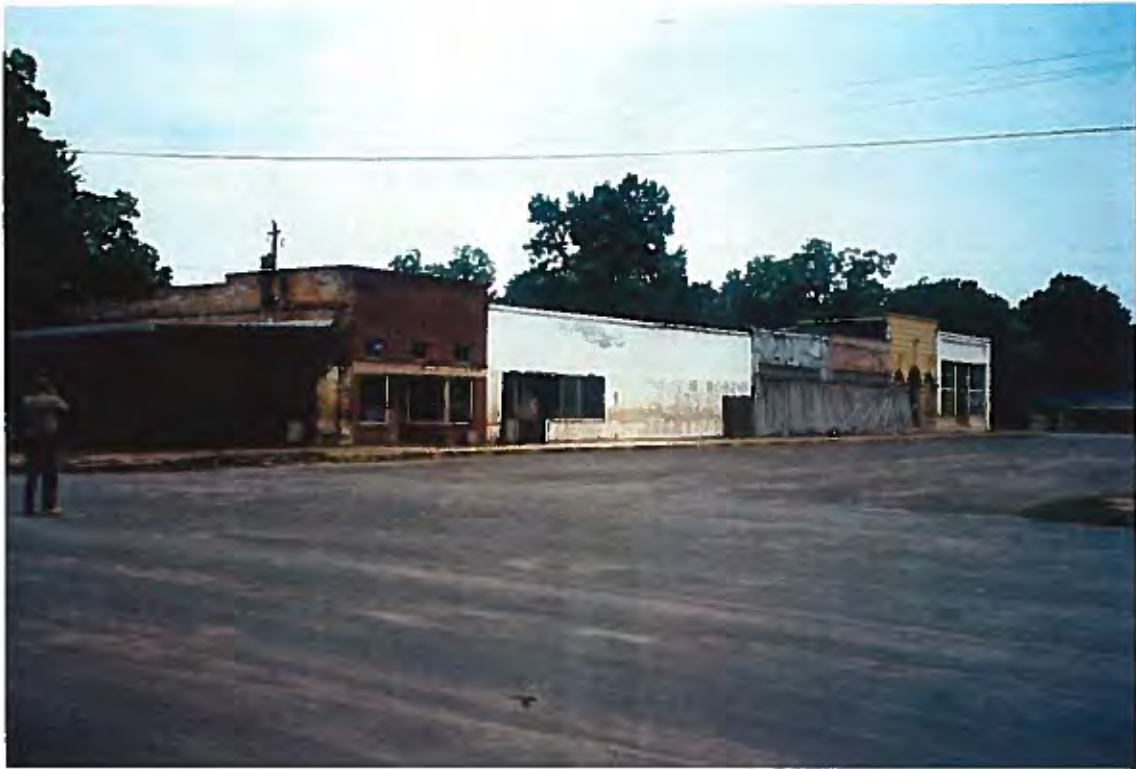
7. Commercial buildings across from courthouse. All goods and furnishings damaged by floodwaters.

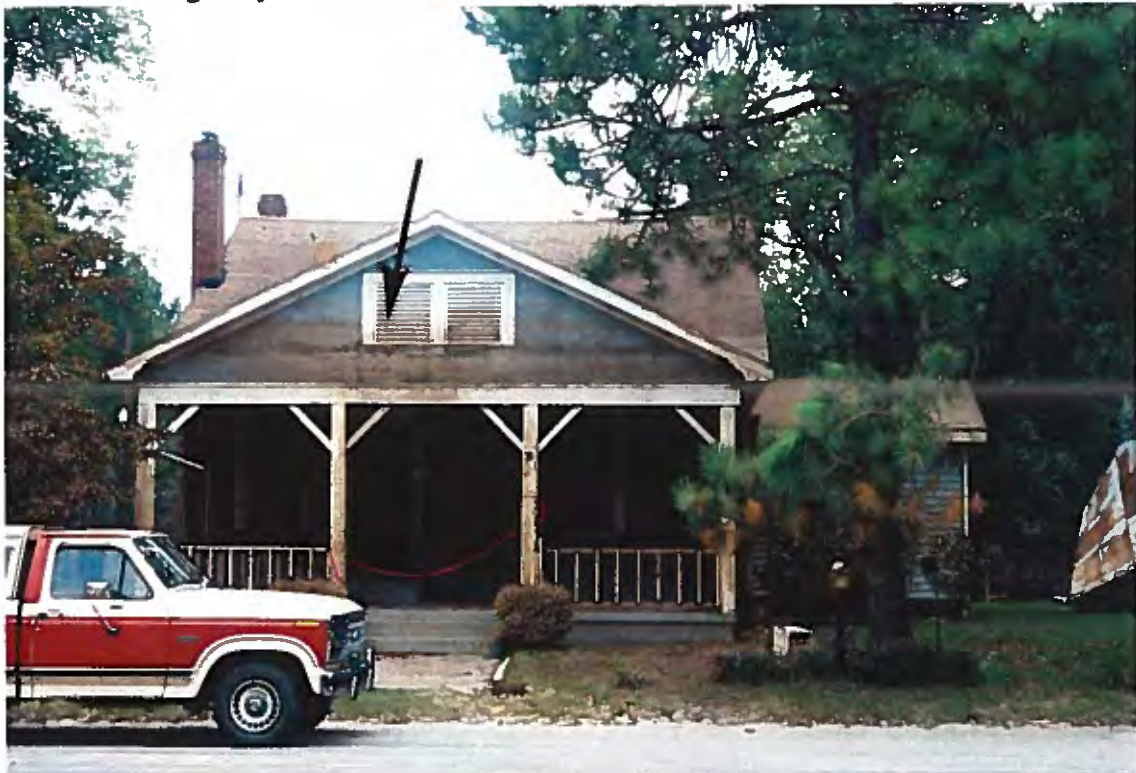
8. House across from courthouse. High water mark indicated by arrow.

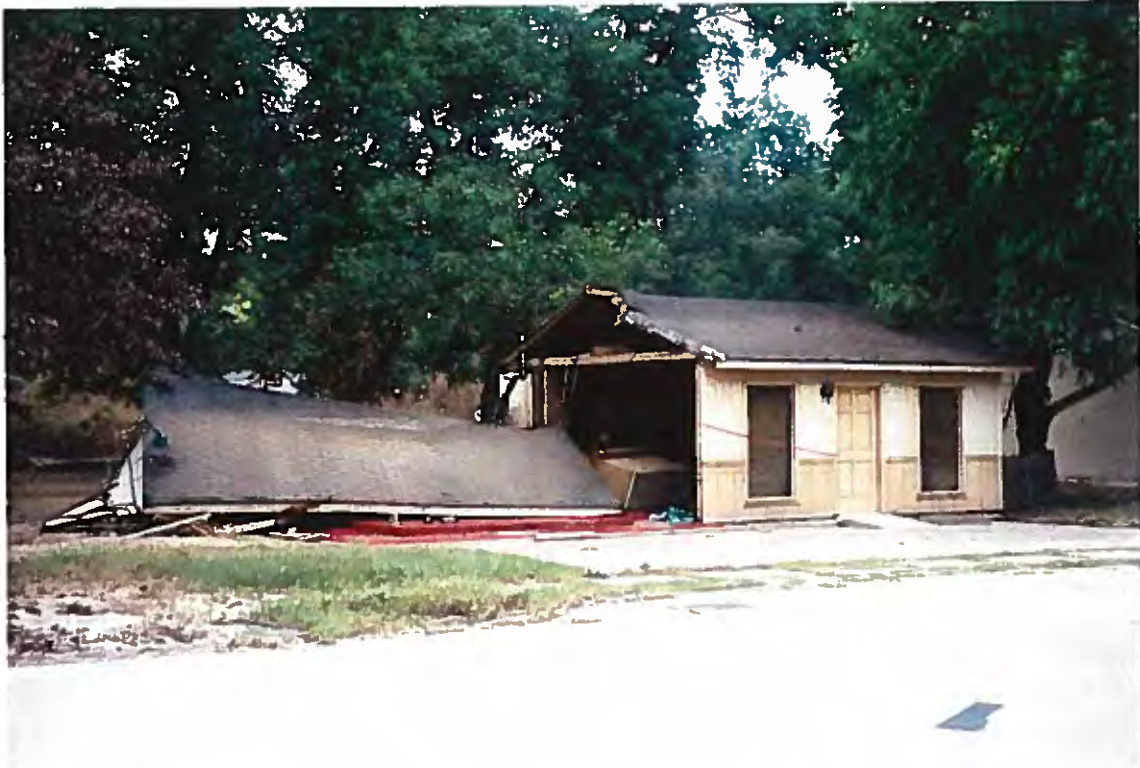
11. House failure on Broad Street (frame construction). Collapse likely due to floodwaters floating the structure off its foundation.

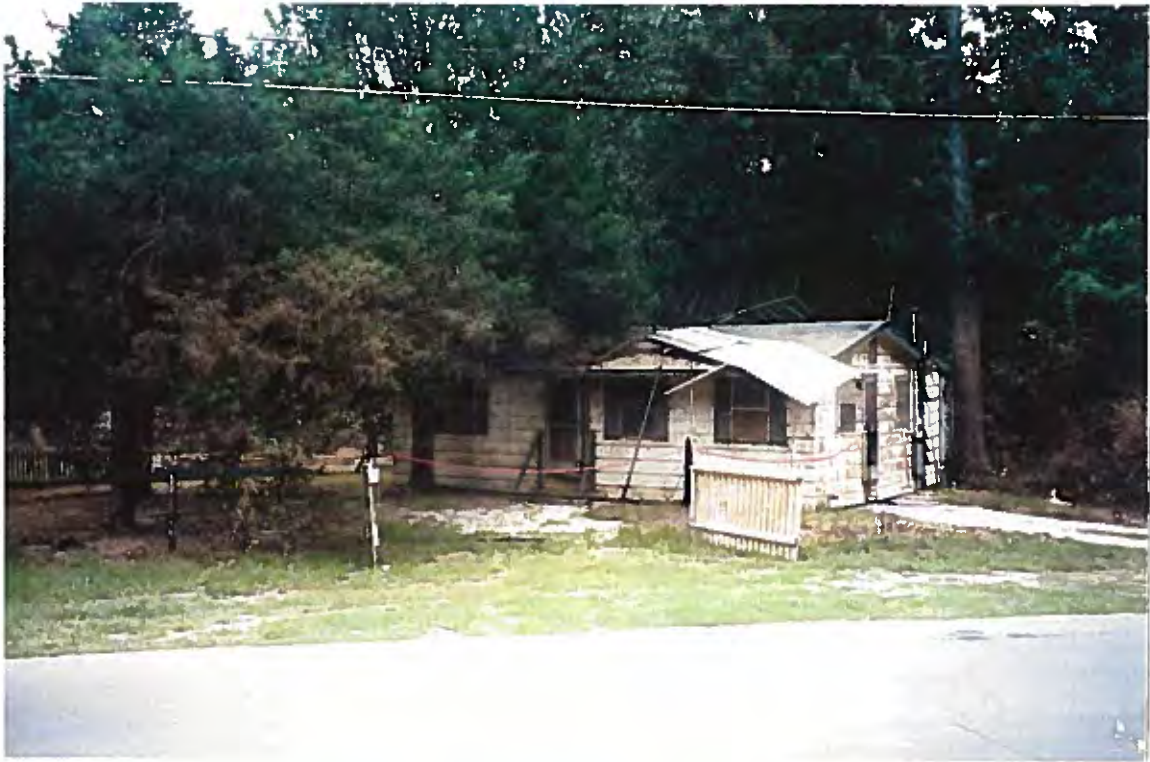
12. Main Street. Frame house floated off foundation and moved 20-30 feet.

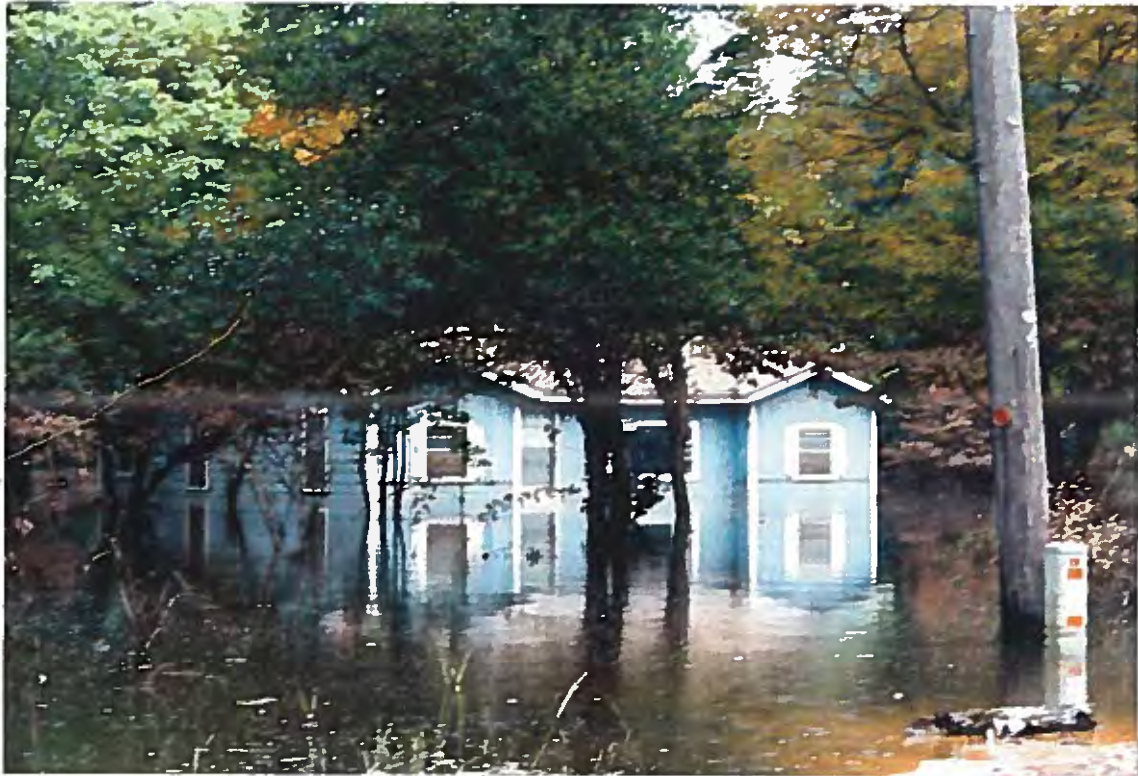
13. House on Clear Water Street still flooded.

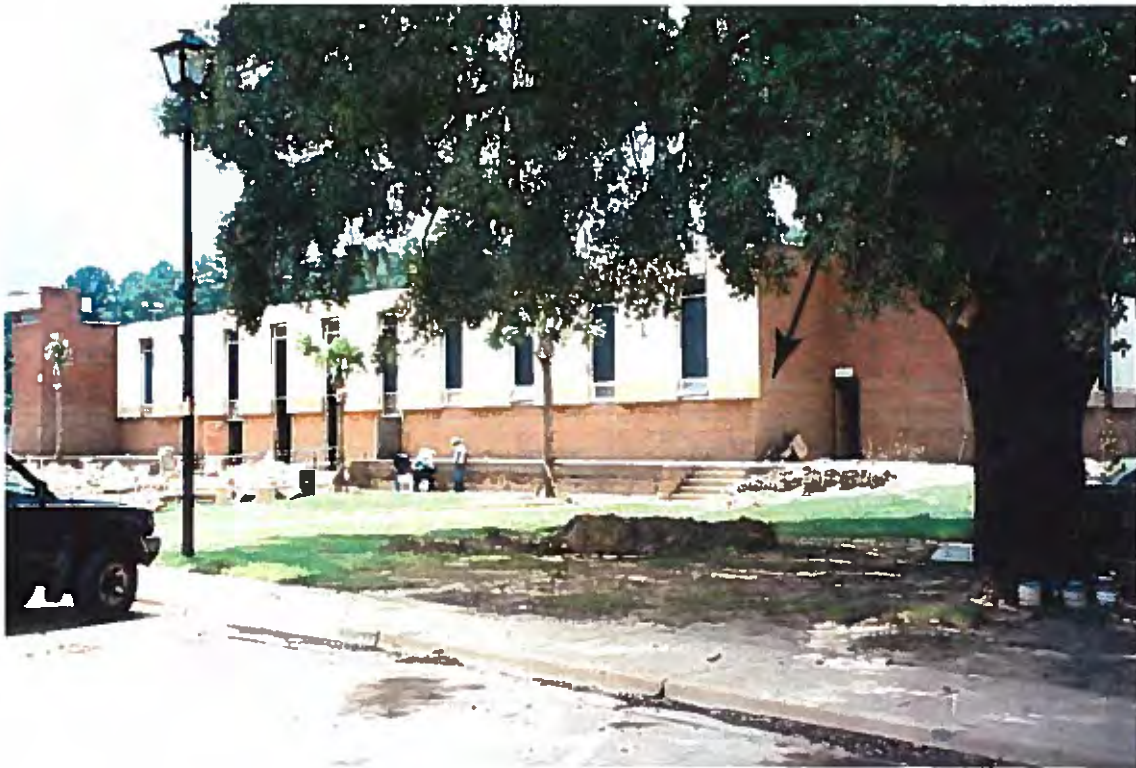
1. Blaylock Dormitory at Albany State College. High water mark indicated by arrow.

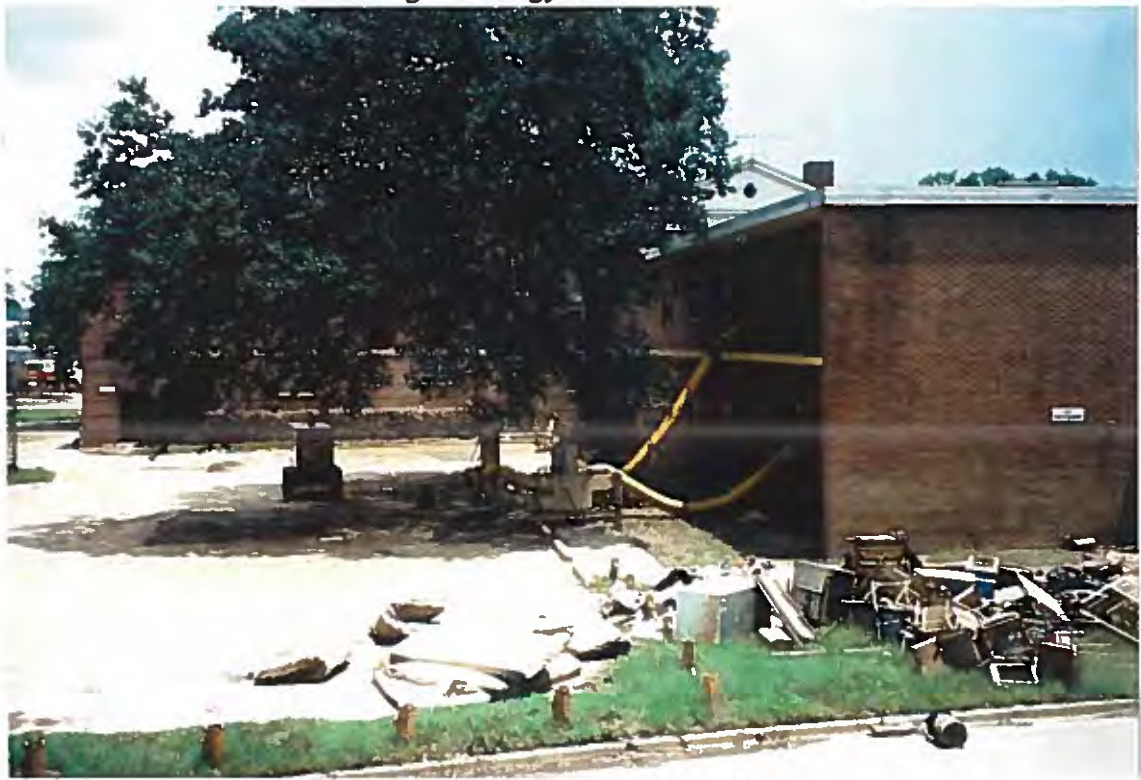
4. Dormitory adjacent to Blaylock Dormitory. Interior goods and furnishings damaged by floodwaters.

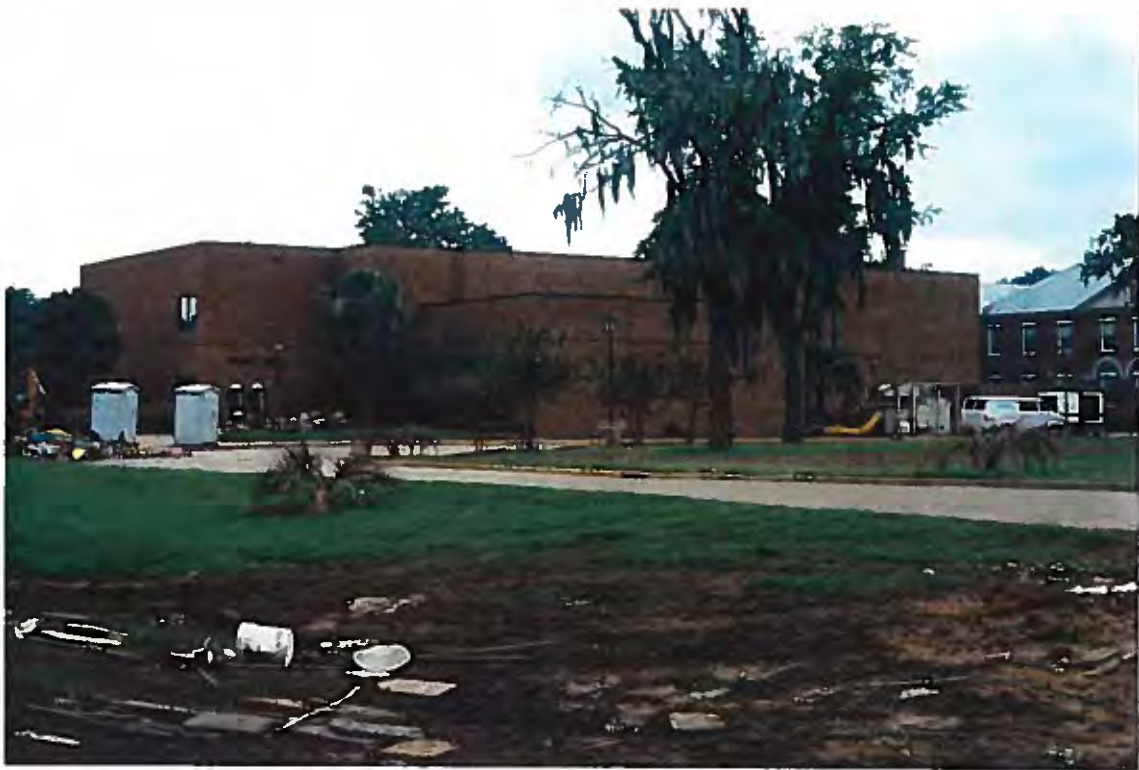
7. Peace Hall. Interior goods and furnishings damaged by floodwaters.

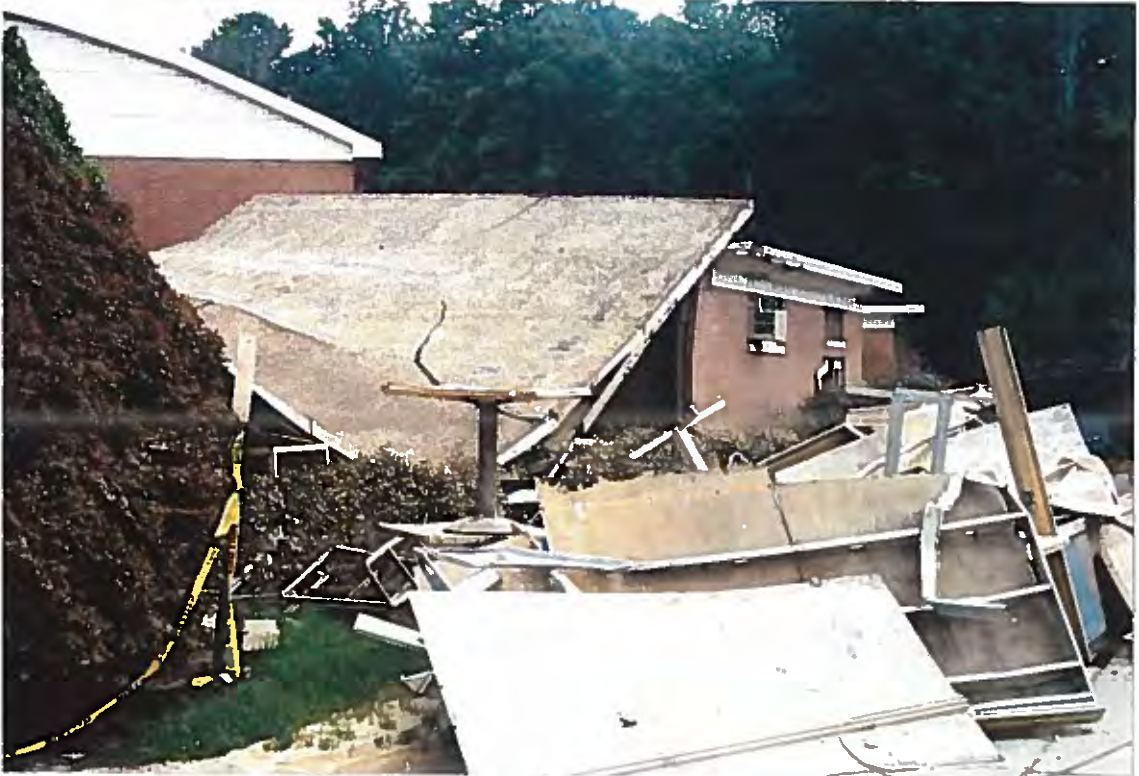
8. Building failure near gymnasium. 4-inch block wall faced with brick collapsed.

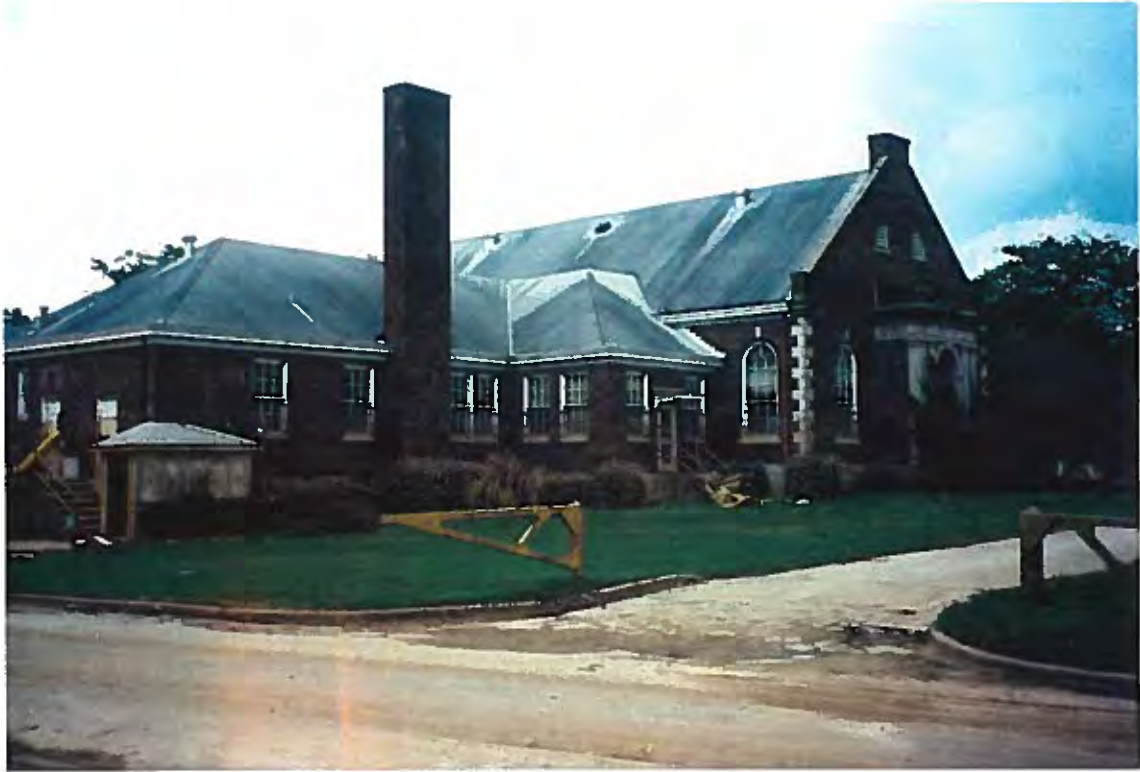
9. Classroom building next to dining hall. Interior goods and furnishings damaged by floodwaters.

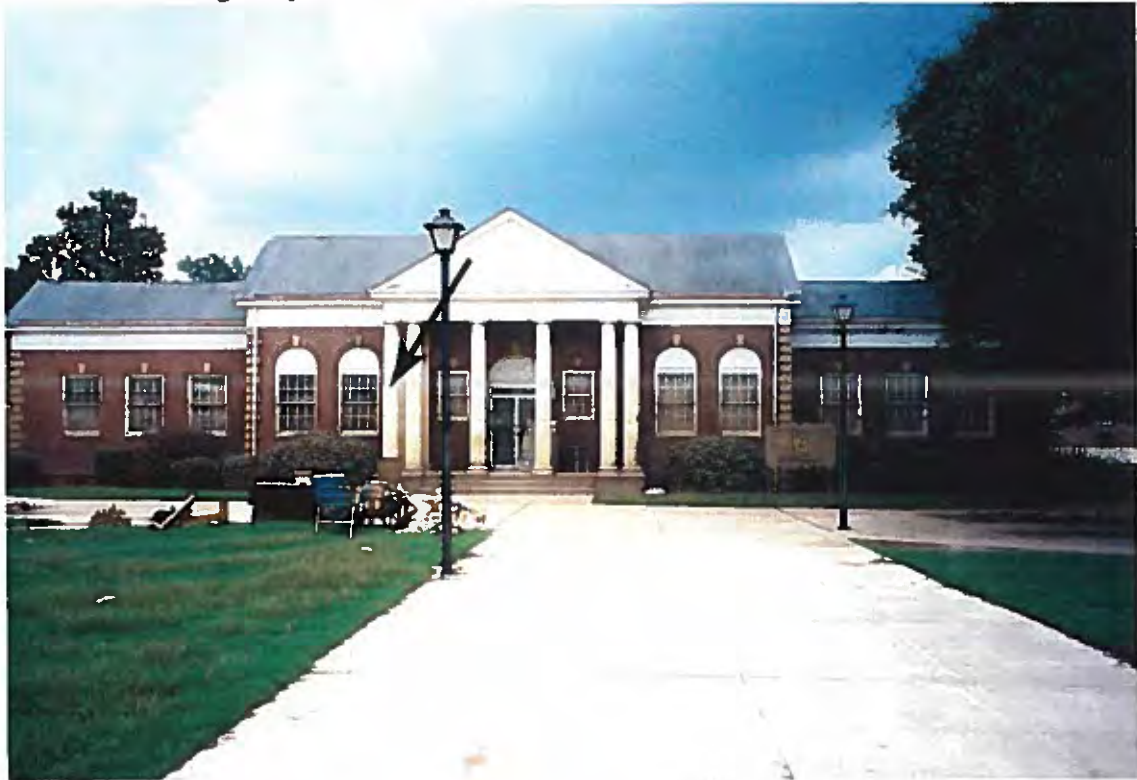
10. ROTC building. High water mark indicated by arrow.

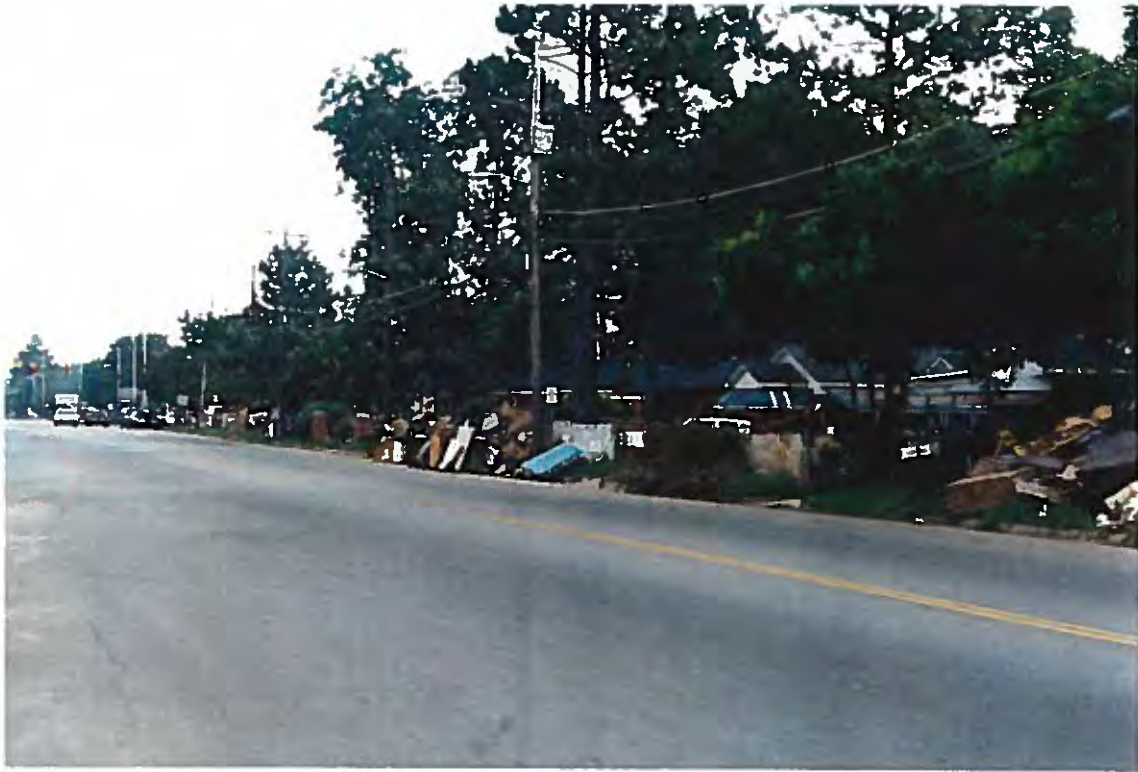
13. Single-family houses on King Drive near Gains Avenue. Interior goods and furnishings damaged by floodwaters.

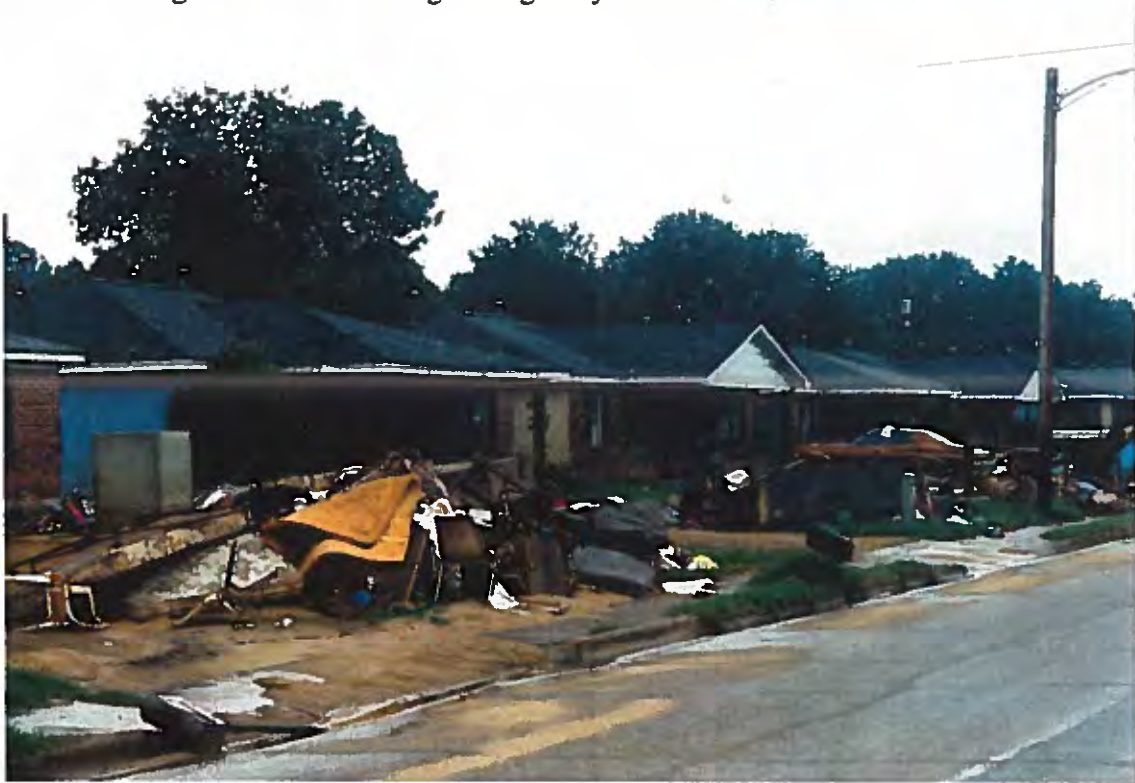
14. Single-family houses on Flintside Drive. Flood depths reached 5 to 6 feet. All interior goods and furnishings damaged by floodwaters.

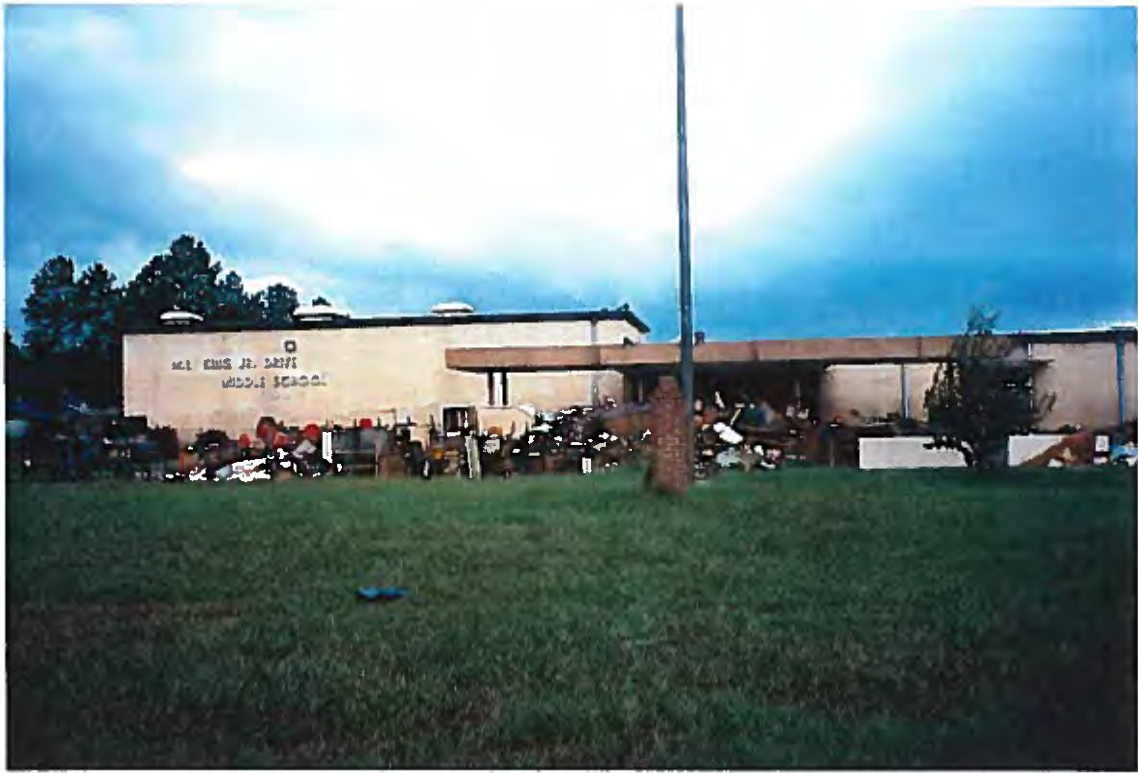
15. Martin Luther King Middle School. Interior goods and furnishings damaged by floodwaters.

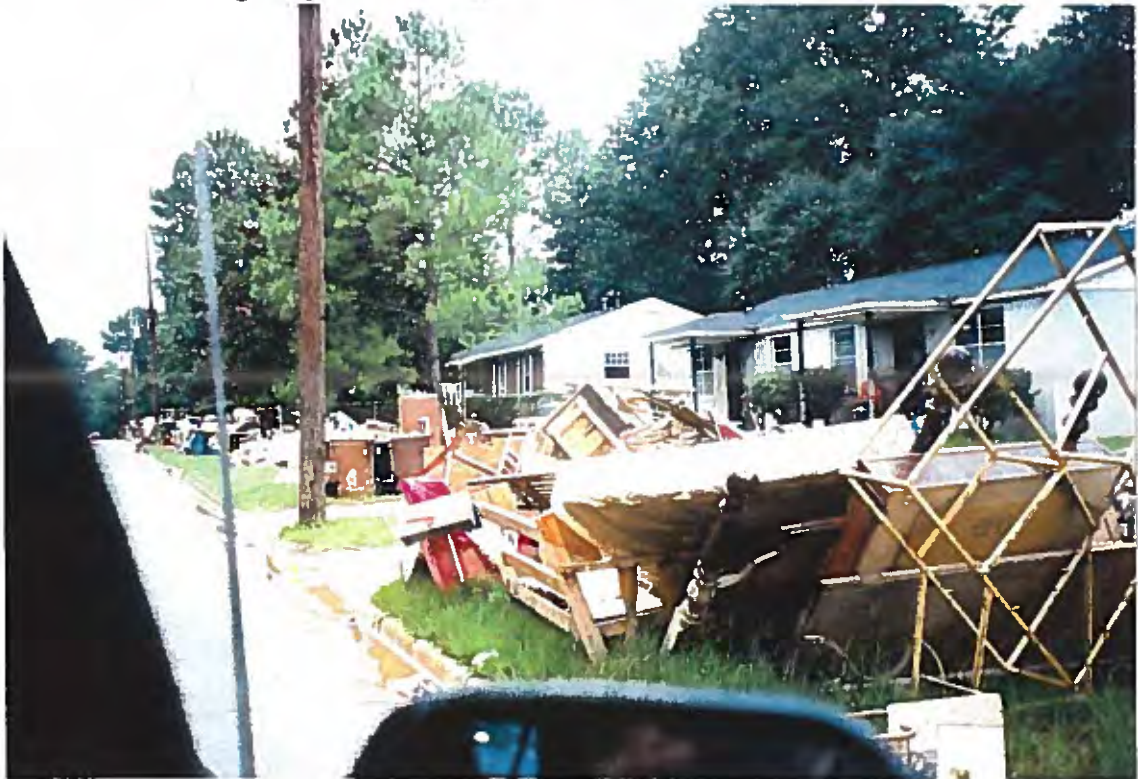
16. Single-family house on Wadkins Street. Interior goods and furnishings damaged by floodwaters.

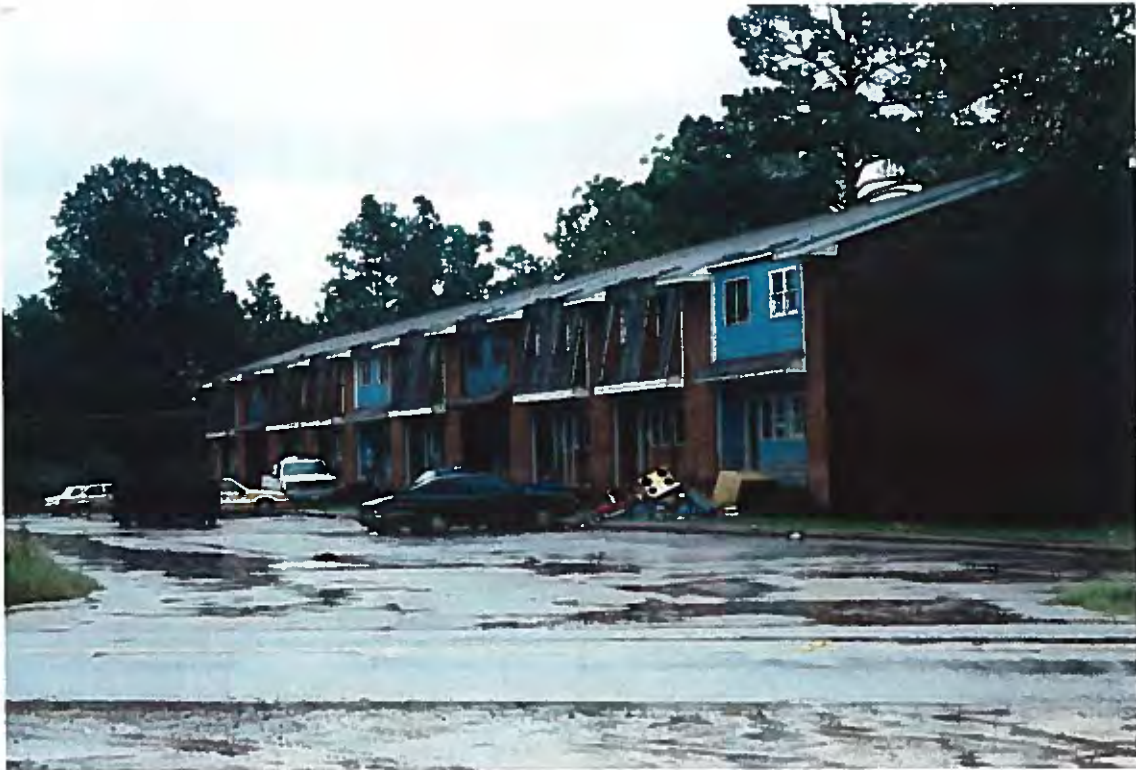
17. Two-story housing on Habersham Street. Interior goods and furnishings on lower level damaged by floodwaters.

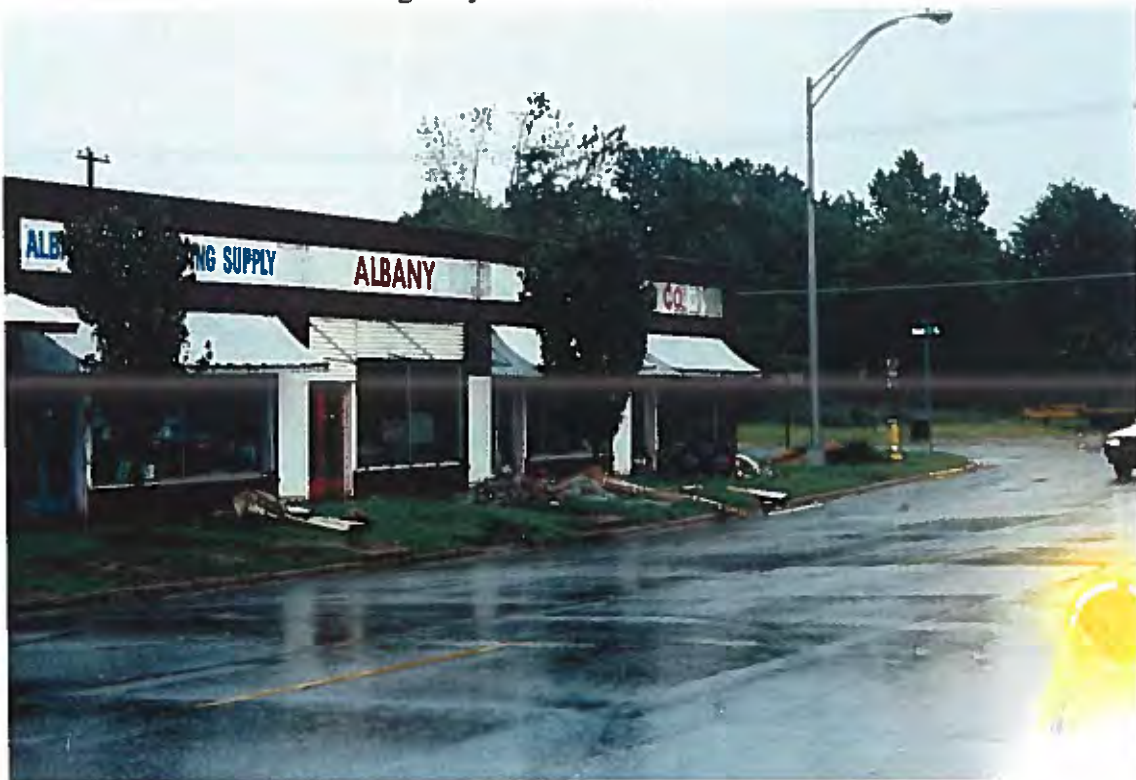
18. Commercial buildings at Flint Street and Front Street. Floodwaters reached depths of approximately 2 feet, damaging interior goods and furnishings.
