FEMA DR-GA-1033

INTERAGENCY HAZARD MITIGATION TEAM

FLOODING IN GEORGIA FROM TROPICAL STORM ALBERTO

PREPARED BY THE
BUILDING AND DAM
PERFORMANCE ASSESSMENT TEAM

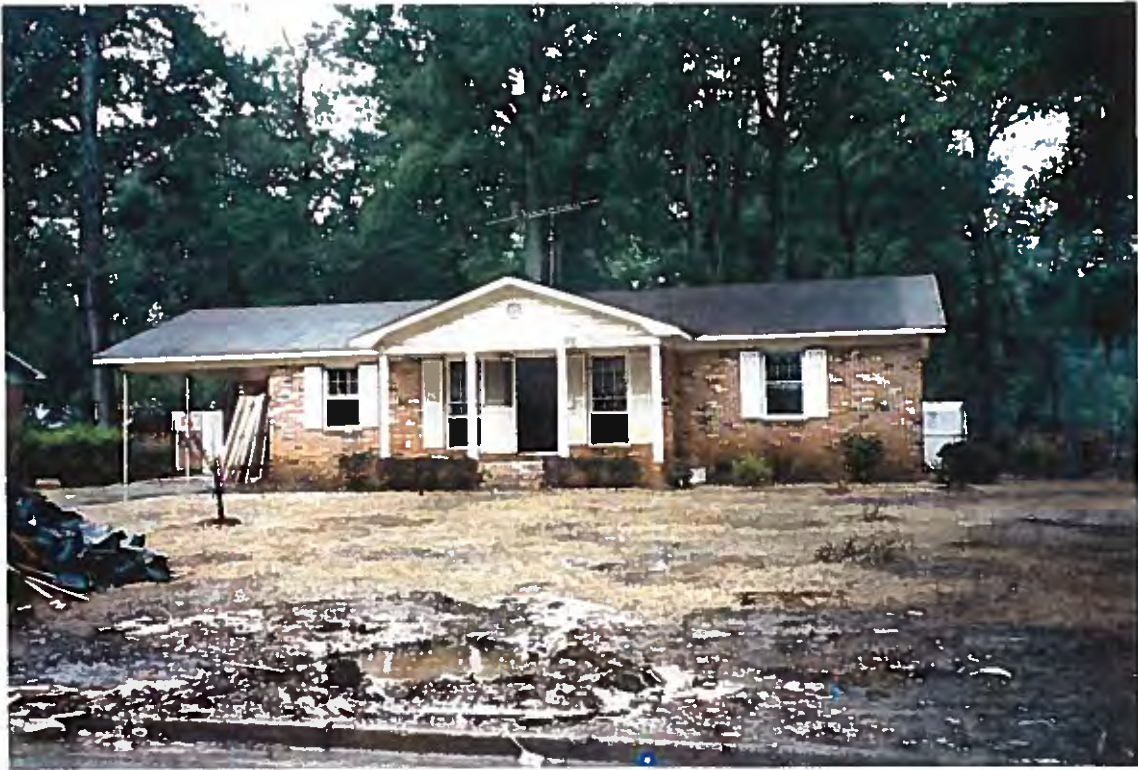
19. Single-family house on 10th Street. Interior goods and furnishings damaged by floodwaters.

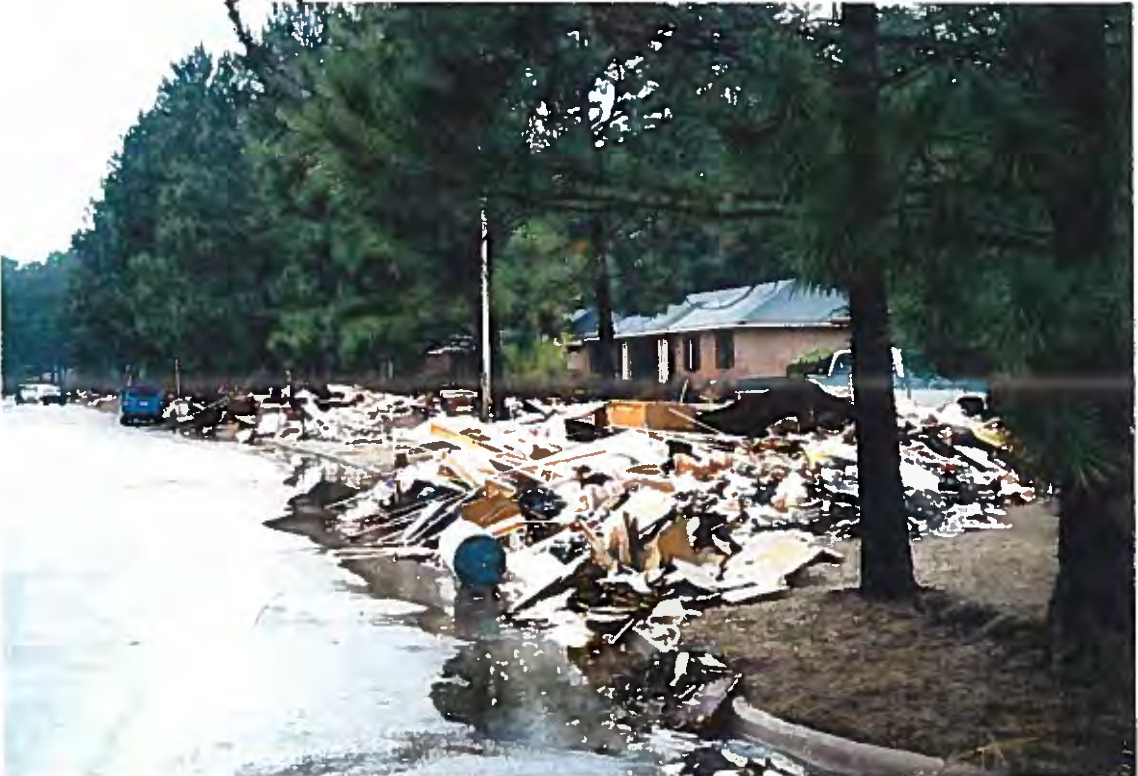
20. Single-family houses on 10th Street. Interior goods and furnishings damaged by floodwaters.

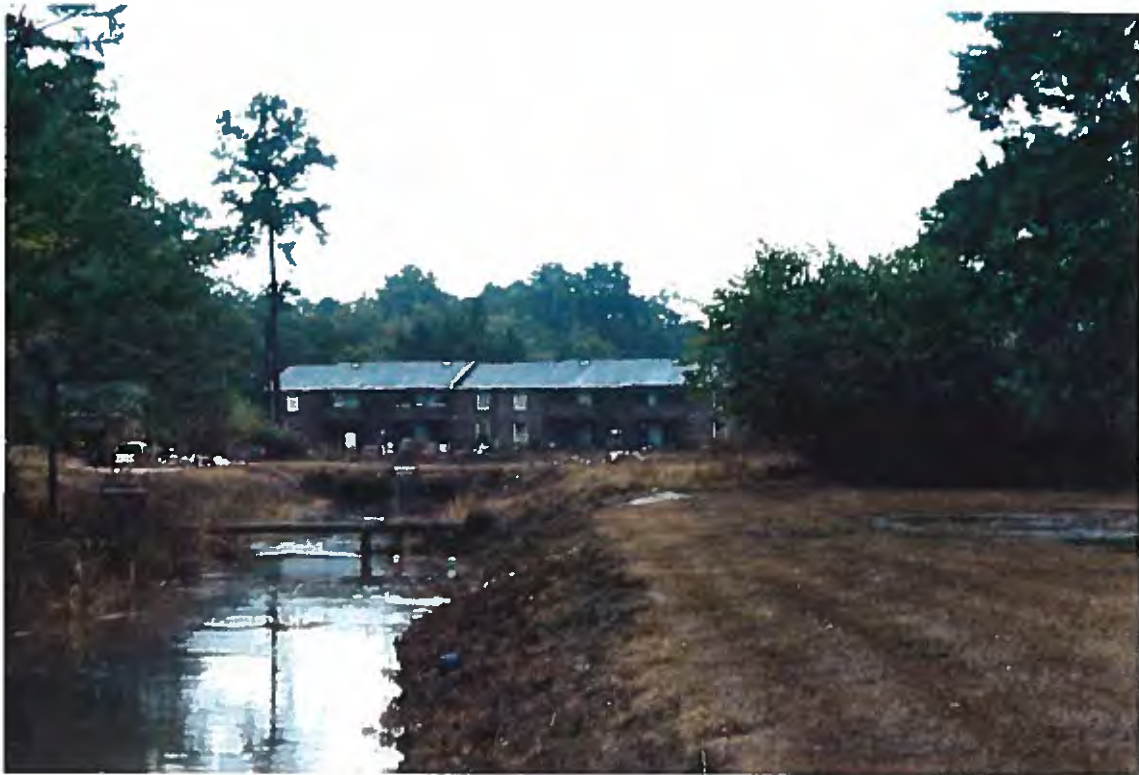
21. Jamestown Apartments. Lower level flooded. Interior goods and furnishings damaged.

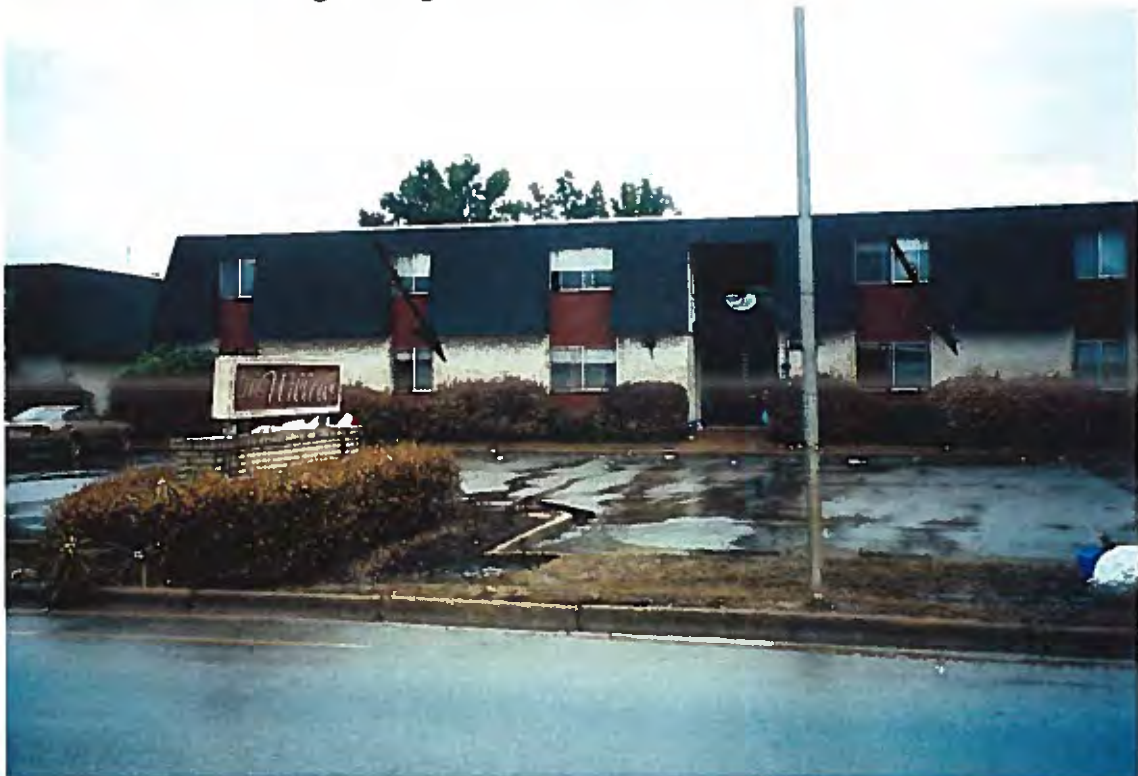
22. Willows Apartments. High water mark indicated by arrows.

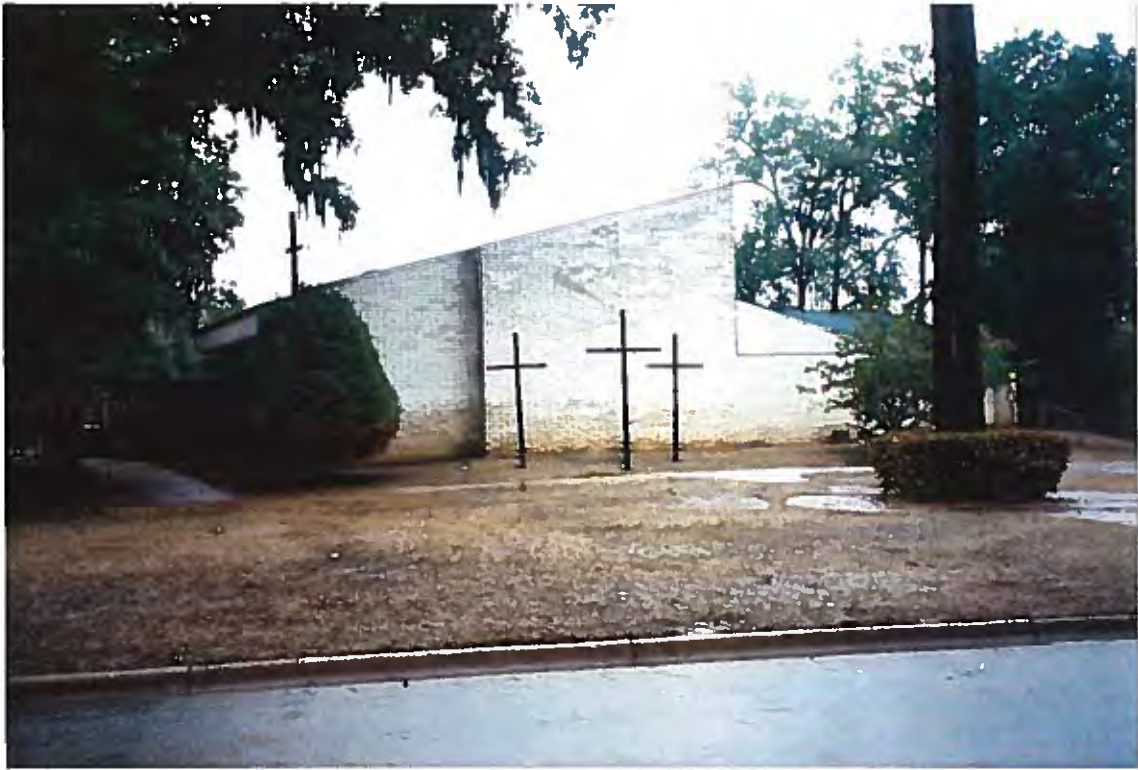
23. Church near Whispering Pines at Edgewood Drive. Interior goods and furnishings damaged by floodwaters.

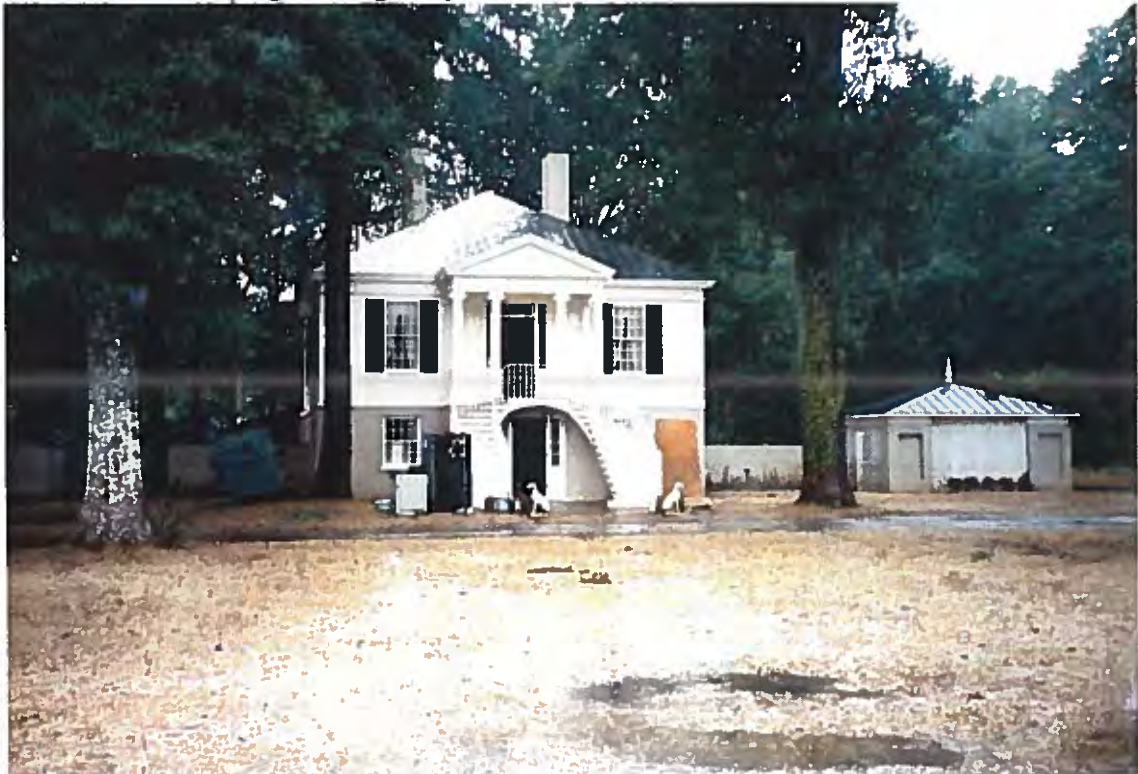
24. Single-family residence on Valley Street. Lower level flooded

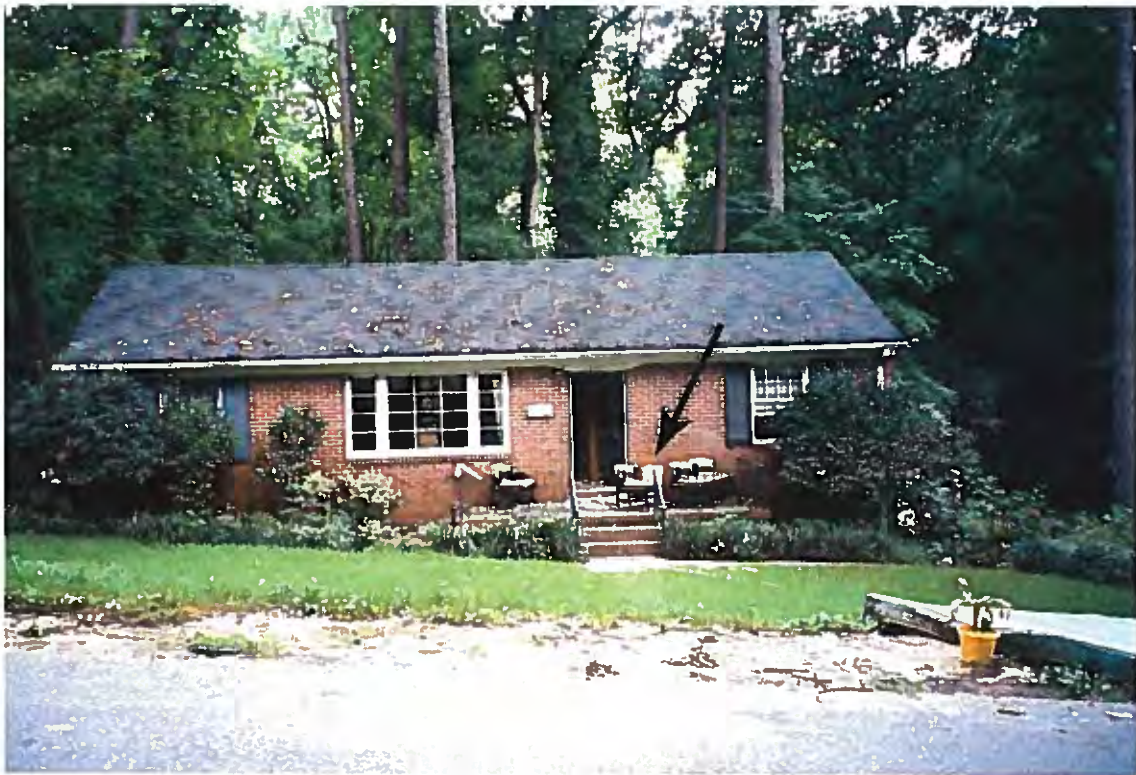
1. Single-family residence at 2595 N. Nancelot Circle. High water mark indicated by arrow.

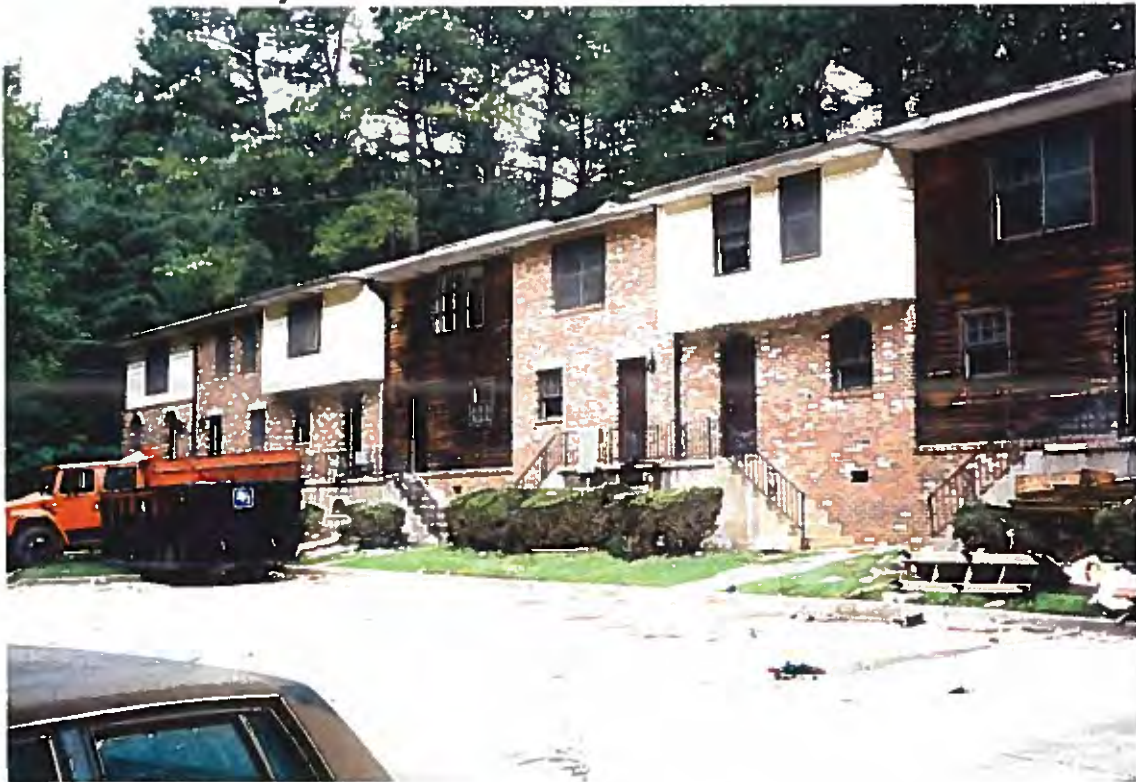
2. Bowman Creek Apartments on Pierce Avenue. Lower level flooded. Interior goods and furnishings damaged.

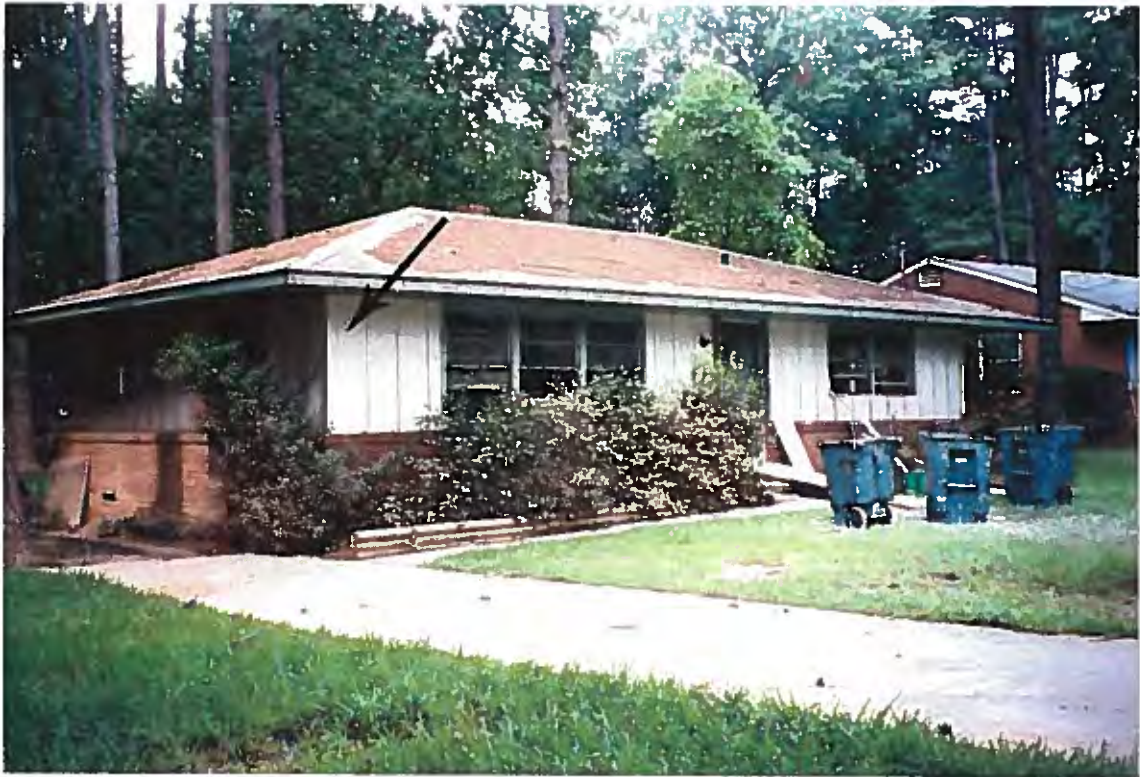
3. Homes along Huntington Drive at Delano Street near water treatment plant.
High water mark indicated by arrow.

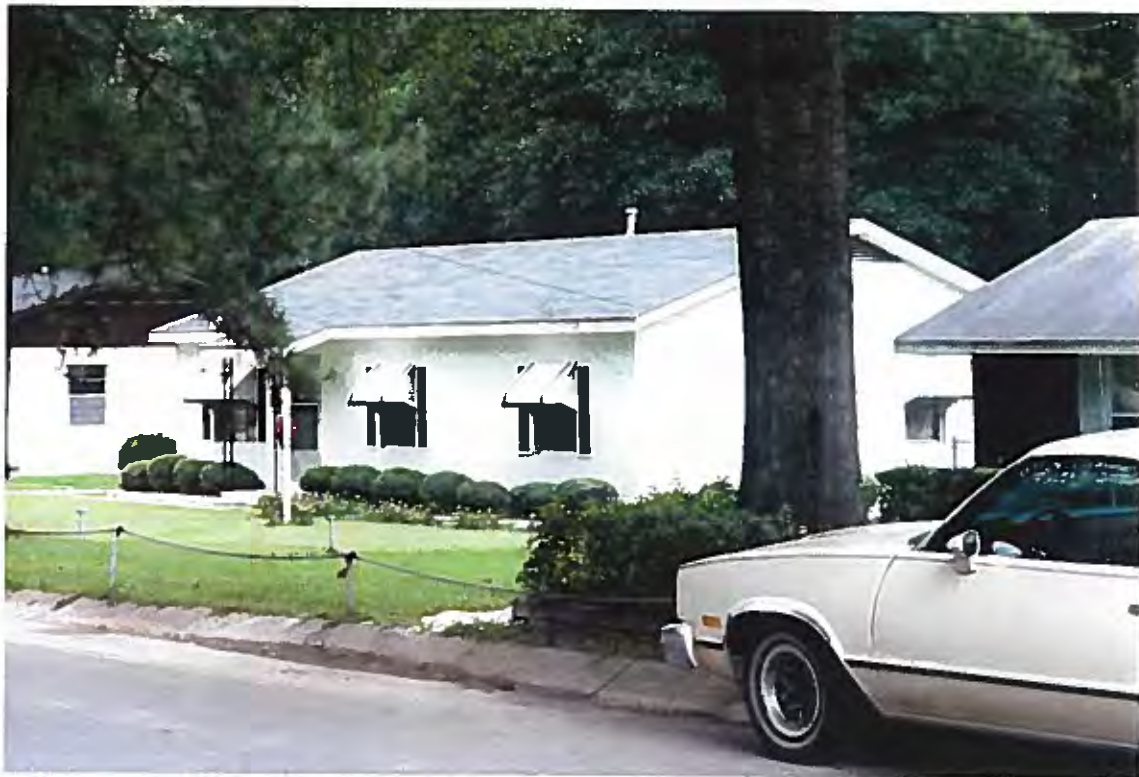
4. Single-family house on Spencer Circle. Minor water damage.

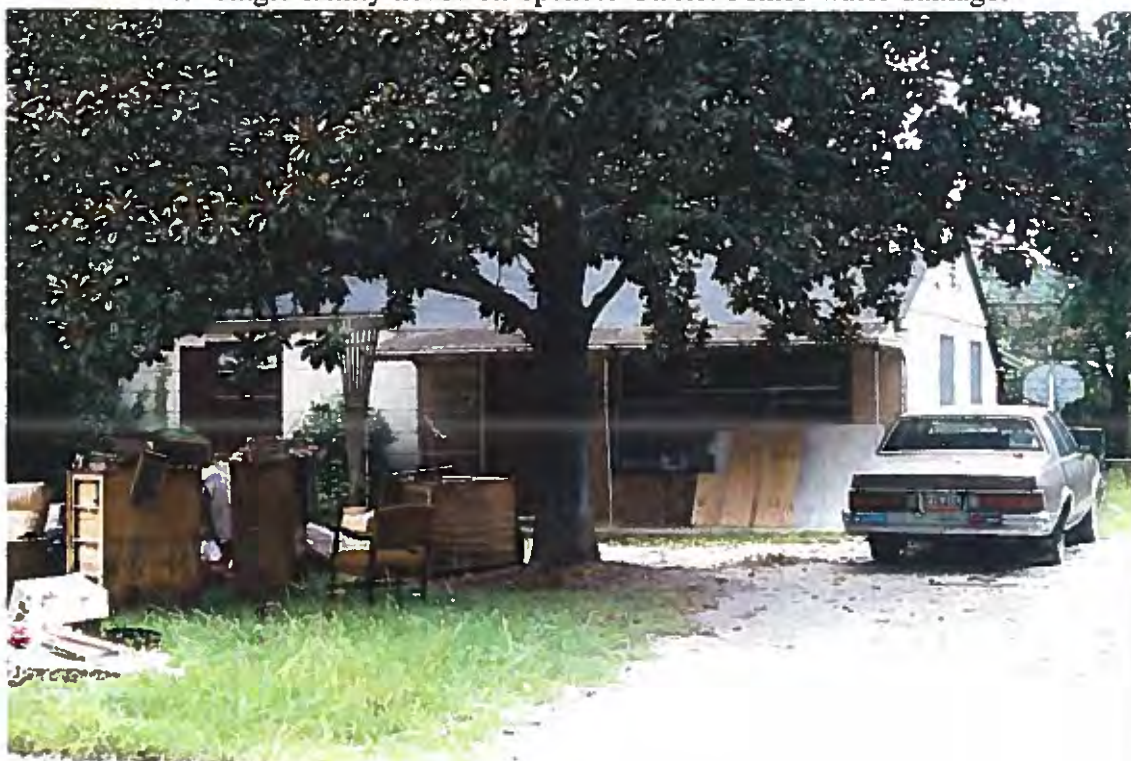
5. Single-family house on St. Charles Place. Minor water damage to interior goods and furnishings.

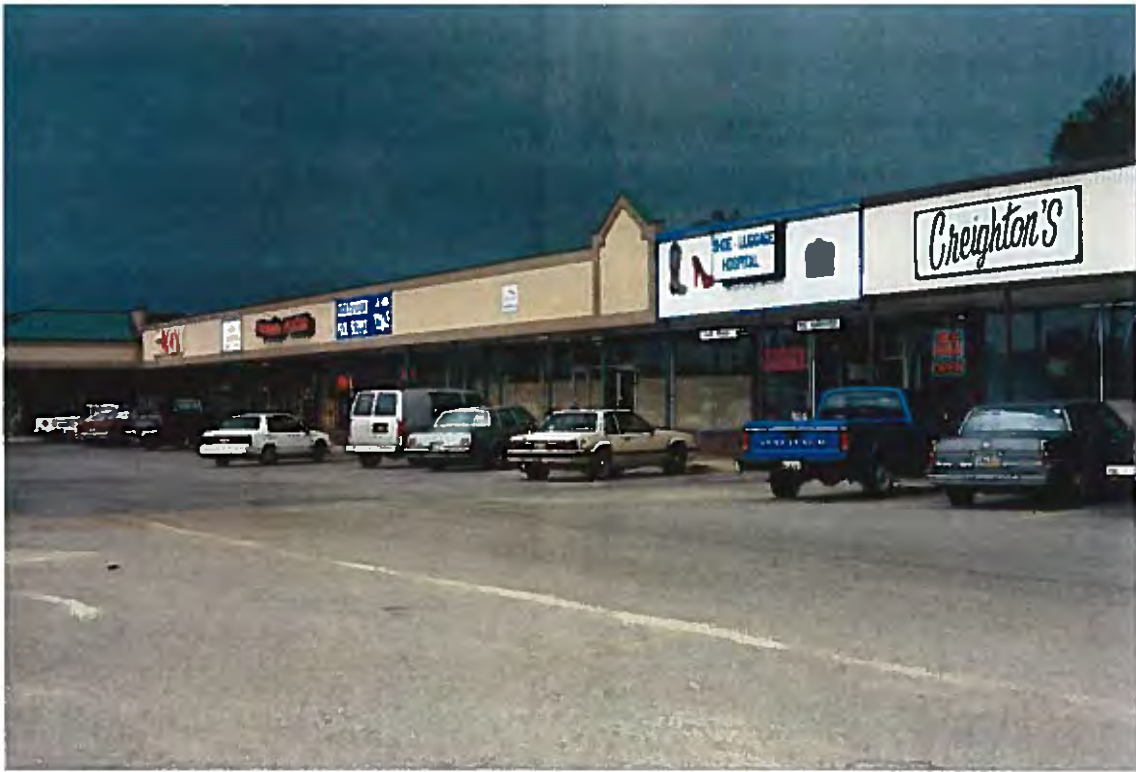
6. Pio Nono Plaza. Minor flood damage to interior goods and furnishings.

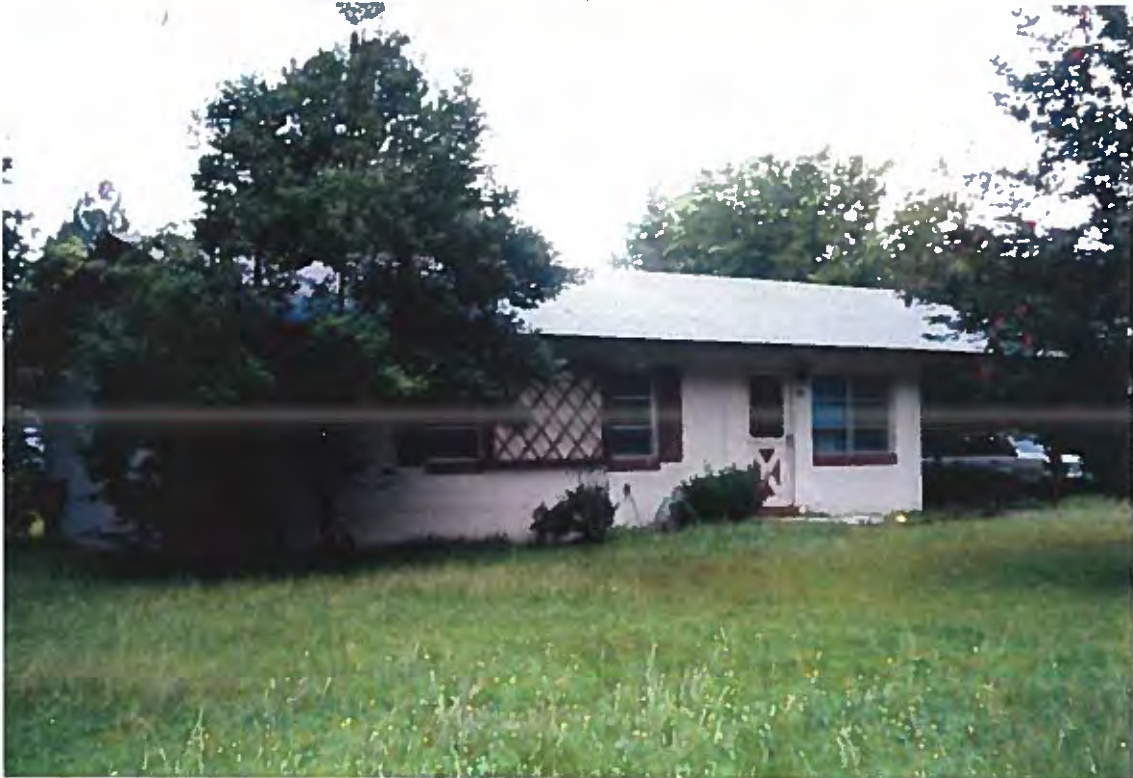
7. 4509 Pinedale. Minor water damage.

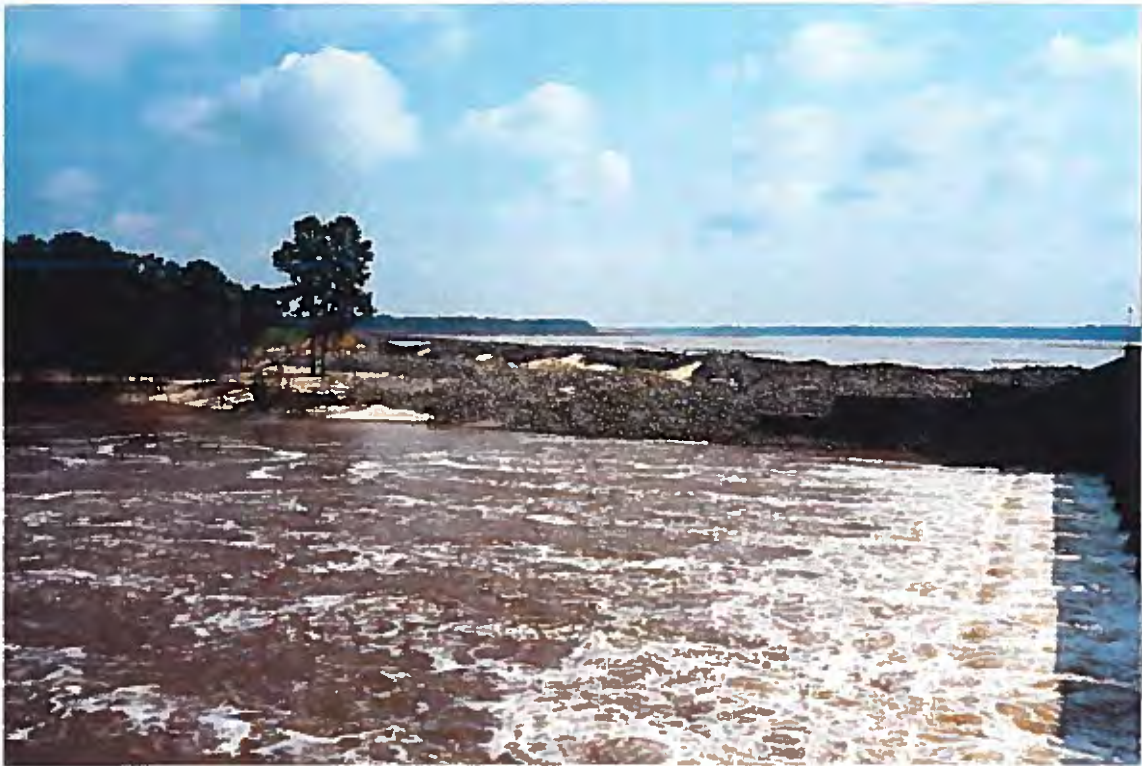
1. Downstream side of dam showing riprap embankment failure area.

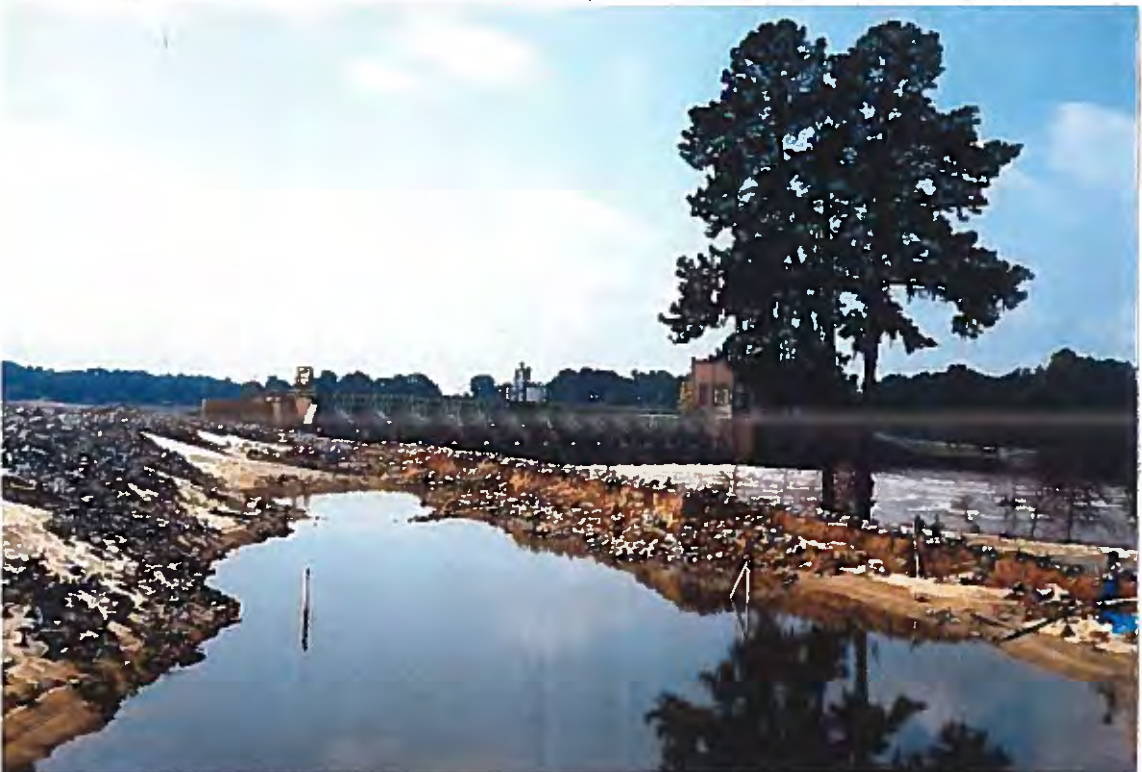
2. Looking upstream at dam across embankment failure area.

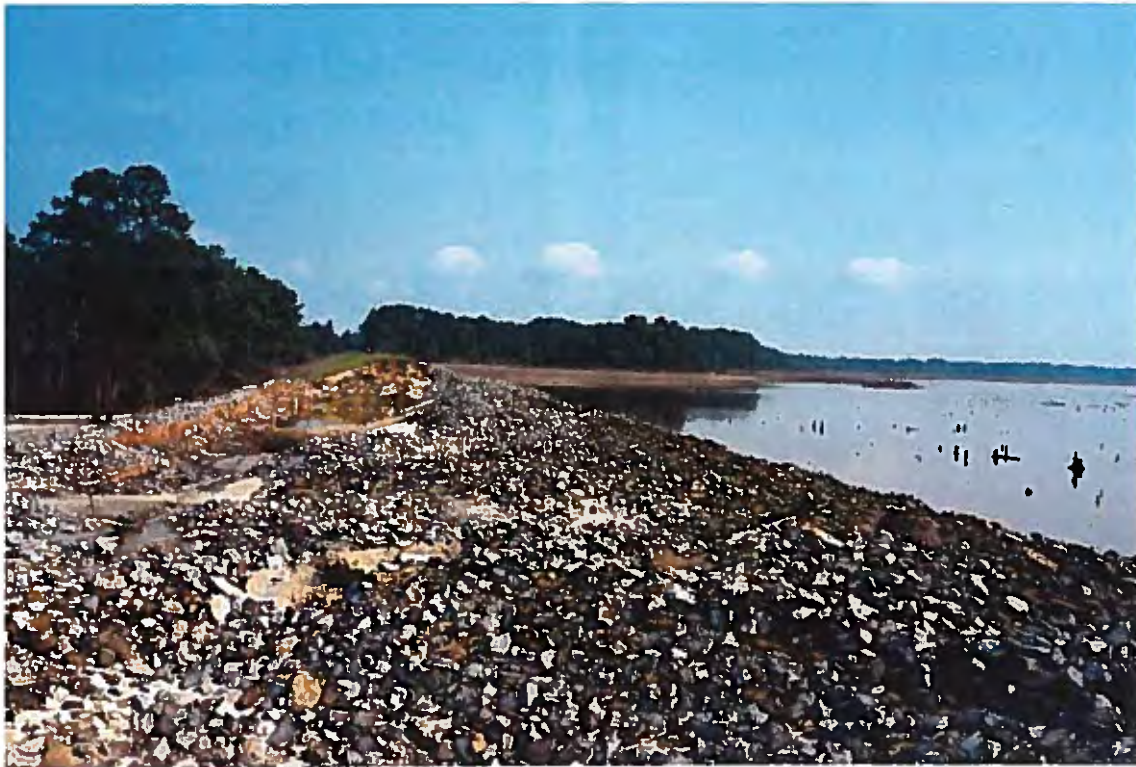
3. View along embankment showing failure area (foreground) and remaining embankment (background).

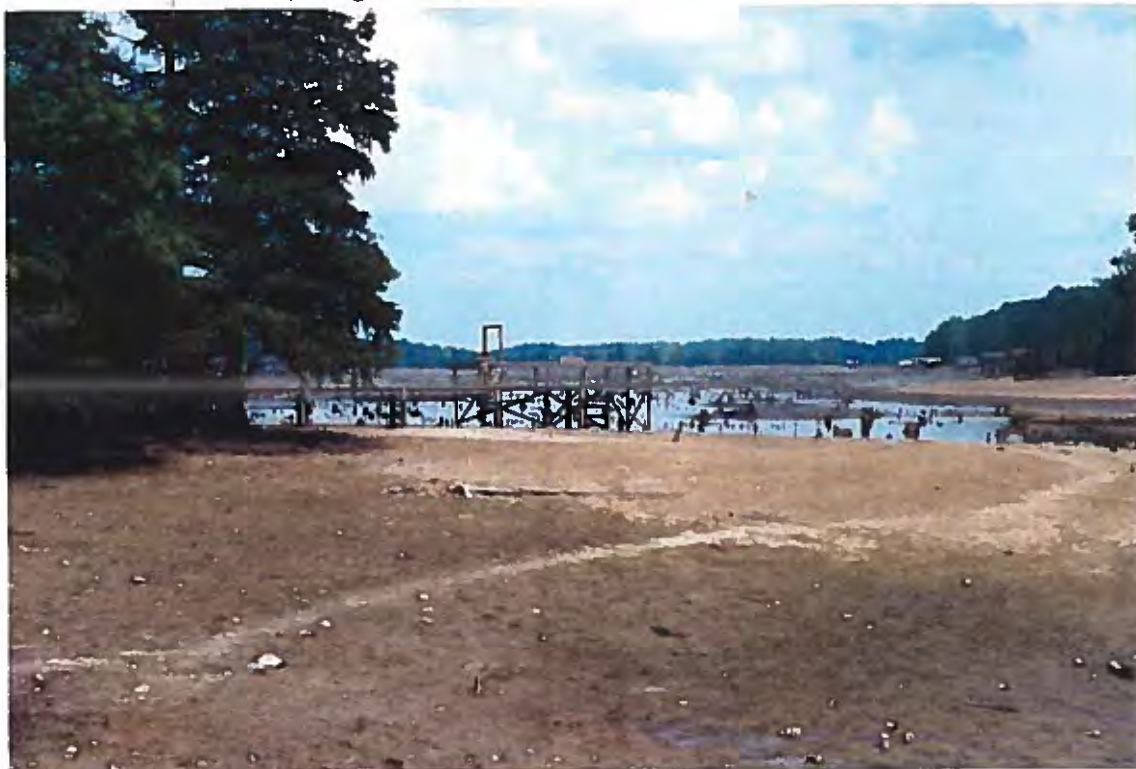
4. Lake area after loss of water; dock indicates original water level.

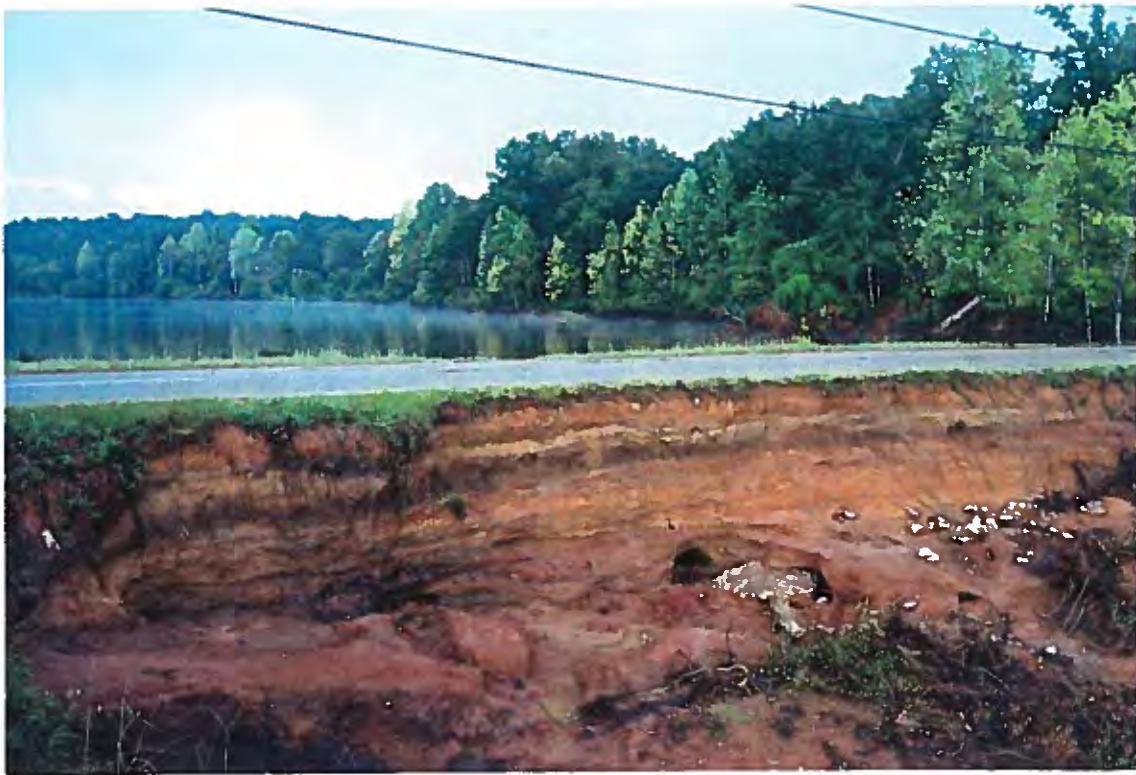
- **Damage Assessment:** Lake Hancock Dam did not breach but sustained severe downstream erosion beneath the emergency spillways and slope due to overtopping. Observed three or four possible piping holes along eroded downstream slope. Observed organics in the embankment fill. Earth dam downstream of Lake Hancock was breached with no sign of spillway structure. Observed damage to downstream floodplain.
- **Approximate Date and Time of Failure:** July 6, 1994, early a.m.
- **Observed Impacts of Failure in Pool Reach:** Loss of recreation opportunity
- **Impact of Failure in Downstream Reach:** Reported downstream flooding in Americus, but the extent to which dam failure contributed to this flooding is unknown.

1. Eroded embankment on downstream dam face.

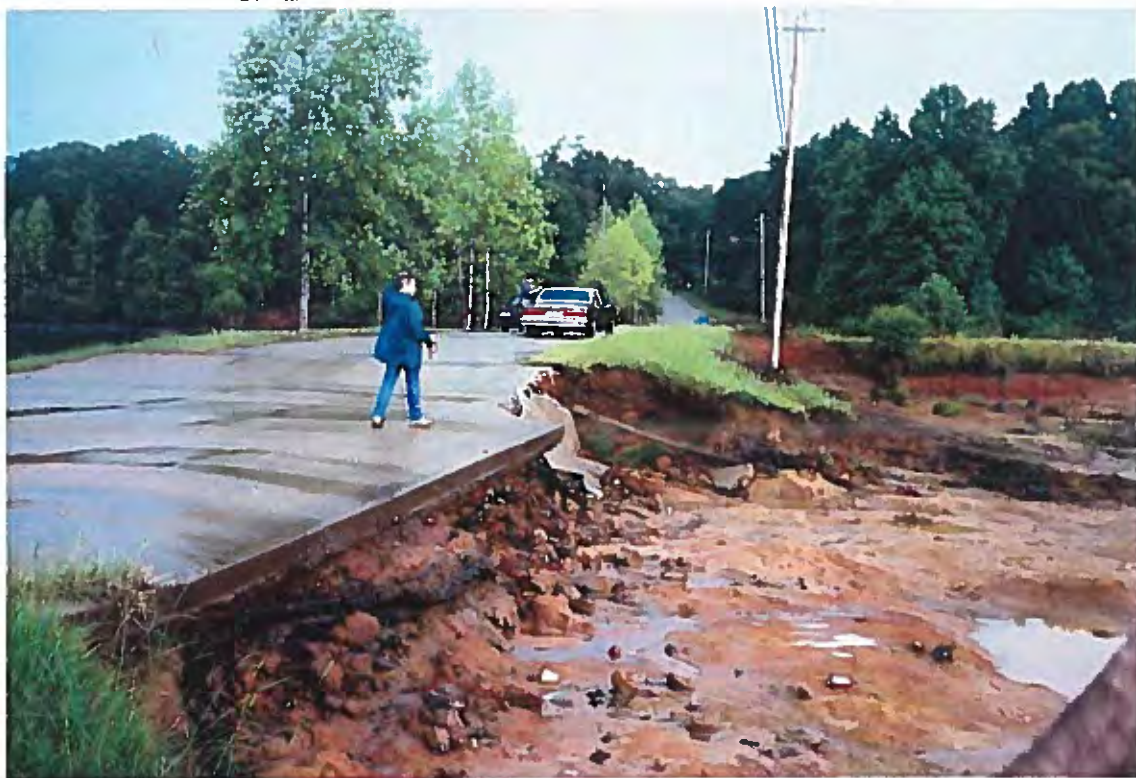
2. Eroded embankment, damaged road, and small failed pond on right.

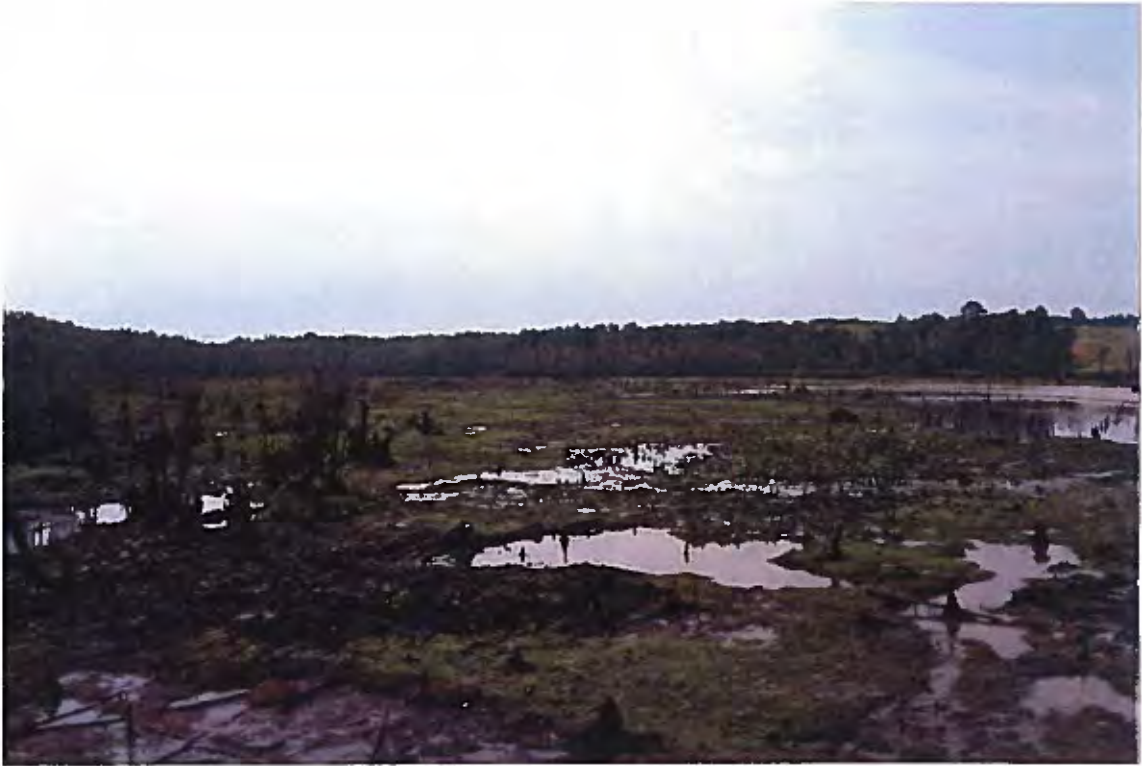
- **Damage Assessment:** Dam breached to left of riser. Breach width on order of 100 feet wide. From farm workers' account, dam would have been overtopped by at least 3 to 4 feet.
- **Approximate Date and Time of Failure:** July 5, 1994, p.m.
- **Observed Impacts of Failure in Pool Reach (life, property, infrastructure):** Loss of reservoir and recreation potential
- **Observed Impact of Failure in Downstream Reach (life, property, infrastructure):** Reported downstream flooding in Americus, but the extent to which dam failure contributed to this flooding is unknown.

1. Lake area after loss of water

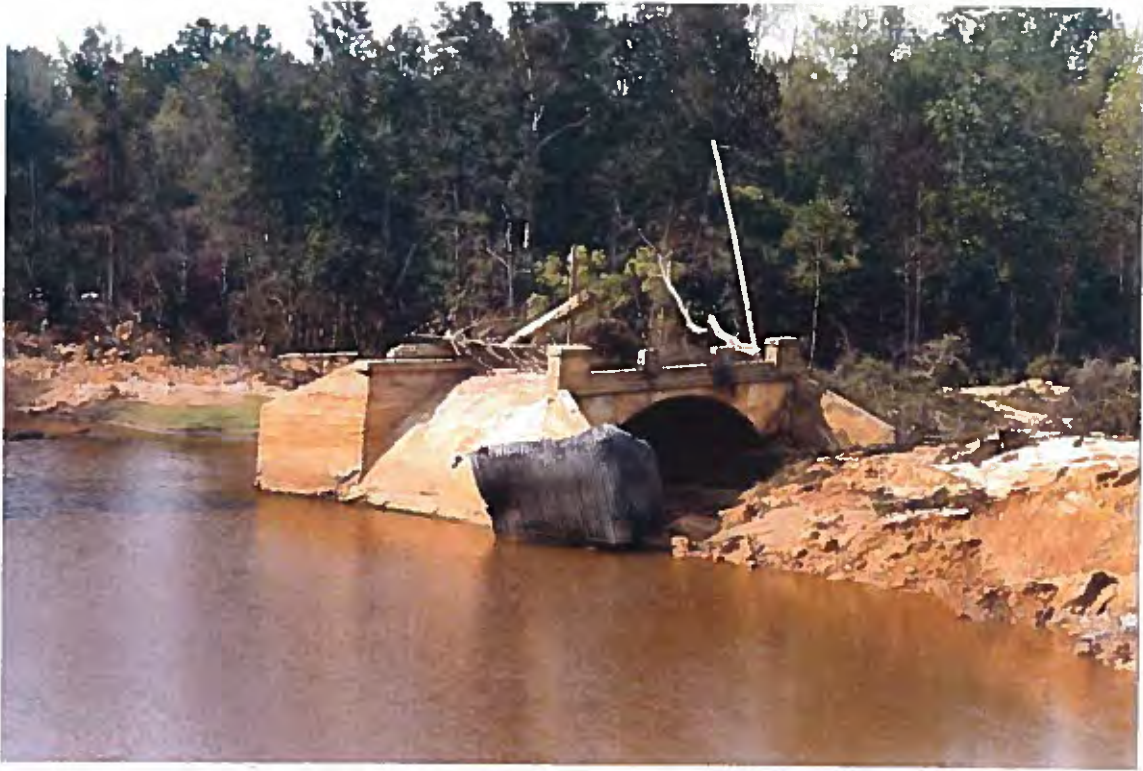
1. Site of breached dam

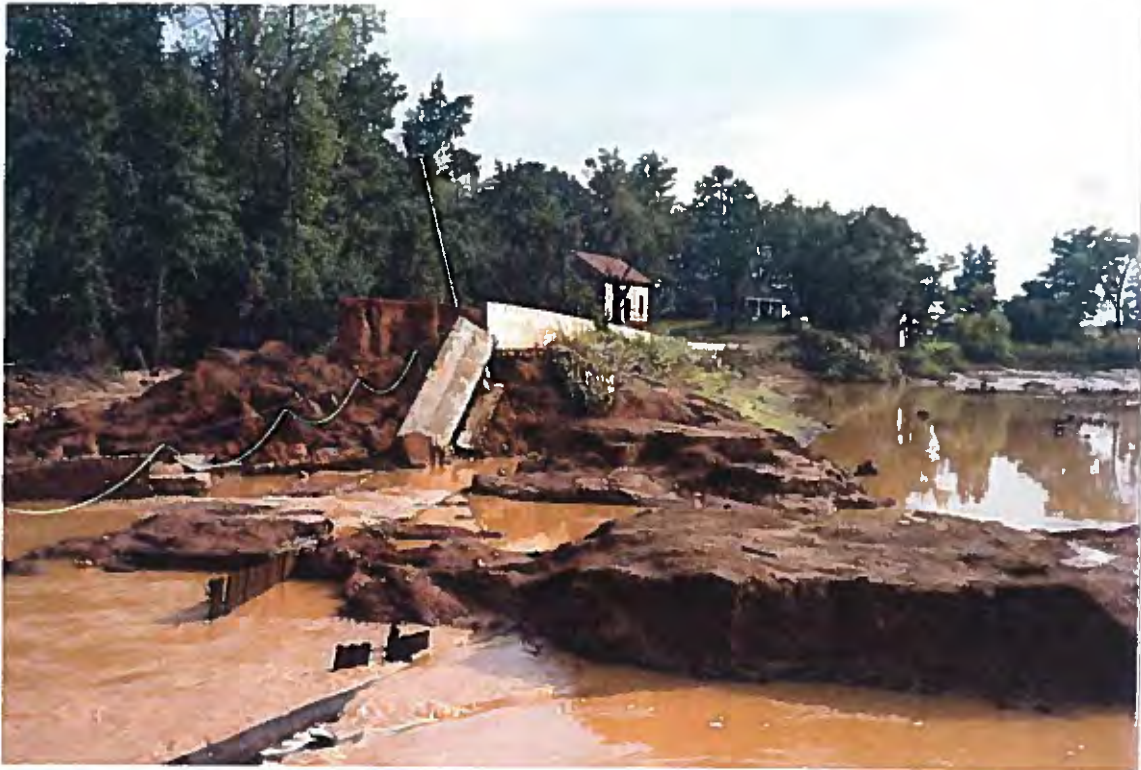
- **Damage Assessment:** Dam is breached at probable location of spillway structure. Breach width of more than 100 feet. Observed decaying wood within the breached section that appears to be part of the structure of a cofferdam left in place. Observed deep erosion holes on upstream right abutment.
- **Approximate Date and Time of Failure:** July 6, 1994, p.m.
- **Observed Impacts of Failure in Pool Reach (life, property, infrastructure):** Loss of reservoir and recreation potential; loss of roadway access and water line across embankment
- **Impact of Failure in Downstream Reach (life, property, infrastructure):** Drawdown of the lake during rapid failure of the dam may have contributed to failure of a road/bridge crossing through the lake, leading to the loss of three lives.

1. Breached dam; purpose of timber pilings near bottom of photo unknown (possibly cofferdam)

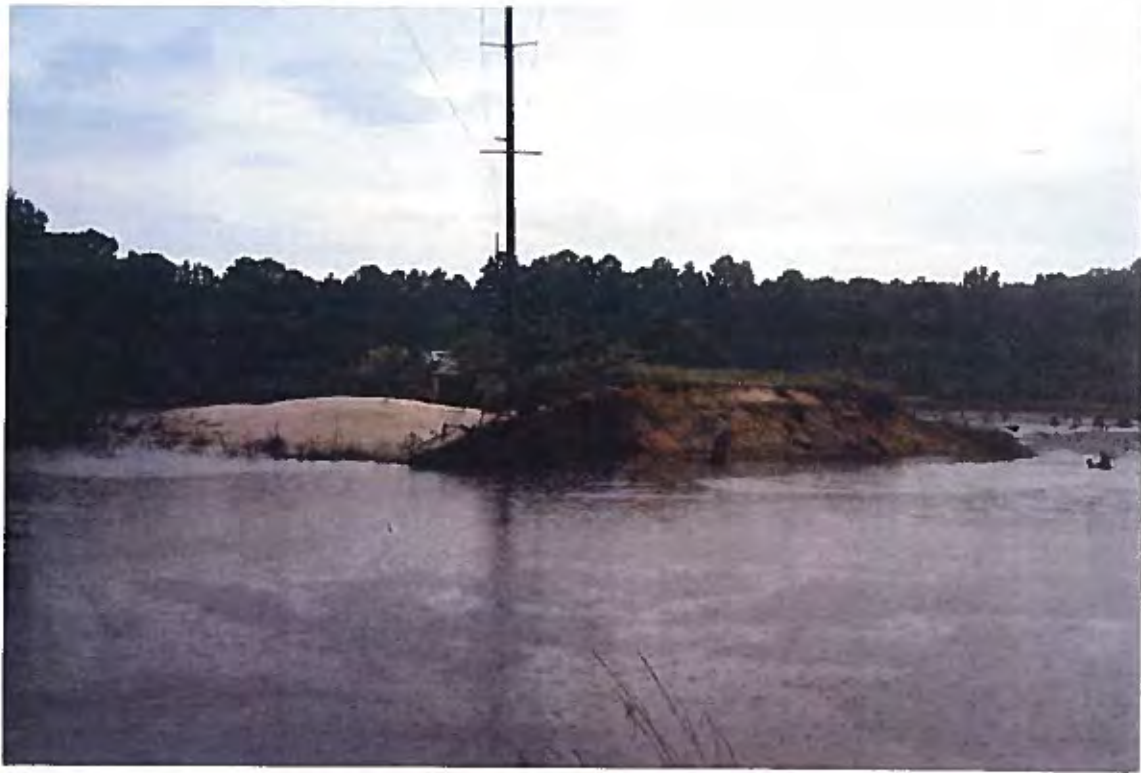
- **Damage Assessment:** Indications are that the dam was overtopped, eroded, and breached. The old gates in the principal spillway could not be opened to allow additional flow out of the lake. Because of limited access, damage to the spillway could not be assessed.
- **Approximate Date and Time of Failure:** July 5, 1994, 8:00 p.m.
- **Observed Impacts of Failure in Pool Reach (life, property, infrastructure):** Loss of recreational opportunity
- **Observed Impact of Failure in Downstream Reach (life, property, infrastructure):** No observed impacts

1. Looking upstream at dam breach area

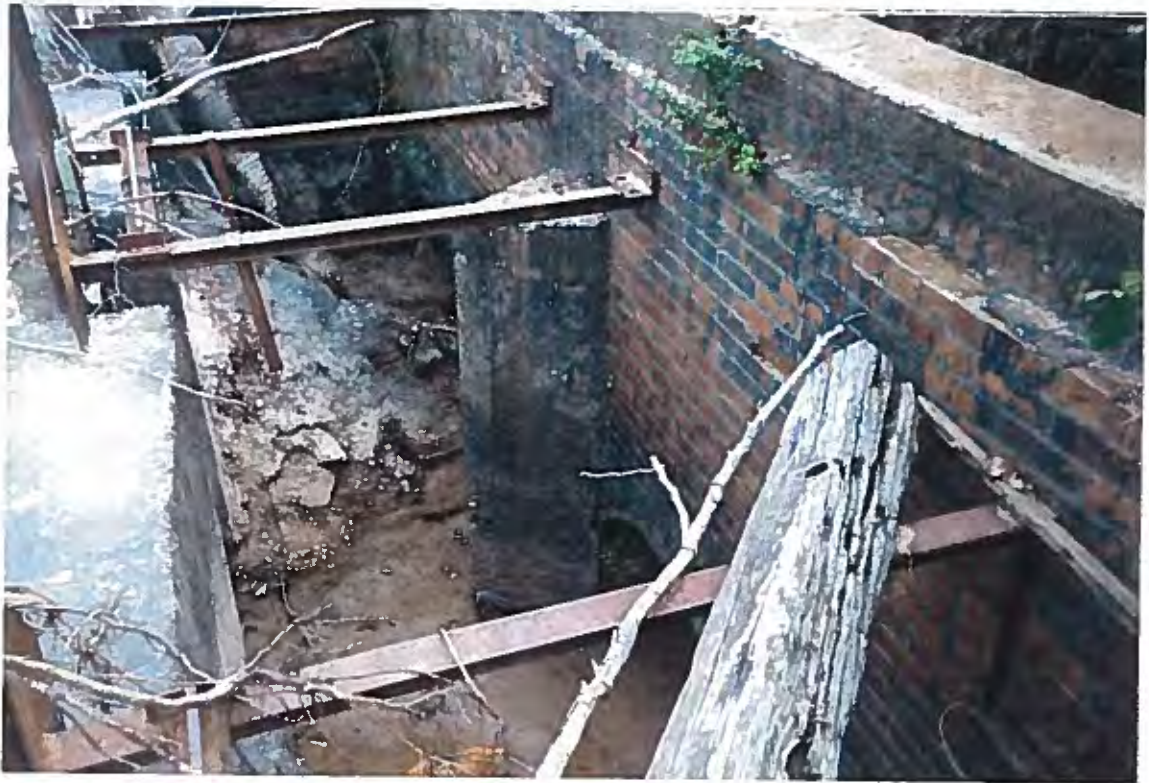
- **Damage Assessment:** Indications are that the dam was overtopped, eroded, and breached. The old gates in the principal spillway could not be opened to allow additional flow out of the lake. Other possible contributing factors included vegetation on the embankment and utilities in the embankment.
- **Approximate Date and Time of Failure:** July 5, 1994, 11:00 p.m.
- **Observed Impacts of Failure in Pool Reach (life, property, infrastructure):** Loss of recreational opportunities
- **Observed Impact of Failure in Downstream Reach (life, property, infrastructure):** No observed impacts

1. Top view of gates that failed to open
