FEMA DR-GA-1033

INTERAGENCY HAZARD MITIGATION TEAM

FLOODING IN GEORGIA FROM TROPICAL STORM ALBERTO

PREPARED BY THE
BUILDING AND DAM
PERFORMANCE ASSESSMENT TEAM

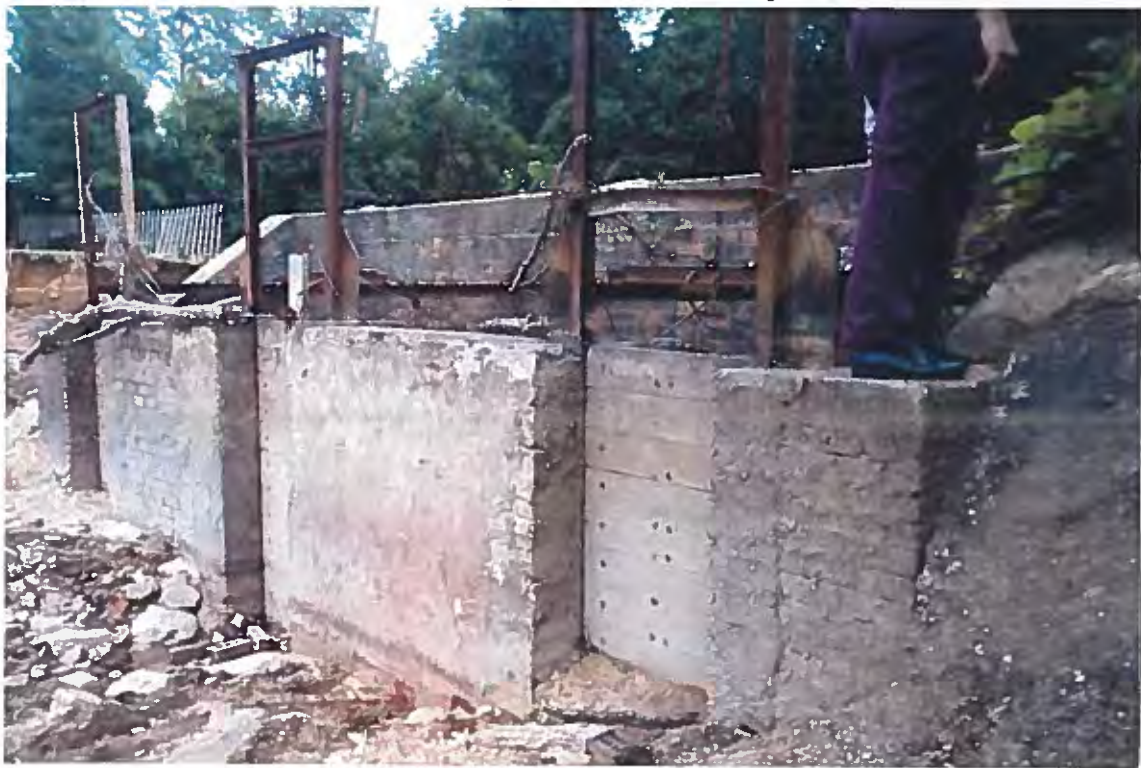
2. Front view of gates

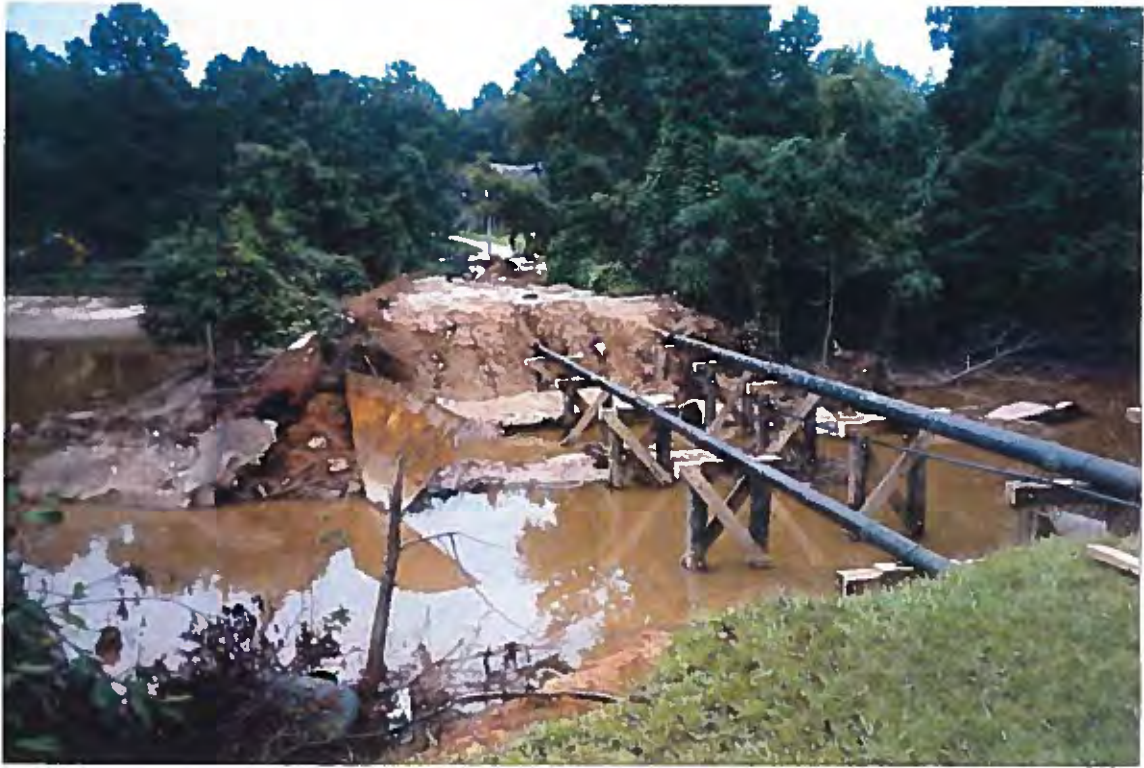
3. Dam breach area showing replaced utility lines

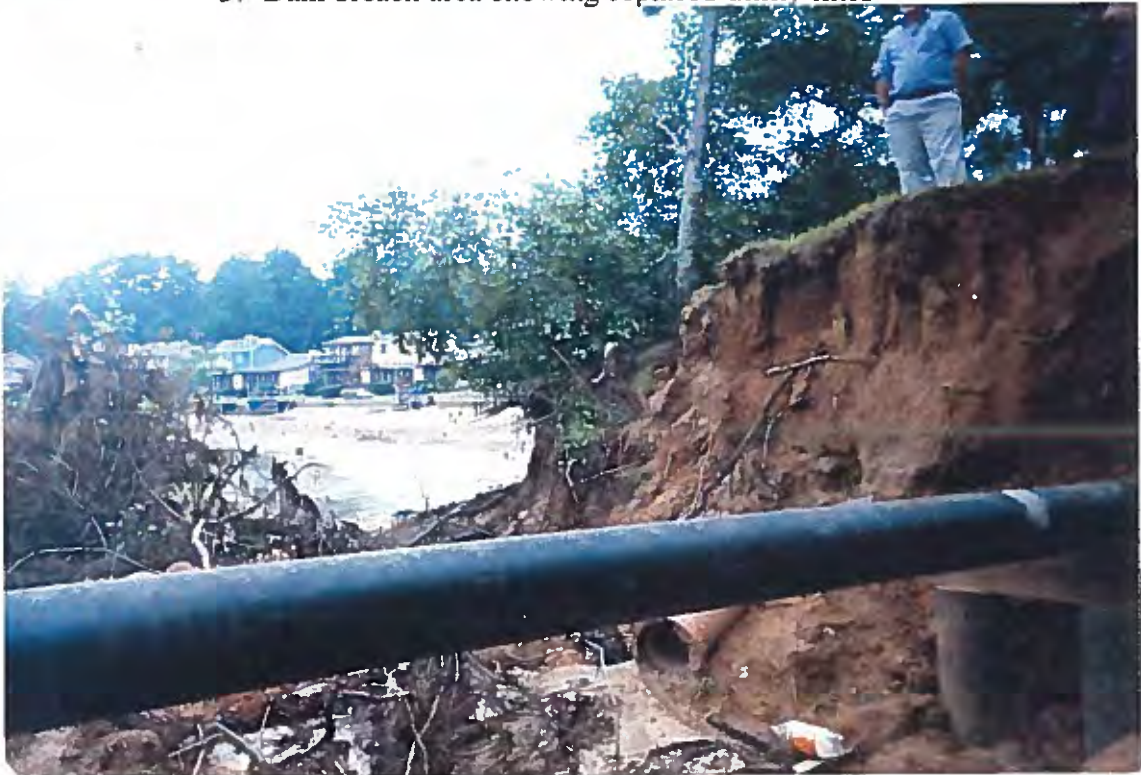
4. Closeup of embankment at breach

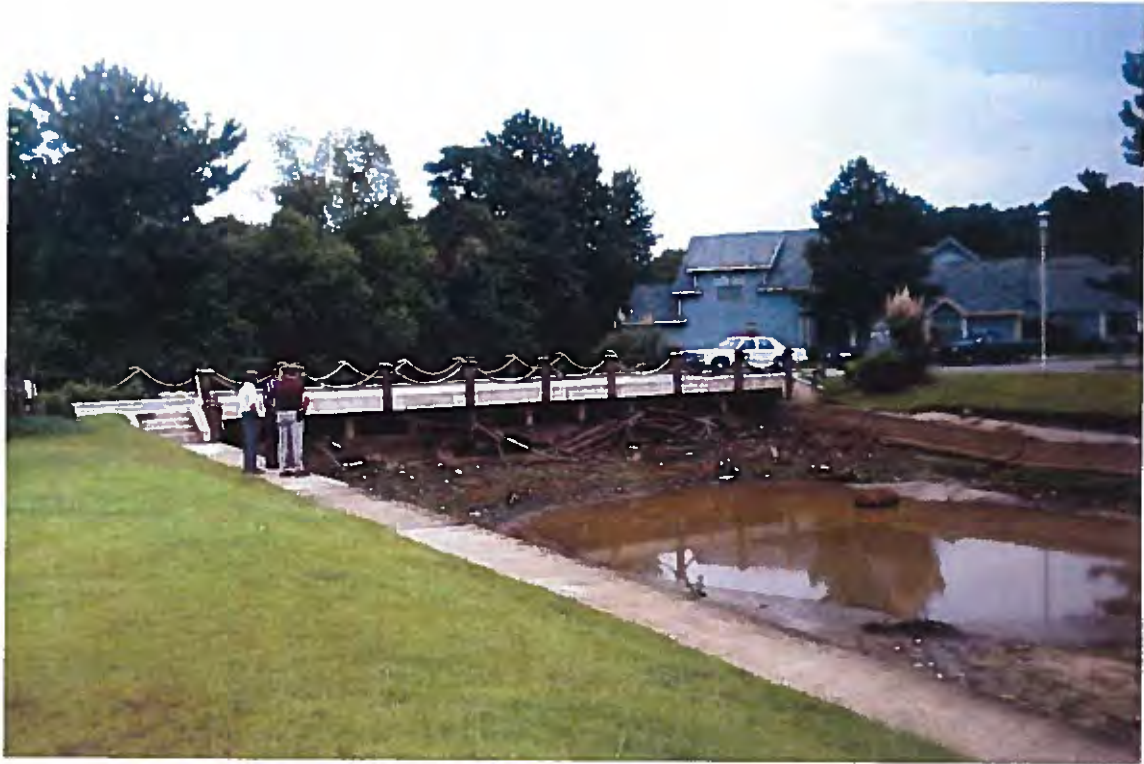
- **Damage Assessment:** Indications are that the capacity of the spillway was exceeded and the embankments were eroded, which undermined the spillway. The capacity of the emergency spillway was limited by a bridge built after completion of the spillway. Utilities in the spillway could have contributed to the failure.
- **Approximate Date and Time of Failure:** July 6, 1994, early a.m.
- **Observed Impacts of Failure in Pool Reach (life, property, infrastructure):** Loss of recreational opportunities; slumping of concrete hard edge around lake due to rapid drawdown of lake during failure
- **Observed Impact of Failure in Downstream Reach (life, property, infrastructure):** None (Lower Leisure Lake just downstream)

1. Control structure on one arm of lake

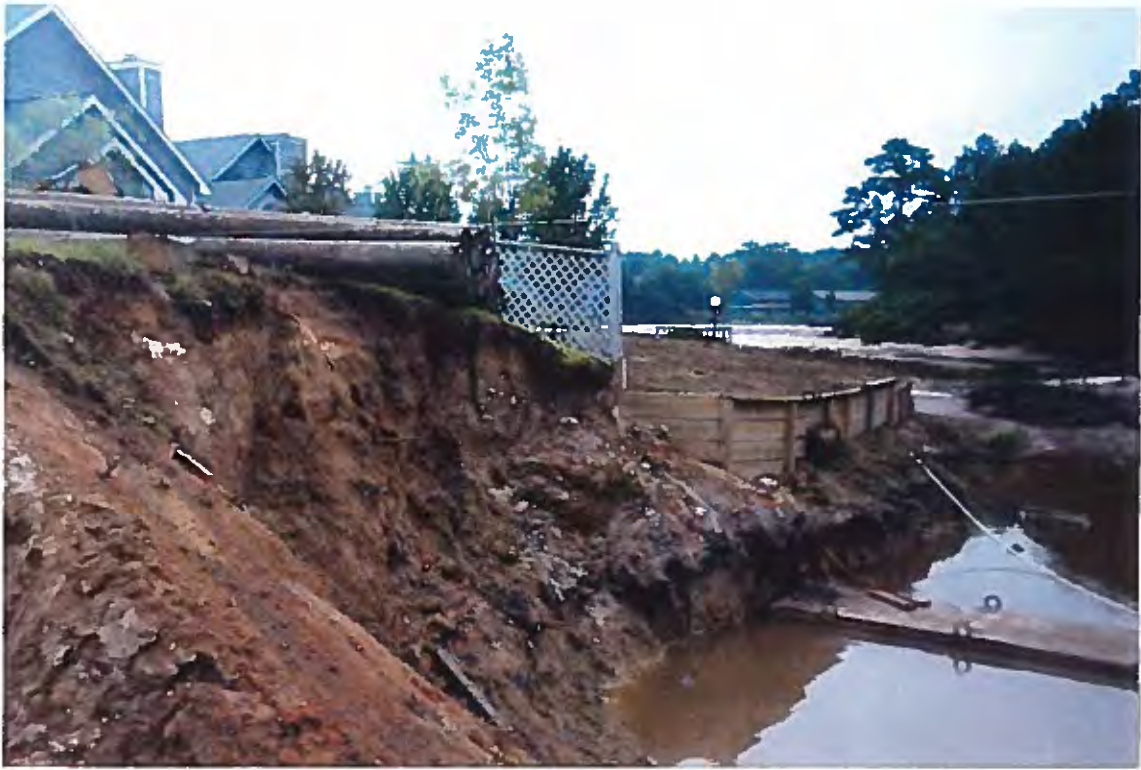
3. Failure area

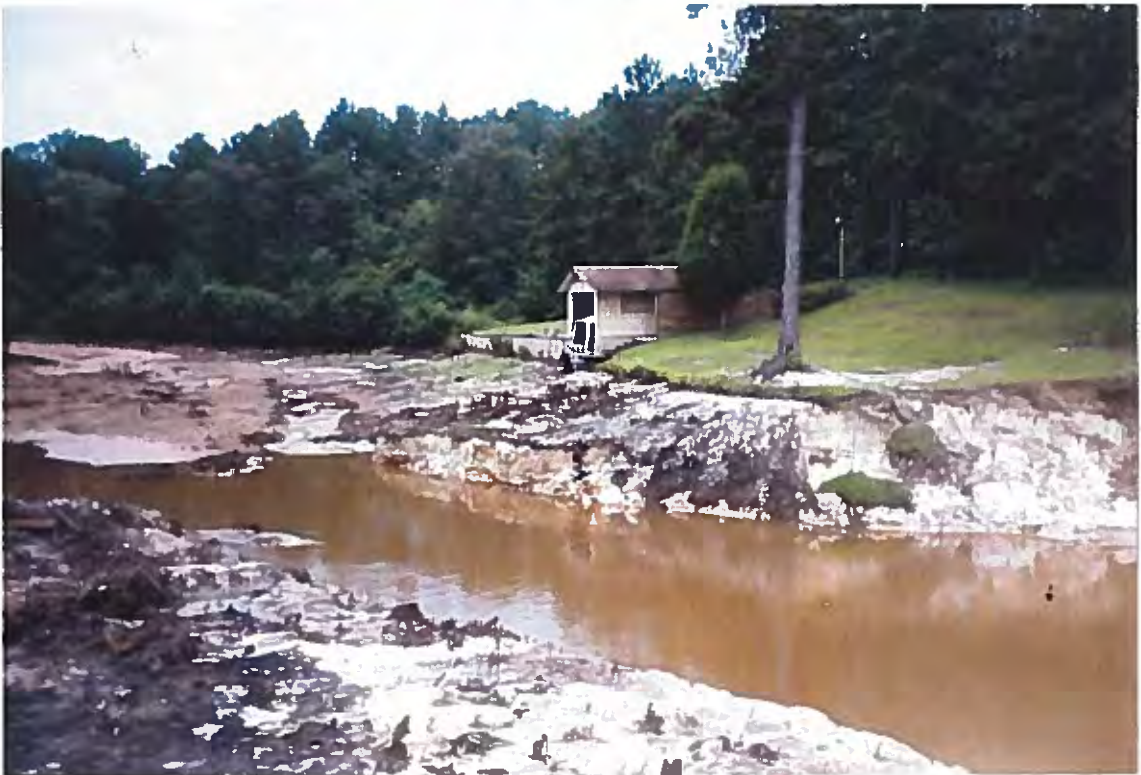
4. Failure area, opposite view

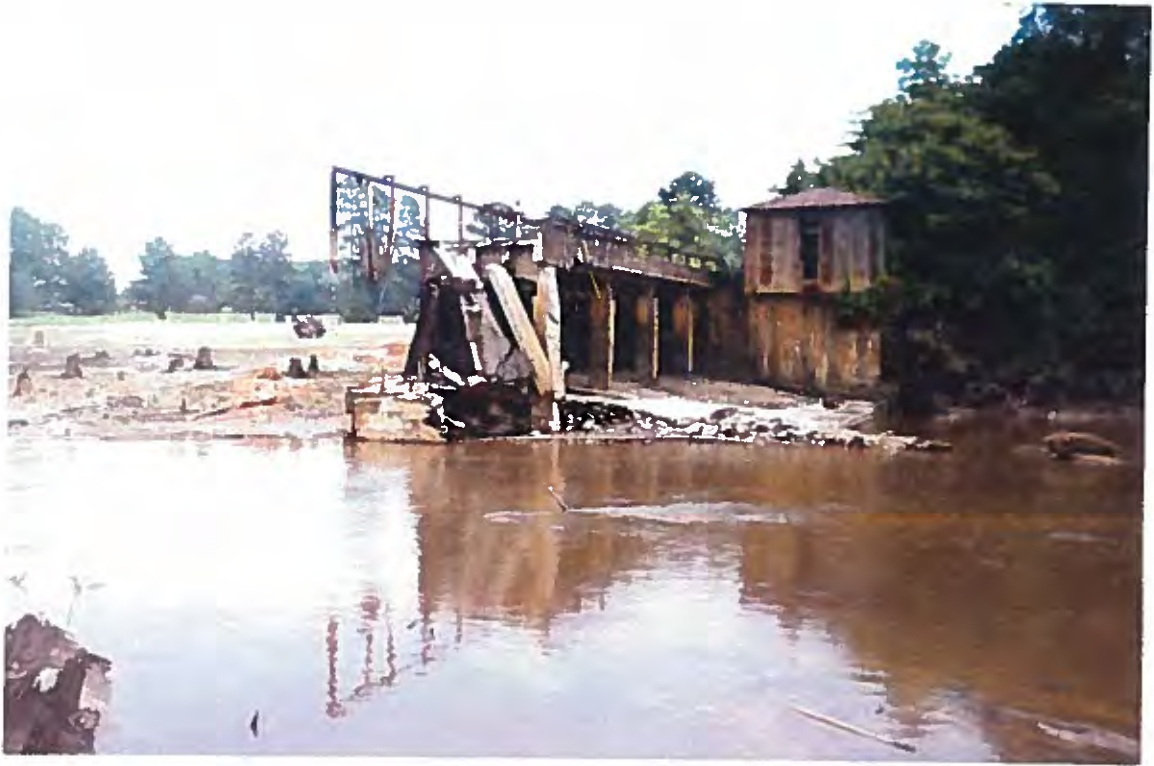
- **Damage Assessment:** The capacity of the spillway was exceeded, and the pool overtopped the dam causing erosion and eventually breaching of the dam. The timber foundations of unknown structures were found in the dam which may have contributed to the failure. Utilities in the embankment may also have contributed to the failure. The gates in the spillway could not be opened to increase the capacity.
- **Approximate Date and Time of Failure:** July 6, 1994
- **Observed Impacts of Failure in Pool Reach (life, property, infrastructure):** Loss of recreational opportunities
- **Observed Impact of Failure in Downstream Reach (life, property, infrastructure):** Downstream road washout

1. Failed dam structure

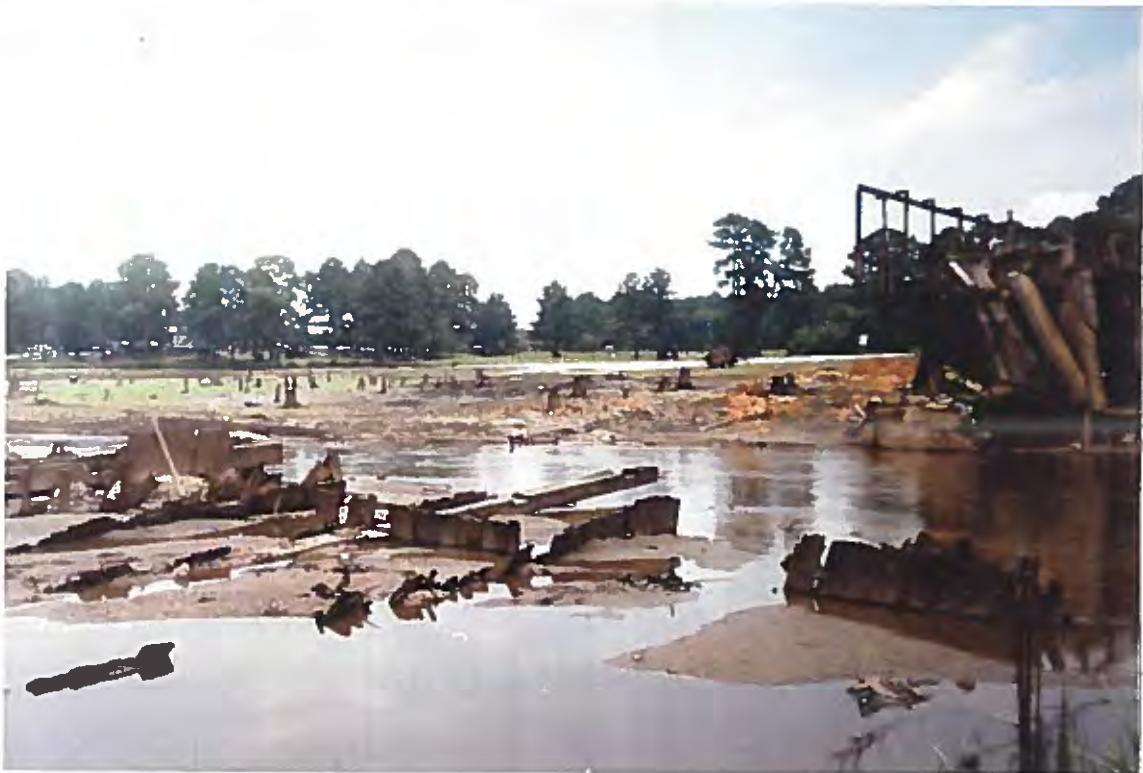
2. Looking upstream across failure area; purpose of wood piles unknown

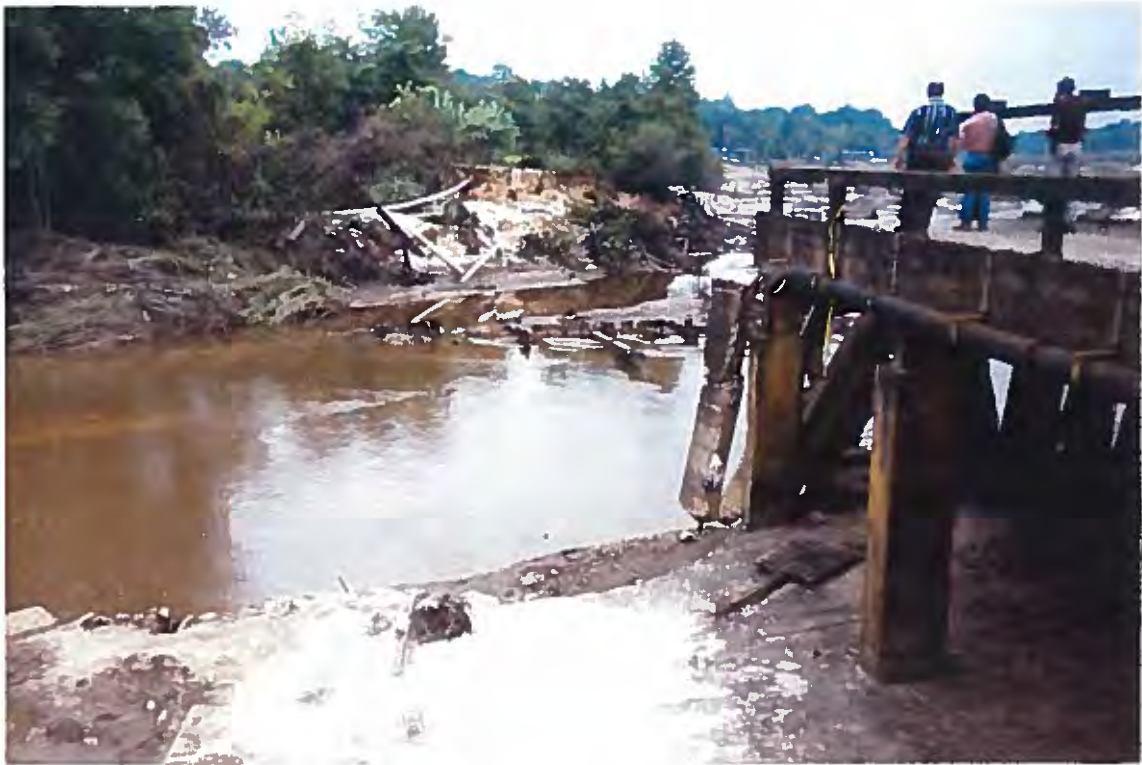
3. View of failure area on opposite bank

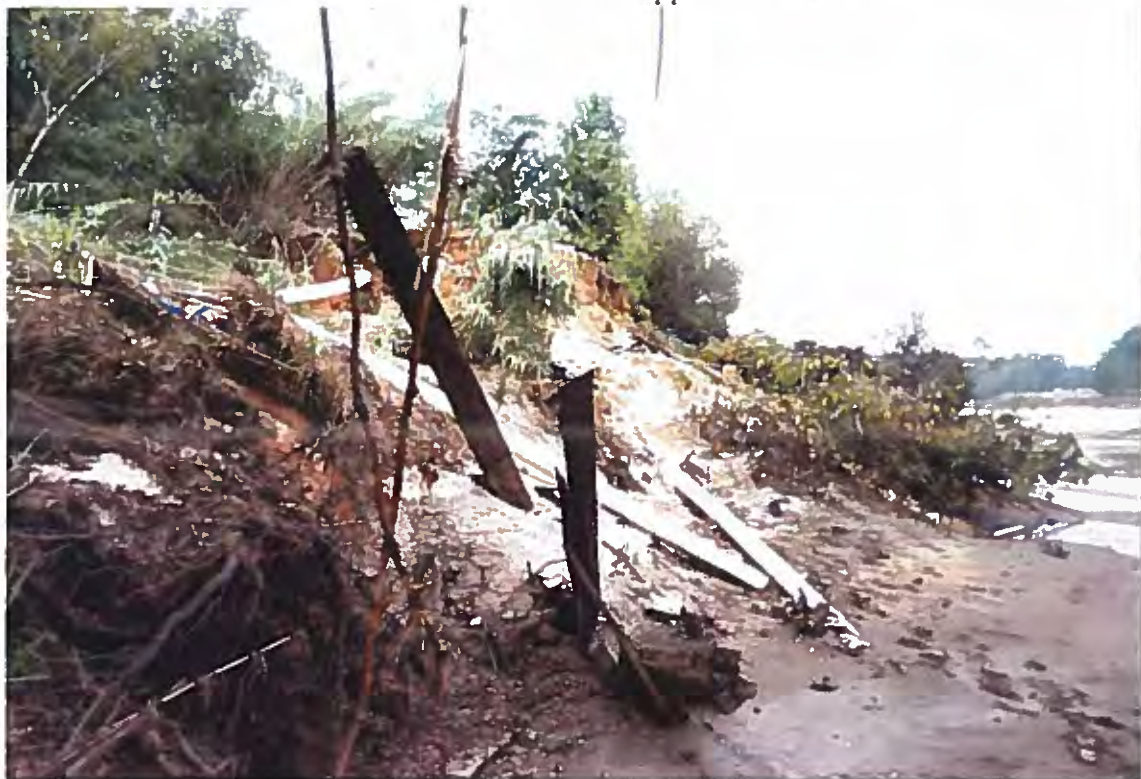
4. Closeup of opposite bank failure; purpose of wood pilings unknown

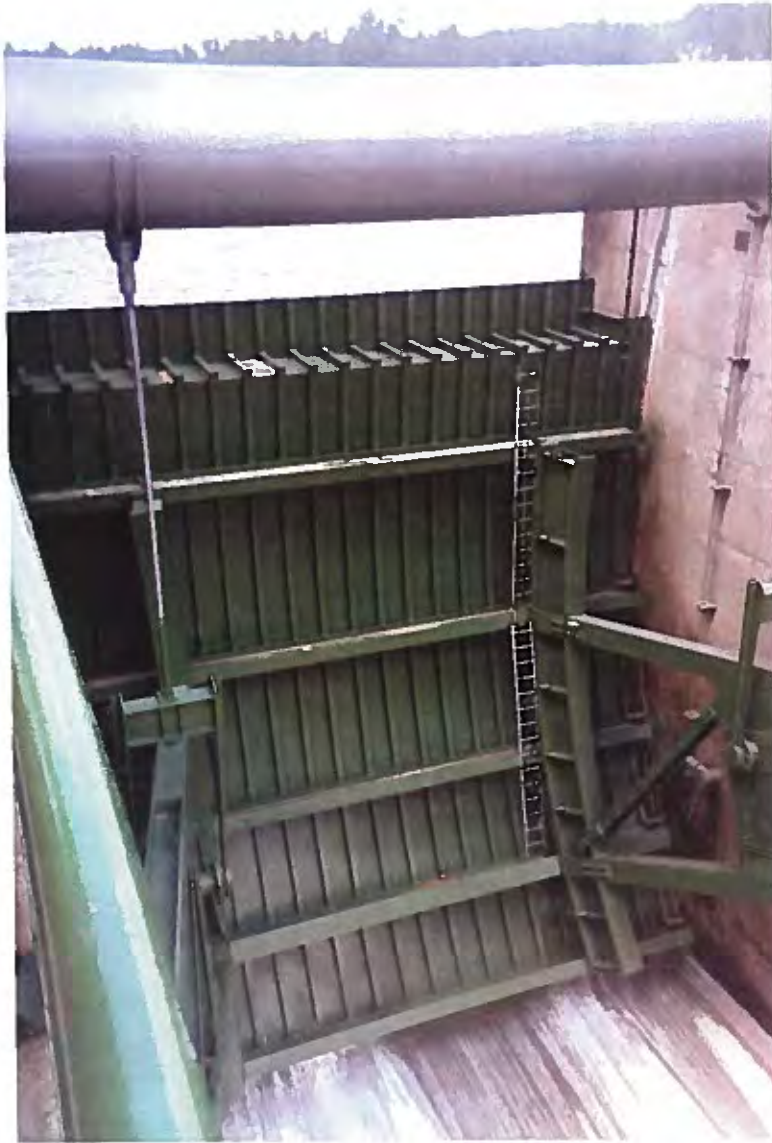
- **Remarks:** Operator reported problems with the automatic gates occurred during the flooding that necessitated a switch to manual operation. No formal early warning system exists, and no hydrologic/hydraulic information exists that would assist the operator in making decisions on gate operation and spillway releases. A telephone call from an upstream resident alerted the operator of an impending flood wave crest in the pool area. As a result, the Operator opened spillway gates in order to prevent the dam from overtopping. Operator reported pool level rose to within about 6 inches of the crest.

1. Electronic gate system did not work; mechanism had to be operated manually

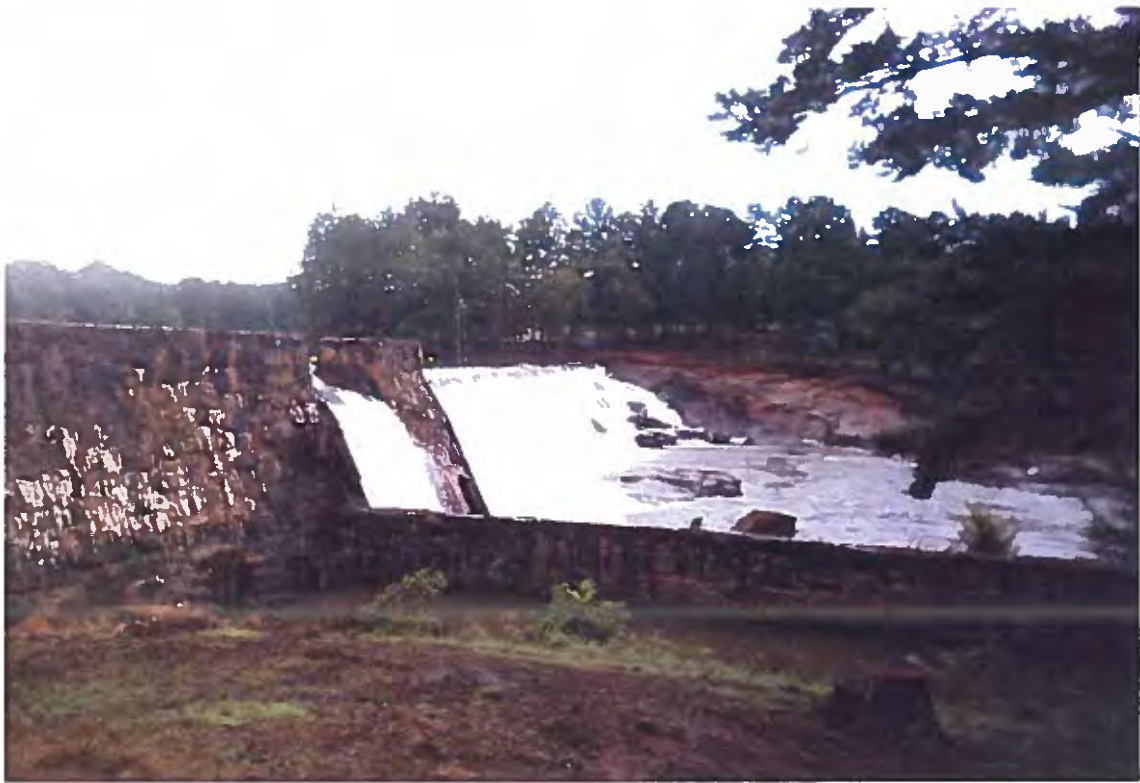
- **Damage Assessment:** Both dam abutments exhibited erosion along the dam-abutment contact.
- **Approximate Date and Time of Failure:** No failure
- **Observed Impacts of Failure in Pool Reach:** Minor flooding of ranger station above dam right abutment
- **Observed Impacts in Downstream Reach:** Washout of pedestrian bridge downstream

1. Dam remained intact; erosion at dam abutment

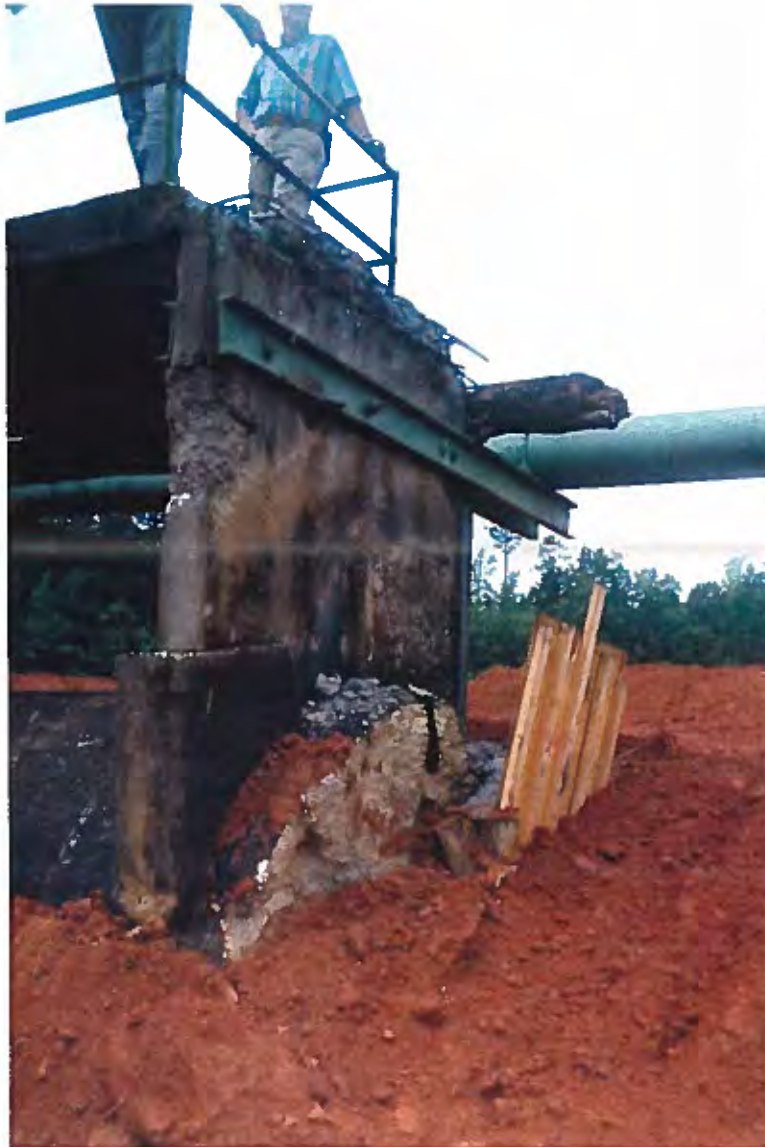
- **Damage Assessment:** Dam was reportedly overtopped by 4 to 5 feet of water and breached following severe erosion at left wingwall of emergency spillway. Erosion was reported as about 30 feet deep extending into the dam foundation. Left side of emergency spillway failed.
- **Approximate Date and Time of Failure:** July 6, 1994, a.m.
- **Observed Impacts in Pool Reach:** Temporary loss of water supply
- **Impact to Downstream Reach:** Reported downstream flooding of Monroe County. Bridge downstream remained intact.
- **Remarks:** City has retained an engineering firm to expand reservoir capacity. Conceptual drawings were provided by the firm.

1. Dam breach area

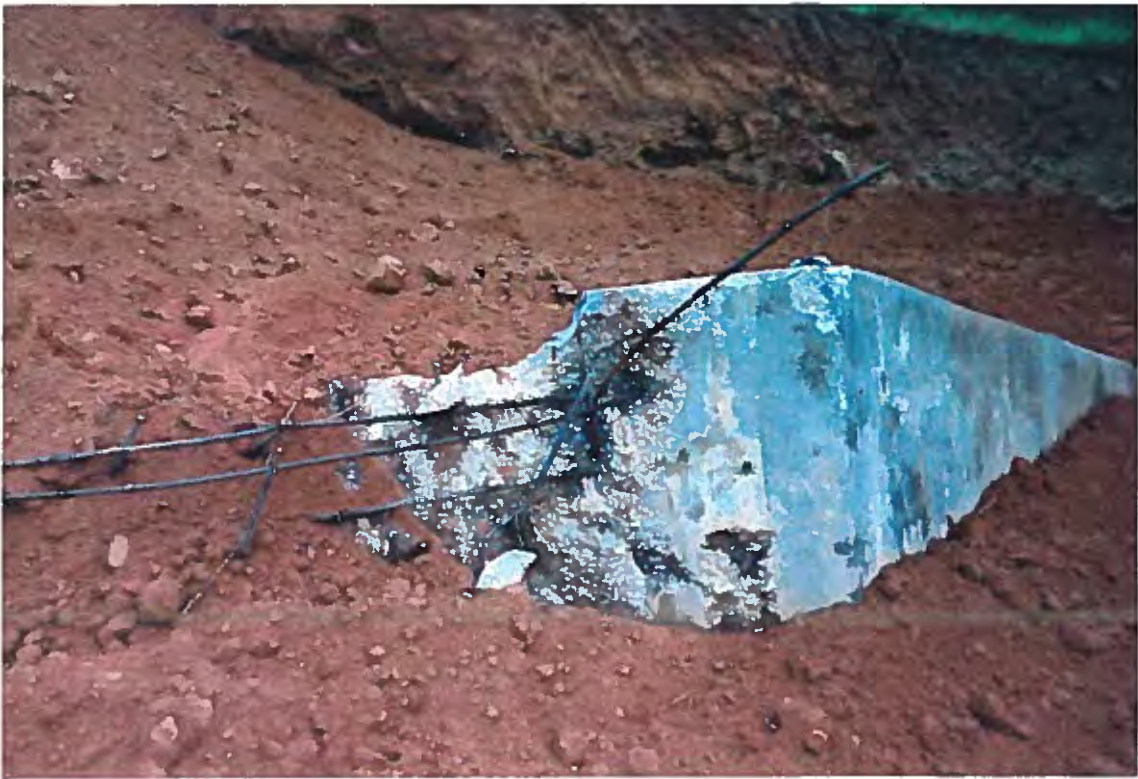
2. Dislodged and damaged wingwall

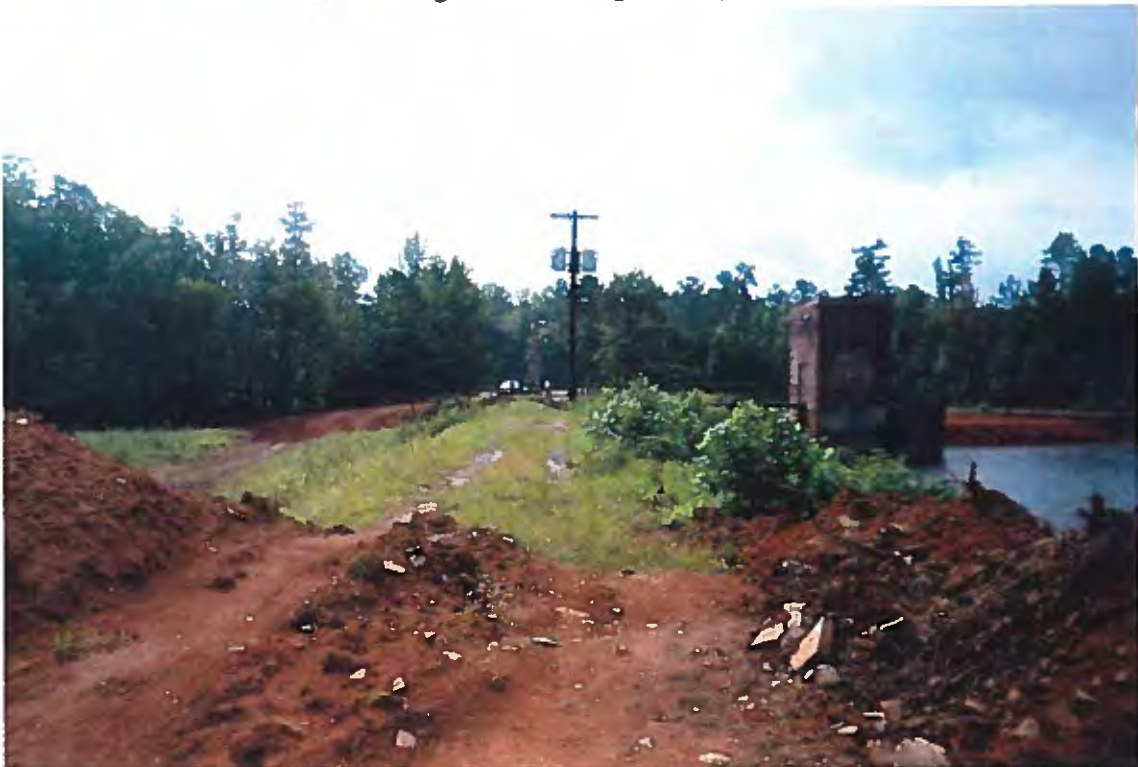
3. View along top of embankment showing vegetation

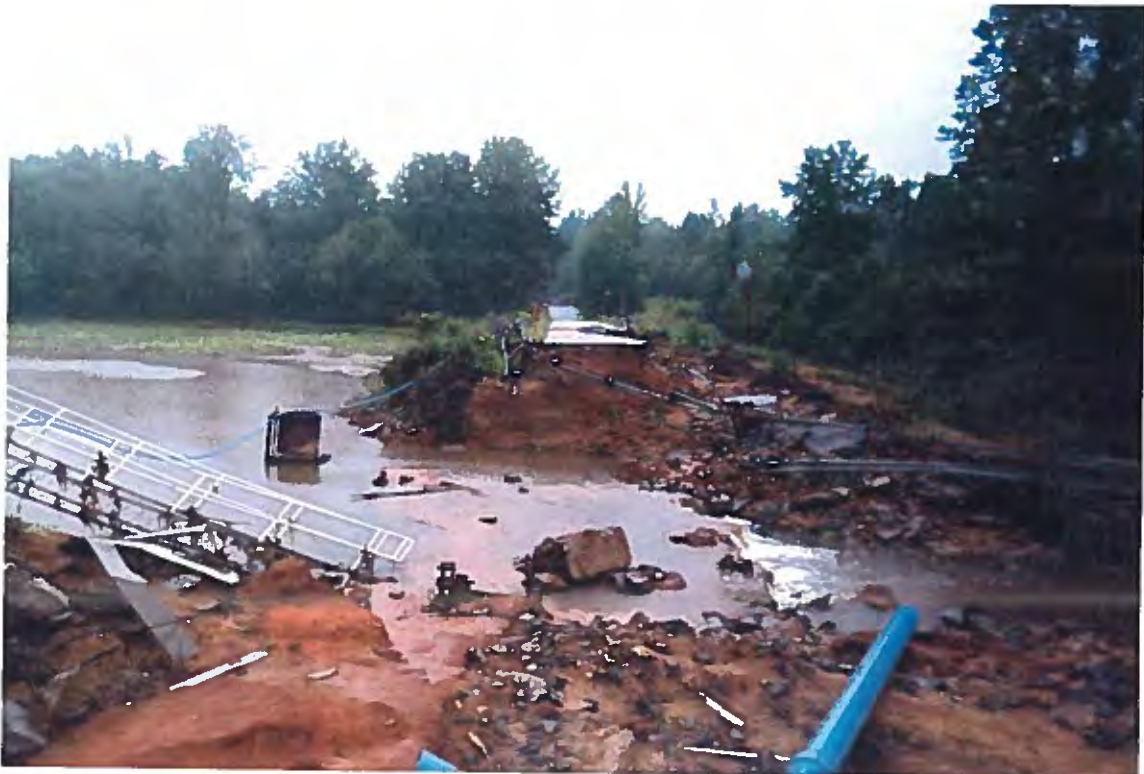
- **Damage Assessment:** Spillway pool rose above top of dam, causing erosion and eventually breaching. Utilities in the embankment may have contributed to the failure.
- **Approximate Date and Time of Failure:** July 5, 1994
- **Observed Impacts of Failure in Pool Reach (life, property, infrastructure):** Loss of recreational opportunities and water supply
- **Observed Impact of Failure in Downstream Reach (life, property, infrastructure):** Dam also included road that failed, limiting access to some properties.

1. Breached section of dam and damaged road

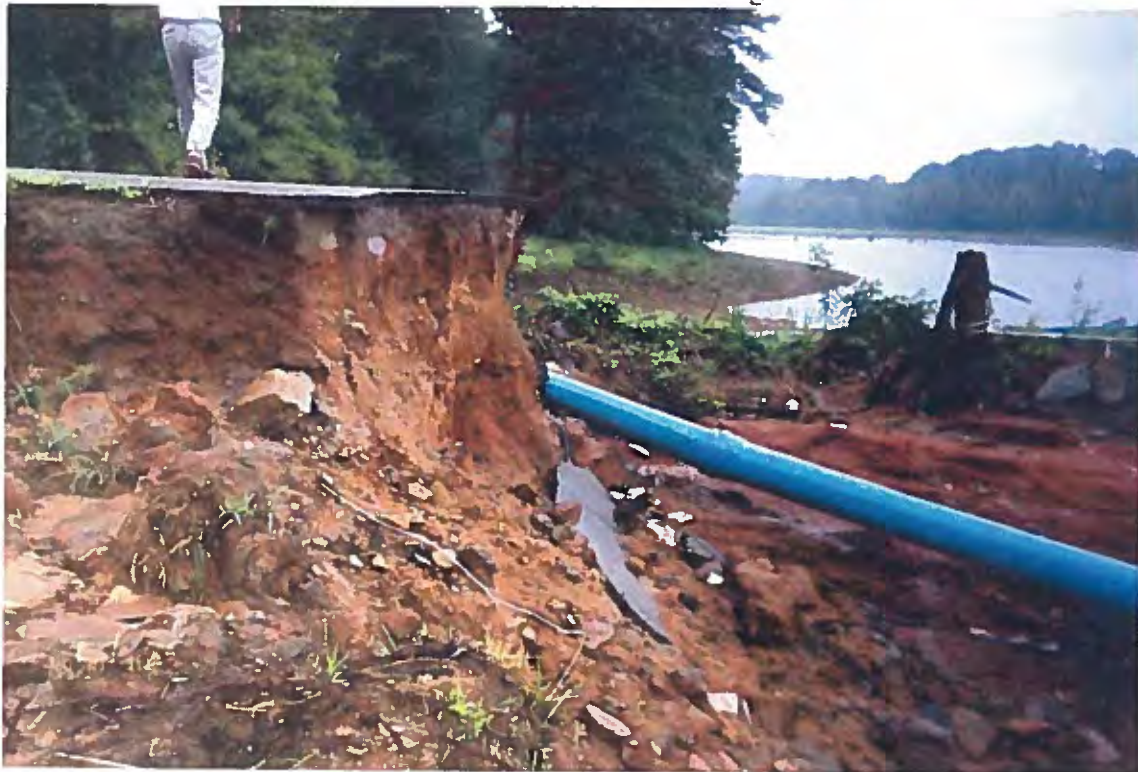
2. Closeup of breach area

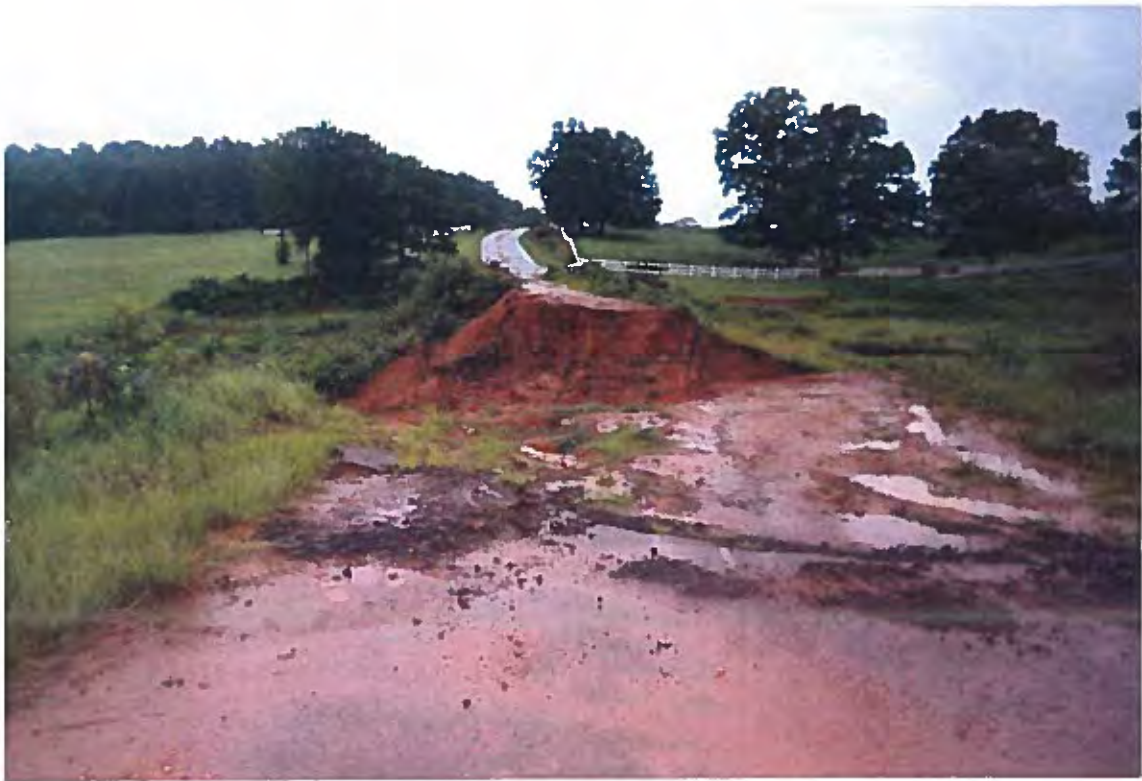
- **Damage Assessment:** Small outlet was not adequate to convey storm runoff. Overtopping caused erosion and eventual failure of the embankment. The steep downstream slope (i.e., 1:1) may have contributed to the failure. Evidence of piping was observed on the downstream face of the embankment.
- **Approximate Date and Time of Failure:** July 5, 1994
- **Observed Impacts of Failure in Pool Reach (life, property, infrastructure):** Loss of recreational opportunity
- **Observed Impact of Failure in Downstream Reach (life, property, infrastructure):** No observed impacts

1. Failed section of dam and road

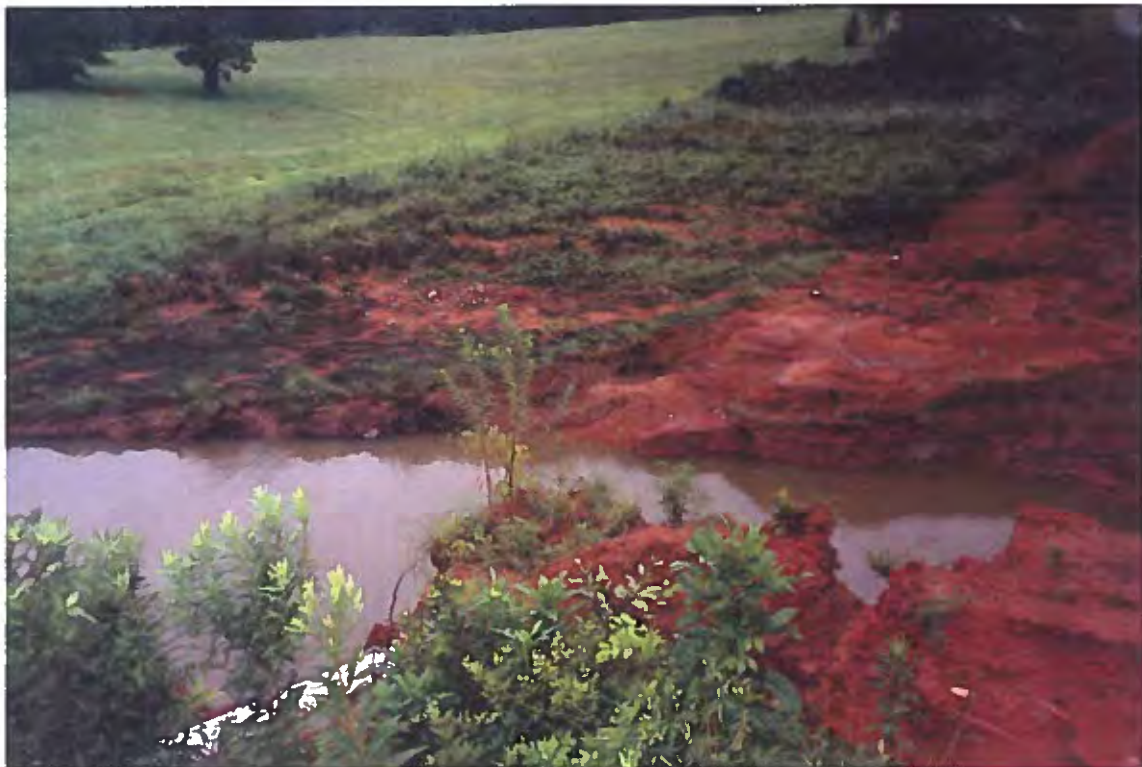
2. Closeup of dam breach area
