Independent Panel of Engineers

Report on Breach of Delhi Dam

December 1, 2010

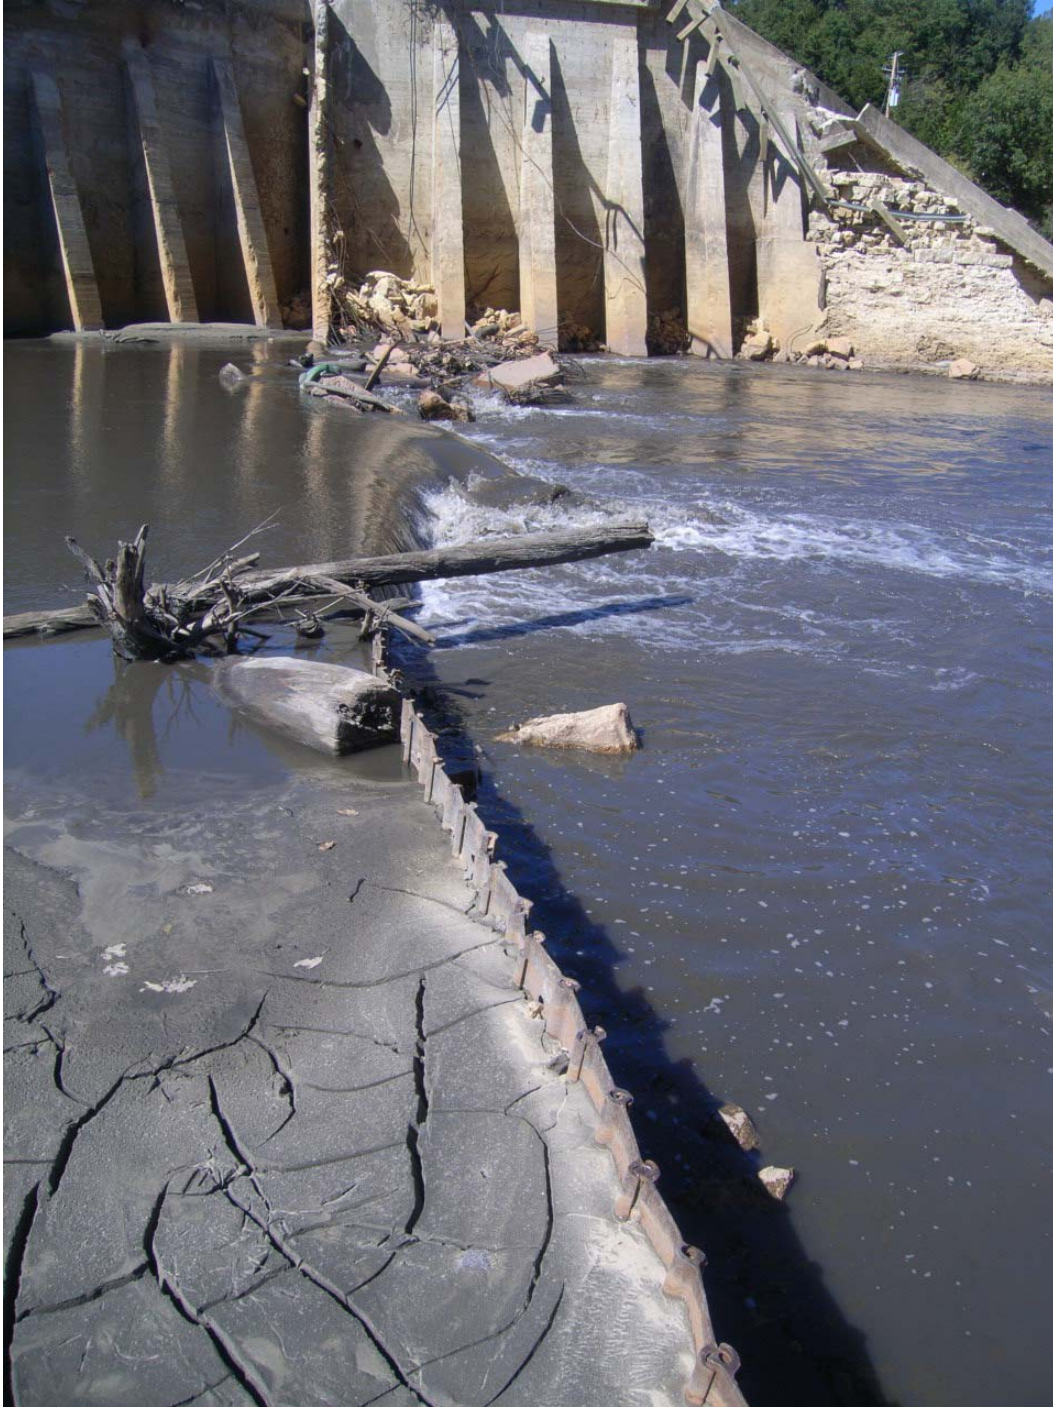
Photo II-3.
Breach area
Note Embankment core wall remnant at gated spillway and sheet pile.

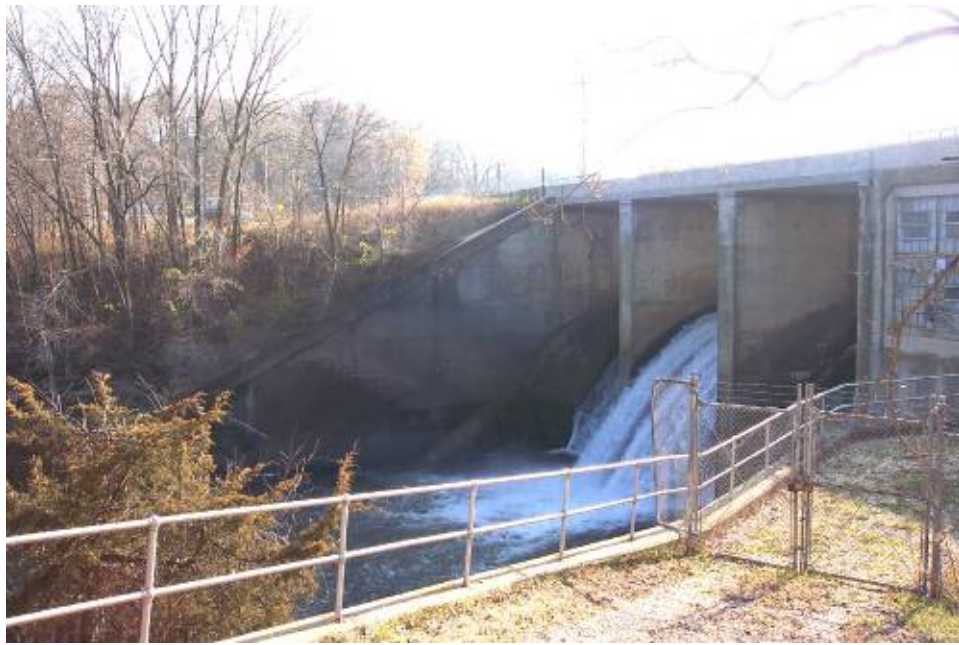
Photo II-5.
Vegetation on the downstream embankment slope

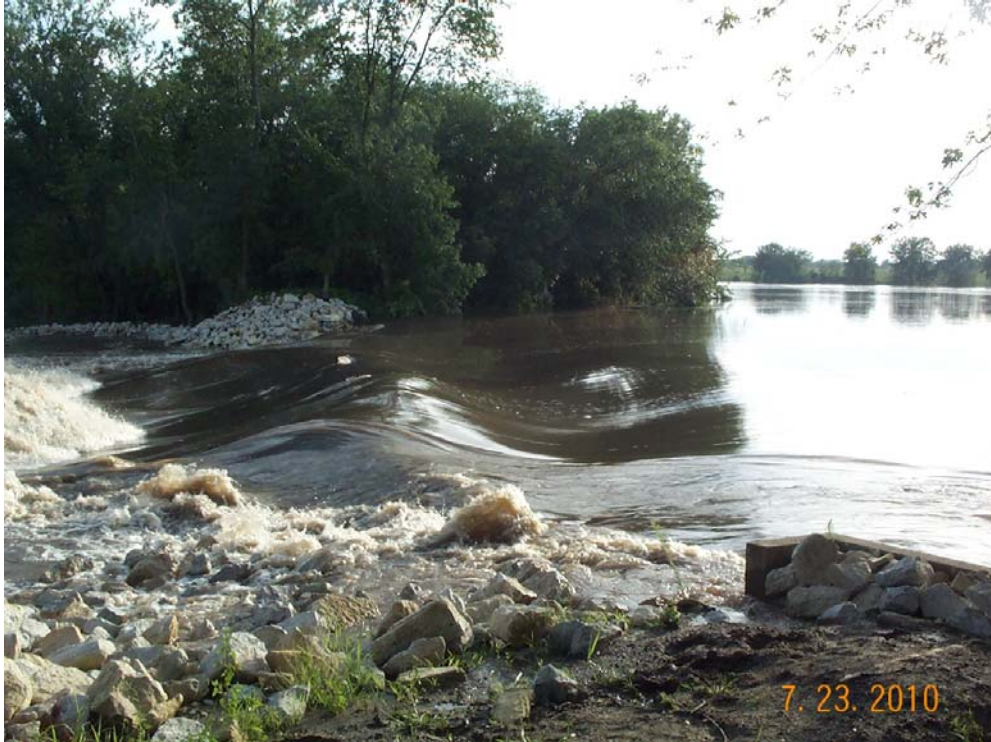
The Quaker Mill Dam Rock Dike breached Friday, July 23. Photo III-2, according to Anthony Bardgett Delaware County Engineer, shows, the dike in the process of breaching and the photo was taken at about 7:00 pm on Friday evening. The rock dike breach was complete sometime Friday. There was speculation that the failure of the Quaker Mill Rock Dike contributed significantly to inflows at Delhi Dam and may have been a factor in the overtopping breach at Delhi Dam. This is not believed to be likely for several reasons. A review of the flood hydrograph at the Manchester USGS gaging station reveals no significant spike in flow on Friday through Saturday. Secondly, the travel time from the Quaker Mill Rock Dike to Delhi Dam is estimated to be about 6-8 hours, so if there was incremental increase in flood inflow, it would have past Delhi Dam well before the peak inflow occurred at Delhi Dam. Thirdly, it is believed that some of the flow that passed through the breach of the dike at Quaker Mill would have been passed over Quaker Mill Dam instead, offsetting an incremental effect of the dike breach.

Photo III-2
Quaker Mill Rock Dike in Process of Breaching on 7/23/2010

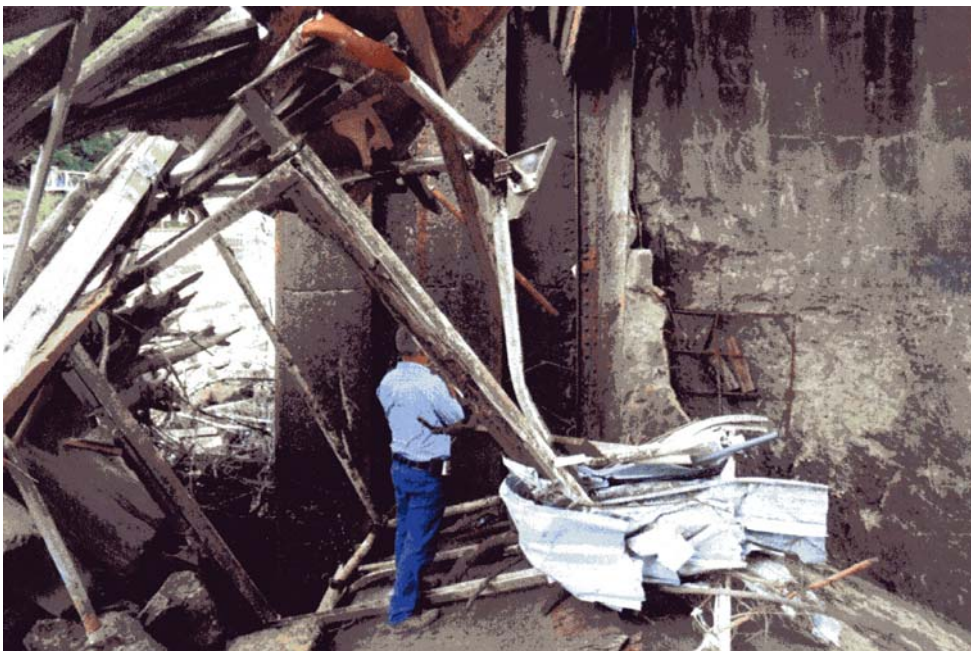
Photo III-4

Damage to spillway pier adjacent to Gate 3 left side guide[Stanley 2010]

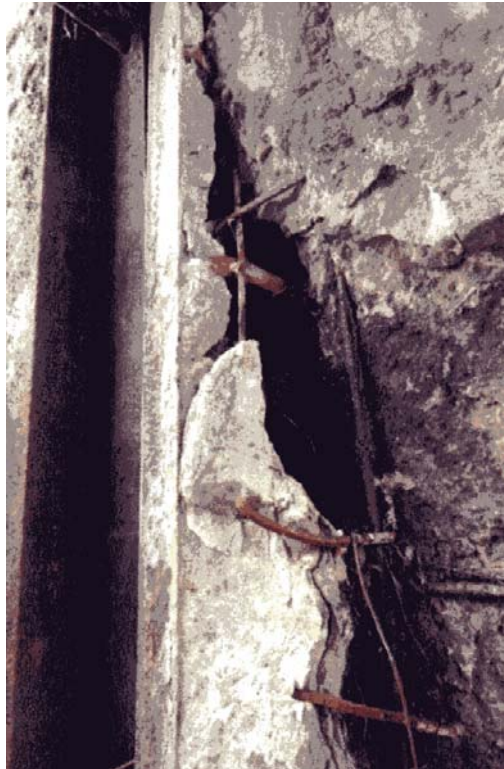
Photo III-5
Damage to spillway pier adjacent to Gate 3 left side guide
[Stanley 2010]

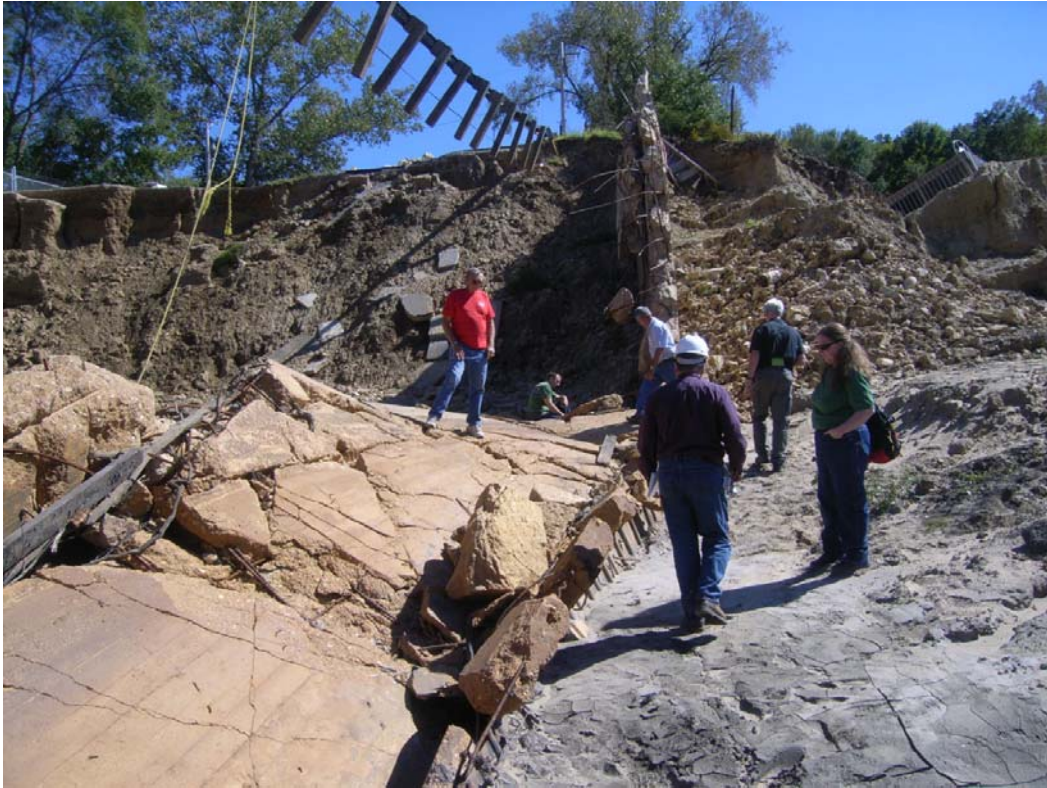
**Photo IV-2.
Exposed embankment material post-breach.**

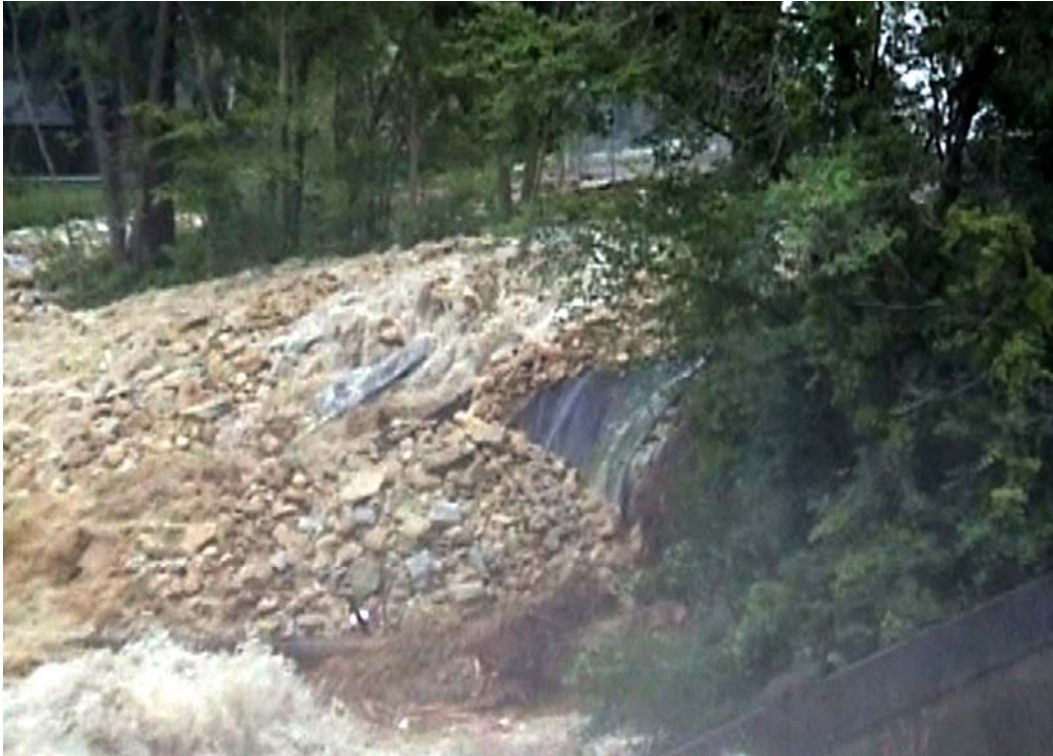
Whirlpools in the reservoir were noted by several observers with the first evidence seen around 3:30am on 24 July by Mr David Fink when he stopped to investigate a sag in the chain link fence at a distance of 40 to 50ft from the gated spillway. At 6:00 am clear seepage was observed emerging through the 2009 LDRA placed riprap on the downstream slope and around 9:00am dirty discharge was first observed. Information from interviews included in the timeline describe areas where the road settled prior to the breach, indicative of loss of embankment material. Testimony by Mr. David Fink and Mr. Wruck identify dirty water discharging at what is referred to as the short section of embankment (that part of the dam not widened by the County construction in 1967). This location was noted by Mr. David Fink on Photo IV-12. This agrees with Photos IV-8 and IV-9 that show discolored discharge in this area

Eyewitness accounts, with description of whirlpool conditions in the reservoir near the core wall alignment, indicates that internal erosion initiated prior to overtopping. Additionally, Photos IV-8 and IV-9 show discolored discharge emerging near the embankment toe (believed to be seepage related rather than related to the surface flow). The seepage from the reservoir to the tailwater may have taken several paths but the description of an orange colored discharge suggests that embankment material was entrained within the flow. The sag in the fence and whirlpool seen observed at 3:30 am on 24 July indicates that a significant amount of flow was entering the embankment. Although a corresponding amount of flow was not observed exiting the embankment, the darkness and the vegetation on downstream slope of that section of the embankment could conceal a discharge point. At 6:00 am July 24, clear flow was seen discharging above the toe of the dam and also seen discharging in the riprap above the berm/staging area shown in Figure II-4. At around 9:00 am, about 5½ hours after the first whirlpool was discovered, dirty or discolored discharge was seen emerging near the embankment toe.

Photo IV-8
Overtopping flow and discolored discharge from beneath geotextile (still photo captured from amateur video).

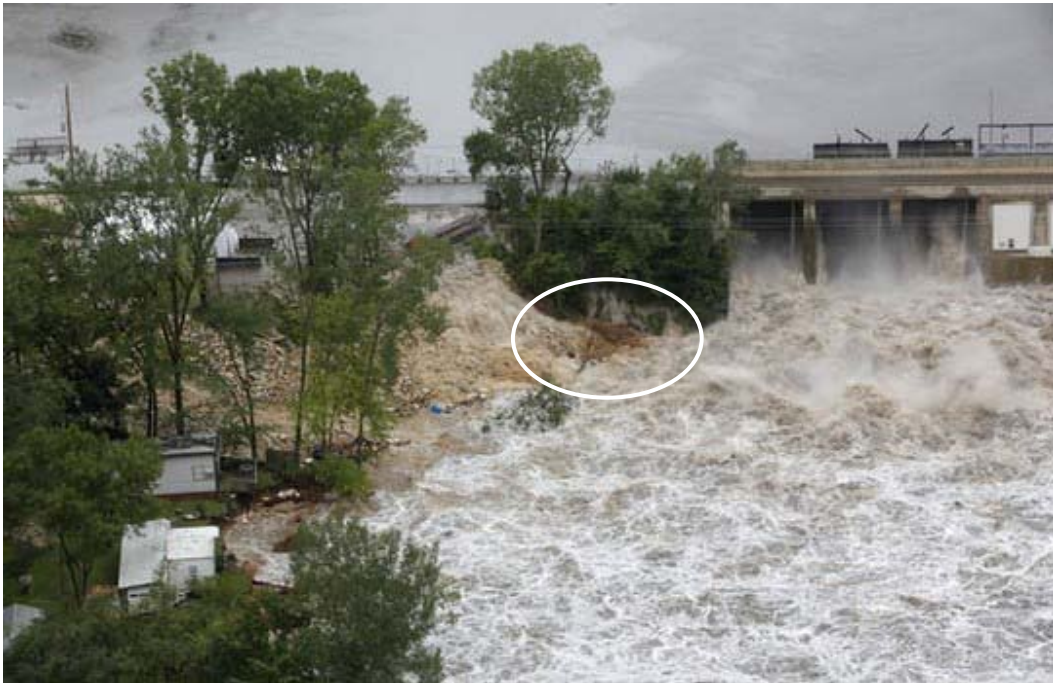
The embankment dam was overtopped about 10:00am and a complete breach through the embankment occurred about 1:00PM July 24. The progression to breach was rapid once overtopping initiated. Photo IV-9 shows overtopping flow over the rock placed by the LDRA in an opening between the trees but also shows surface flow emerging from the trees in the short section of the embankment. Overtopping flows would exacerbate the conditions already started by internal erosion.

Photo IV-9
Discolored discharge emerging near toe (DesMoinesregister.com).

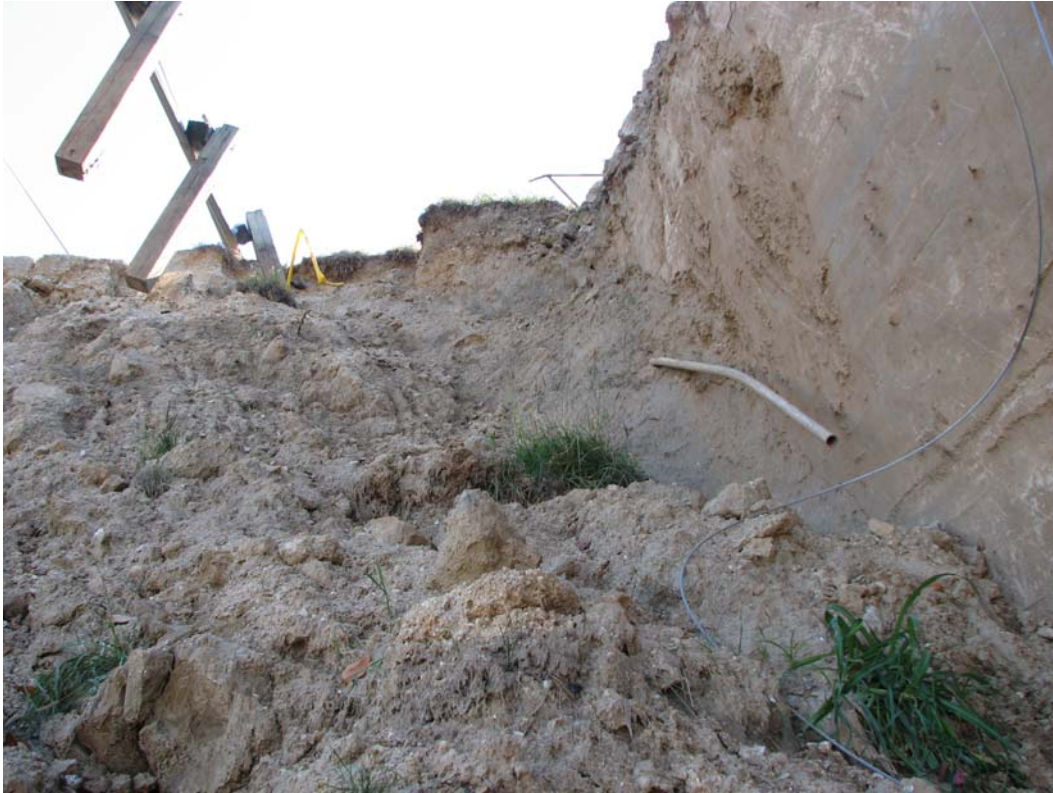
Photo IV-10
Fill material downstream of core wall at breach. Note coarser fill material above top of core wall.

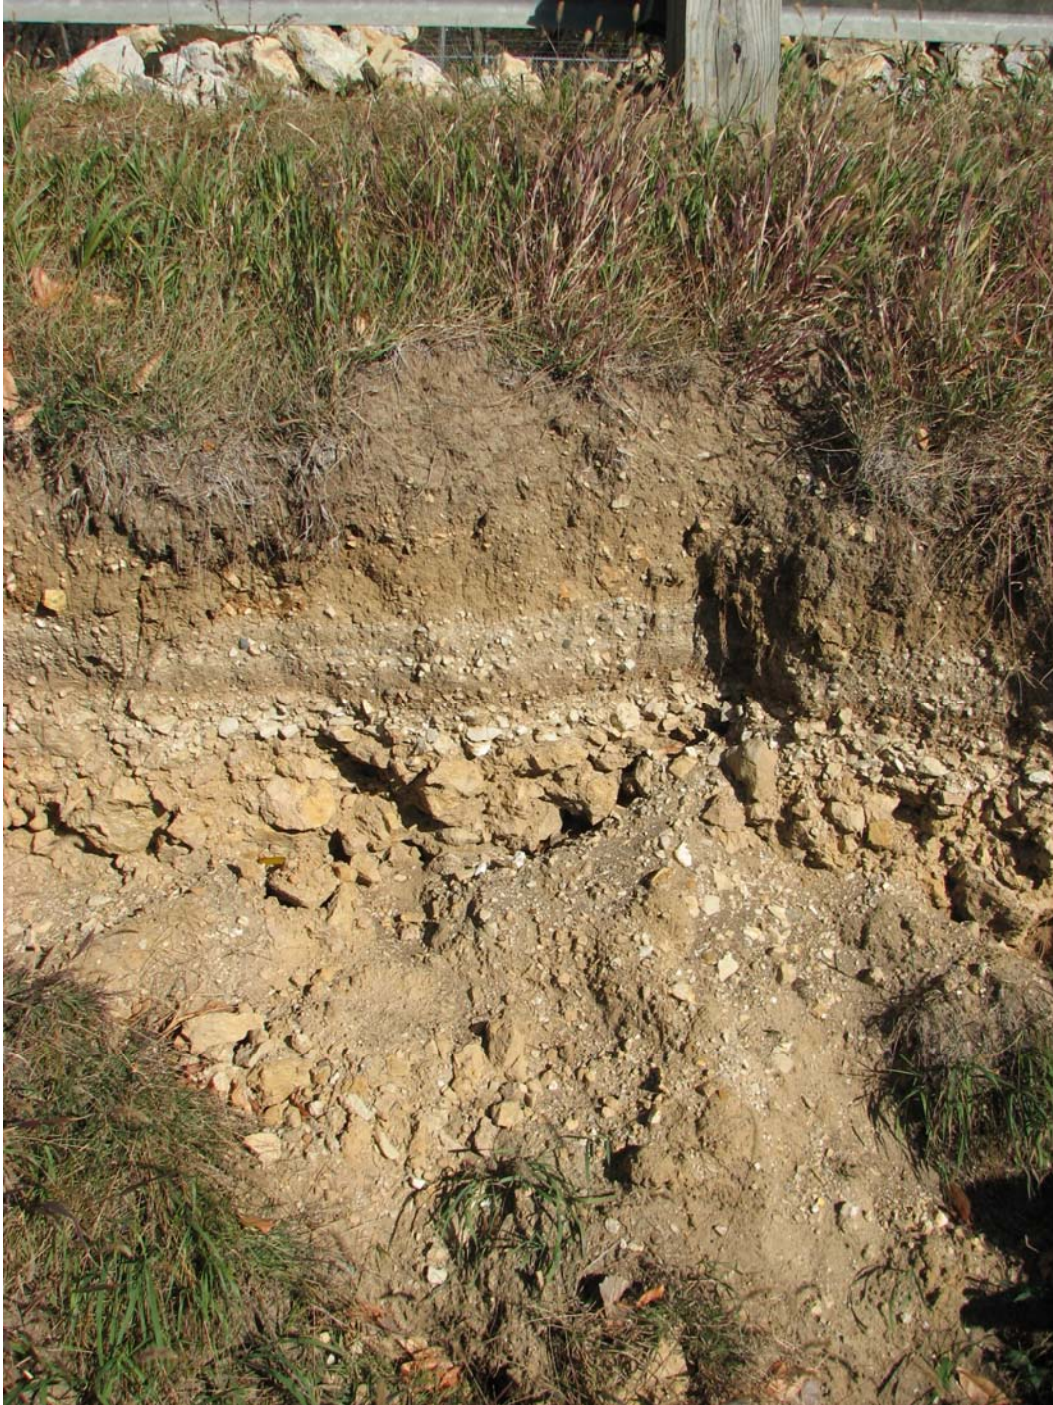
Photo IV-11
Coarse material observed above the top of core wall at the remaining sinkhole

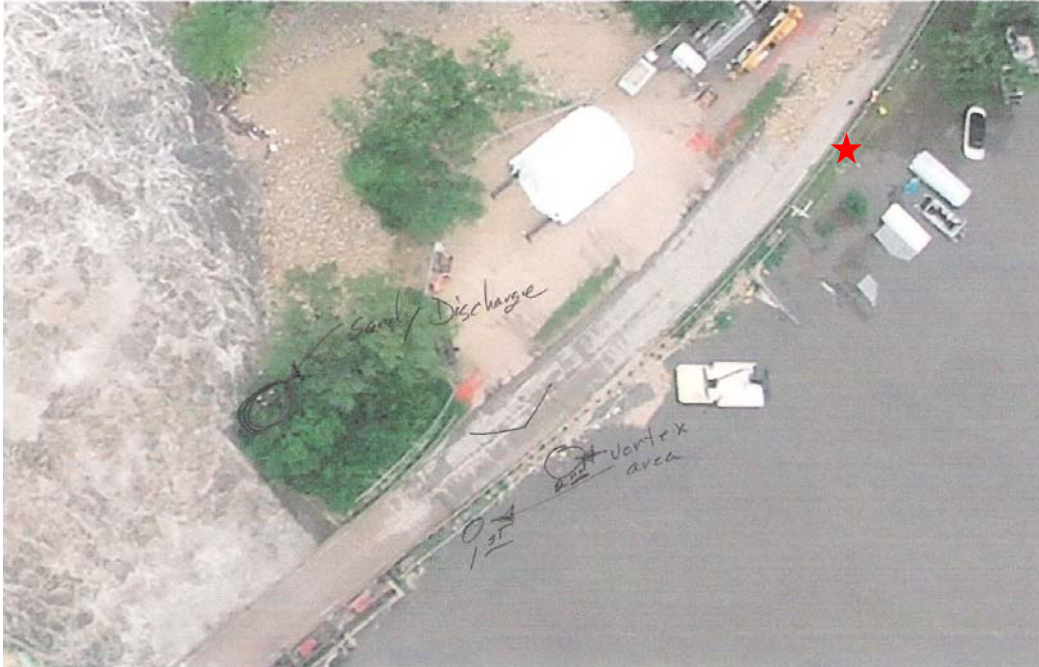
Photo IV-12

Approximate whirlpool/vortex locations by Mr David Fink. Approximate developing sinkhole location from post breach inspection shown by red star.

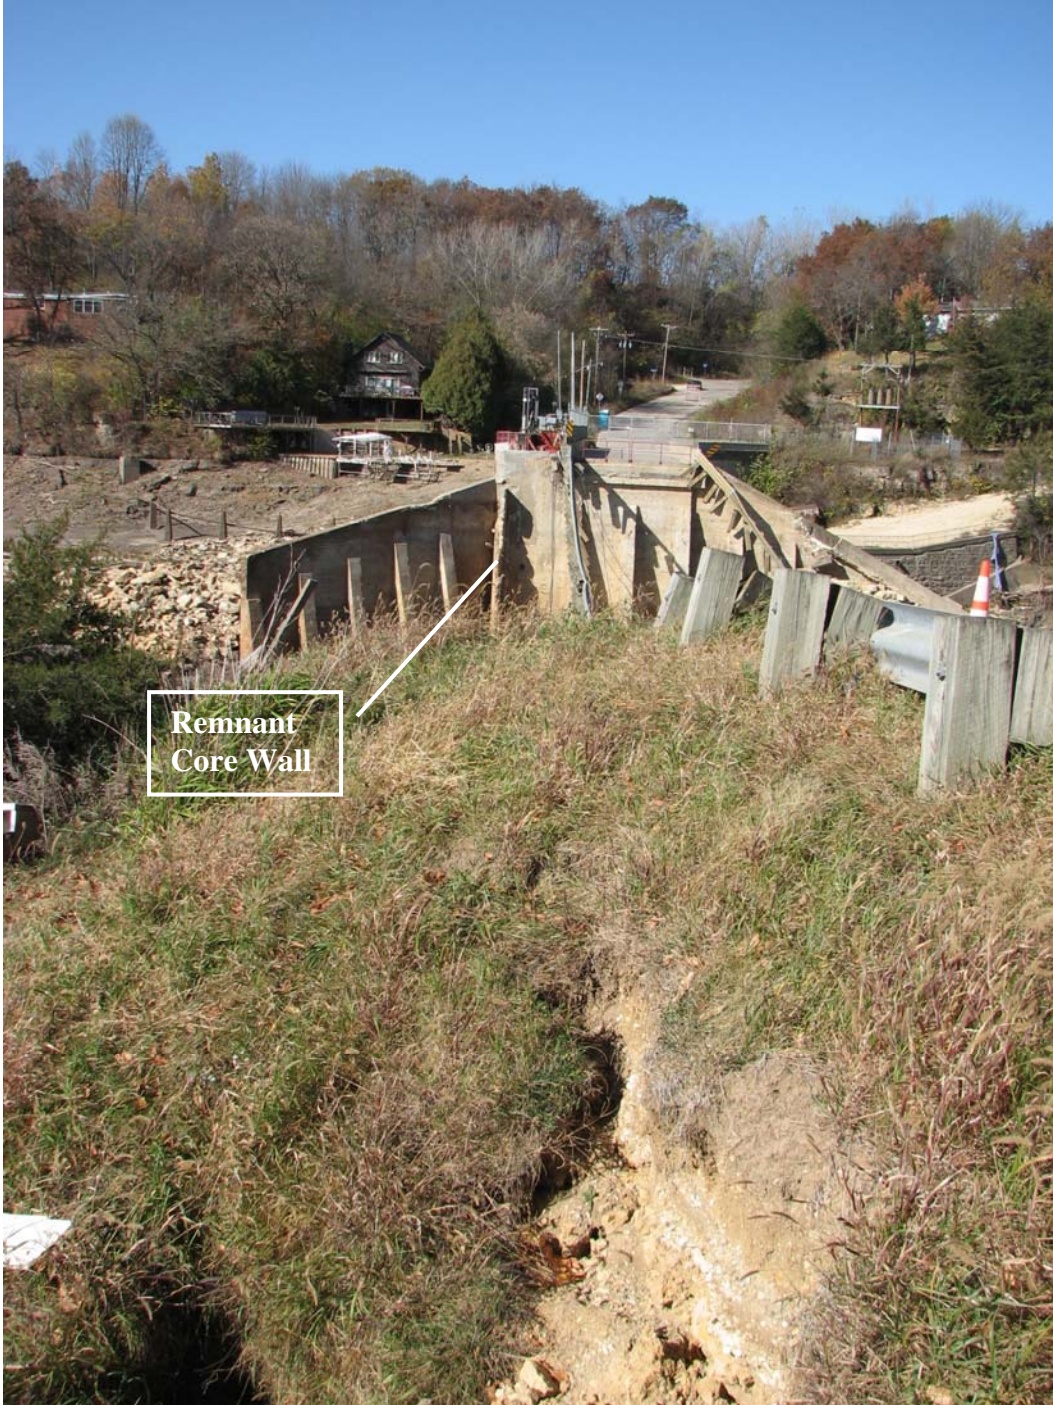
Photo IV-13
Developing sinkhole location in line with remnant core wall.

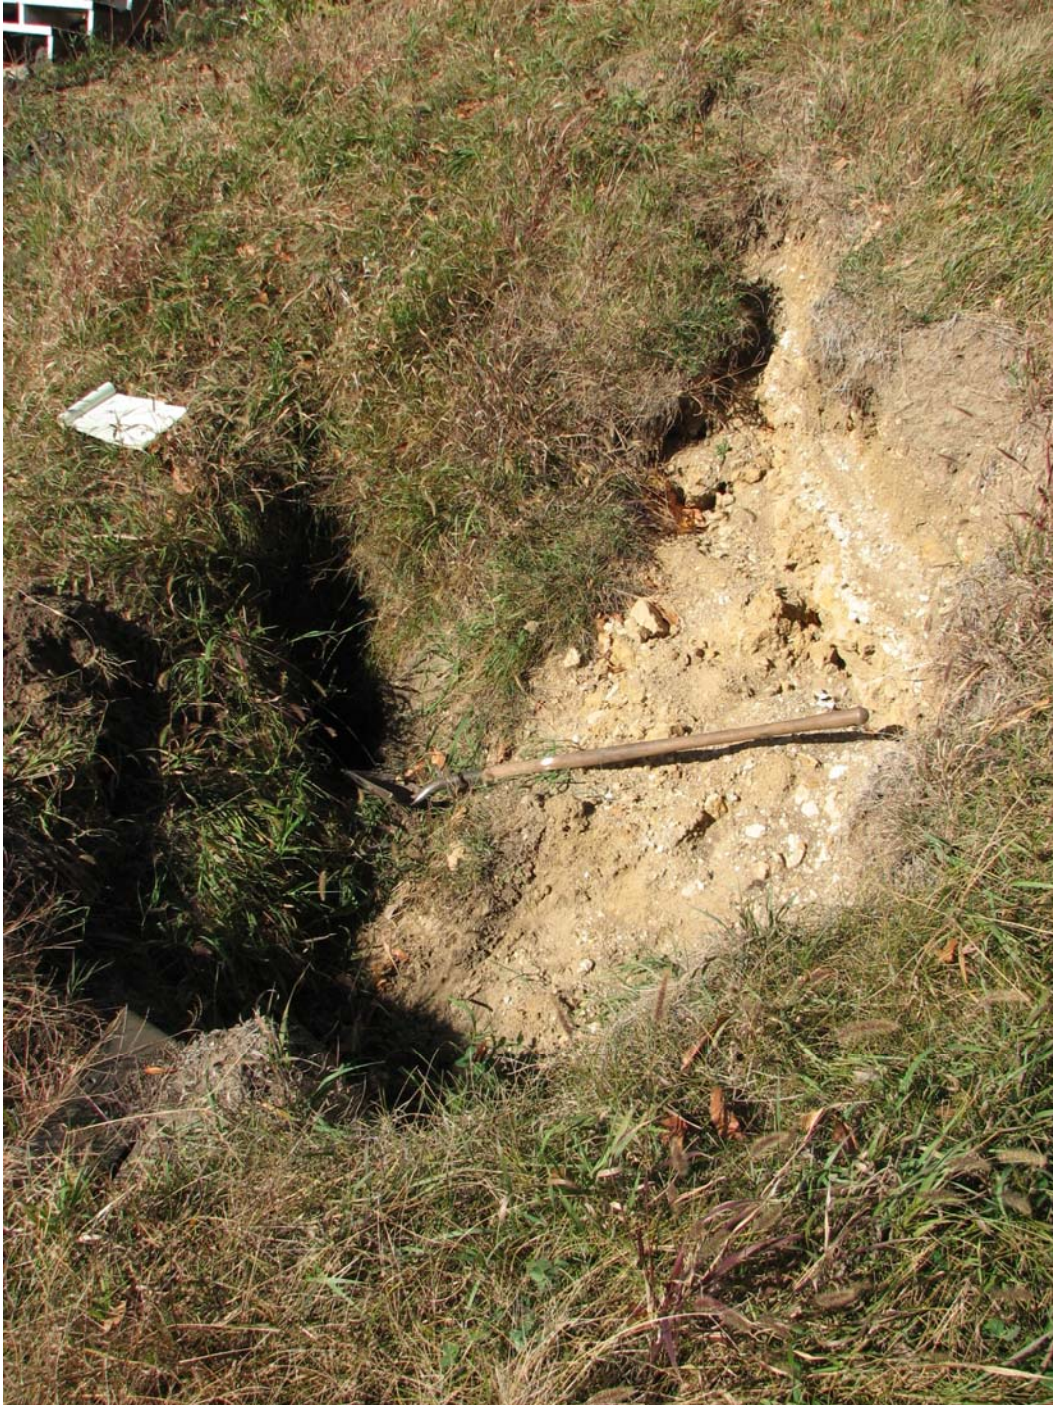
Interviews of several individuals describe events that suggest internal erosion was a significant factor in the dam breach. Two whirlpools in the reservoir were observed at locations that closely align with the location of the core wall. What appears to be a third developing sinkhole remains on the upstream face of the embankment. The two whirlpool/vortex locations were estimated by Mr David Fink and are shown along with the developing sinkhole location on Photo IV-12. Photo IV-13 shows the location of the developing sinkhole in line with the core wall remnant at the gated spillway. Photo IV-14 shows a close up of the

developing sinkhole with a deeper part of the hole extending towards the breach. A void in the sinkhole was not found but material dug from the bottom of hole is visually classified as an SP-SM, 85% sand, 5% fine gravel and 10% silt, loose with no plasticity and scattered root fragments (likely sloughing surface material). The onsite inspection indicated that the sinkhole was in alignment with the core wall. It did not appear to be related to a toppling tree or surface erosion and was too high up slope to be considered the site of a boat anchor device. Sloughing of grass into the hole and lack of material around the perimeter of the hole indicated water flow and subsequent erosion progressing downward, apparently in the direction of the breach.

Developing sinkhole with deeper area between notepad and shovel. Note surface vegetation above this area was in the process of sloughing into this hole. No void was found at the bottom of the hole but a larger rock limited the depth of excavation.

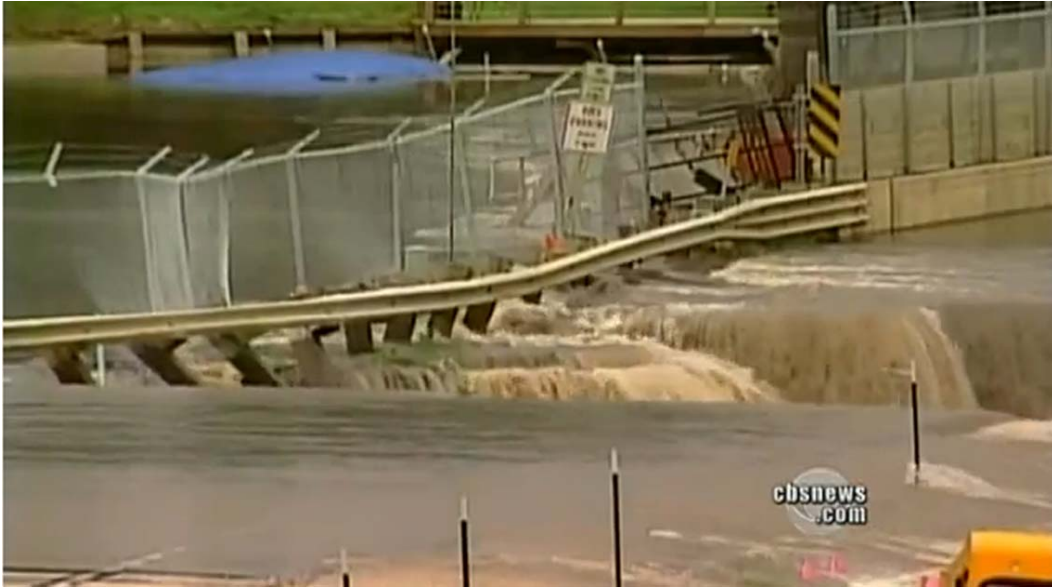
Photo IV-15
Developing breach along two fronts near gated spillway (photo from CBS news video).

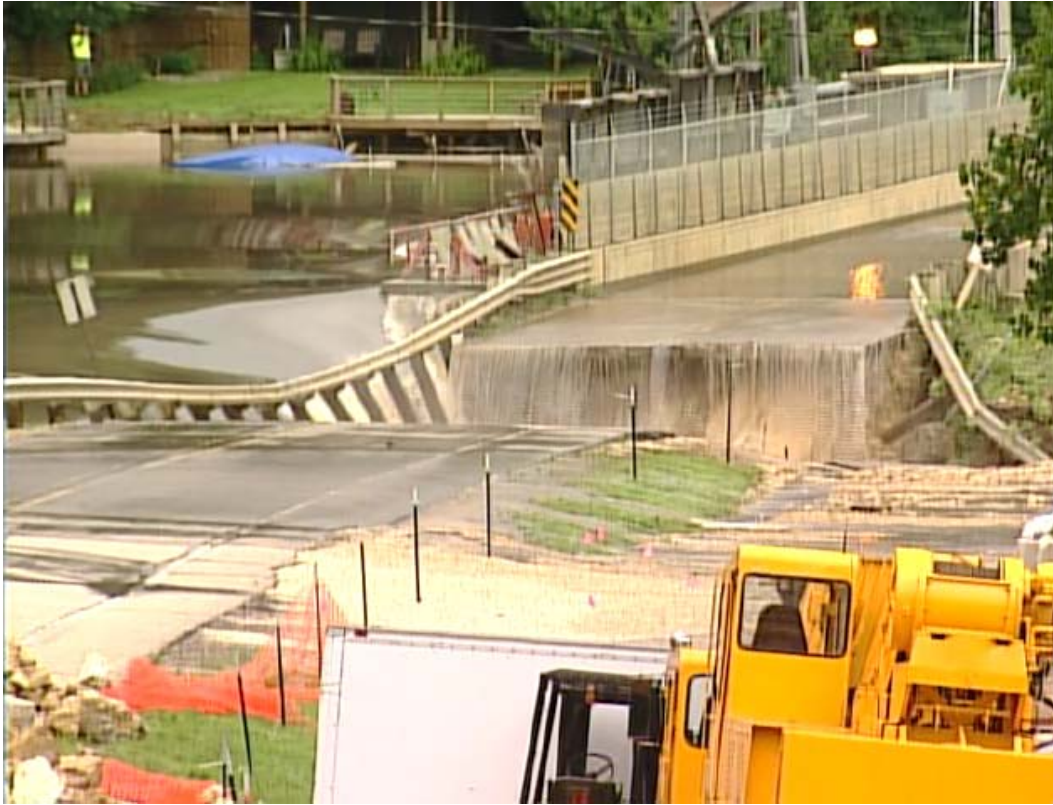
Photo IV-16 shows a fully developed breach where the reservoir drawdown appears to be controlled by the top of concrete core wall. In Photo IV-17 the drawdown has extended farther upstream as it appears the core wall has failed near the structure.

Complete breach through embankment with drawdown water surface in reservoir that appears to be controlled by the concrete core wall (photo from CBS news video).

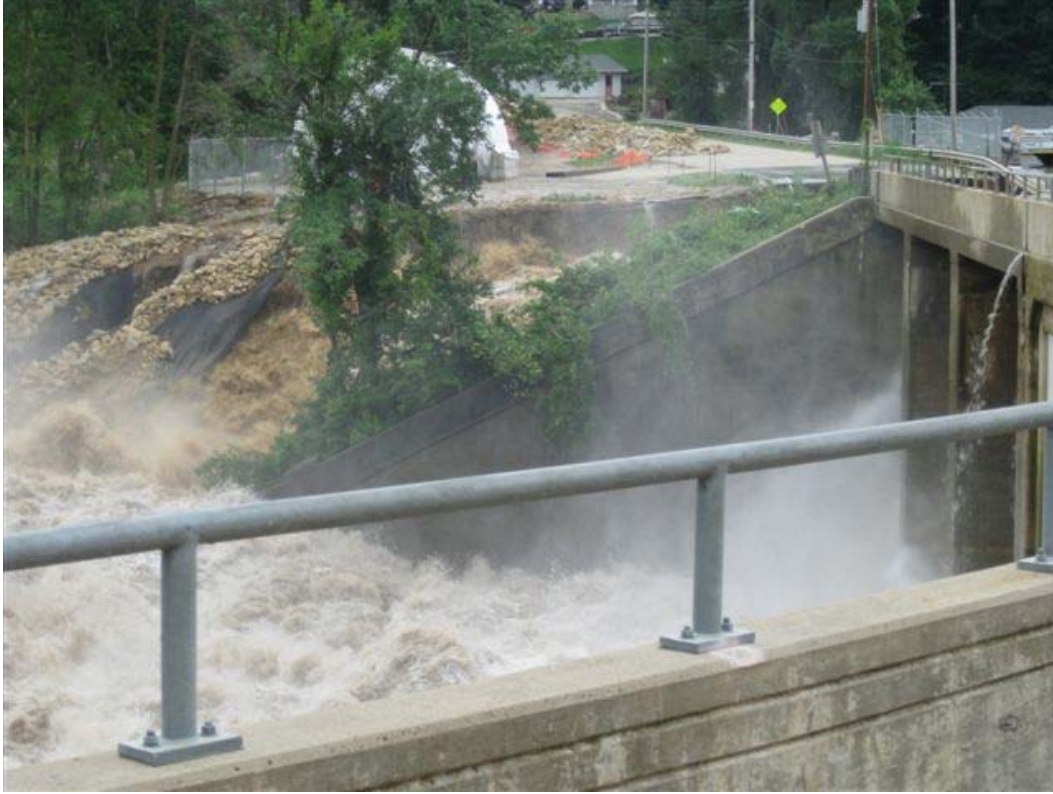
Photo IV-17

Photo taken following the complete breach through the roadway. Breach does not appear to be full depth (photo by T. McCarthy).

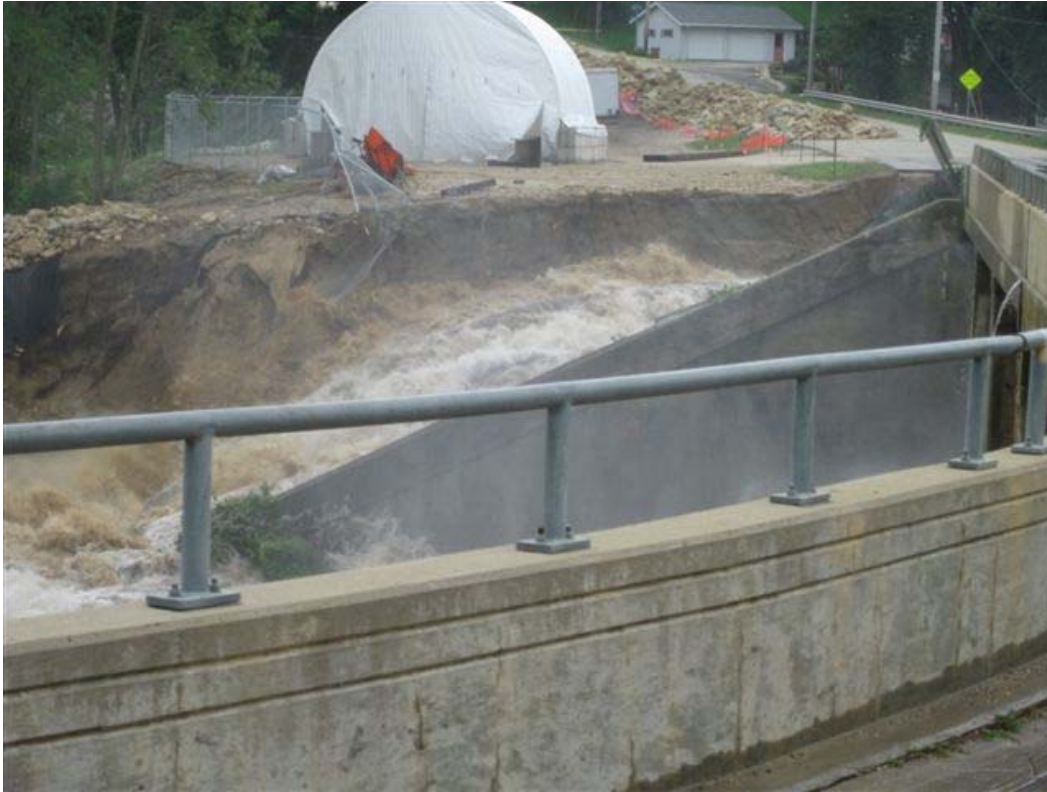
Photo IV-18
Continued breach development (photo by T. McCarthy).

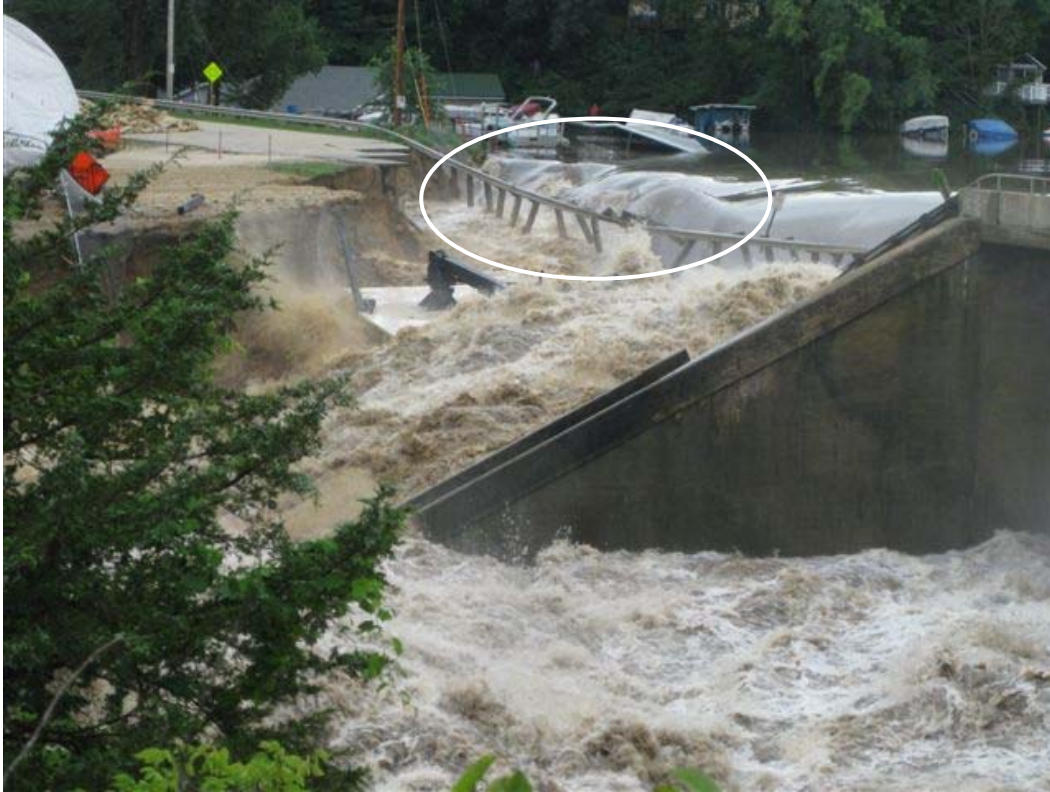
bedrock and then southward. Photo IV-19 indicates the core wall remained in place where erosion hadn't down cut sufficiently to lose support. The down-cutting action of the flow through the breach suggests that either the piping was occurring at a shallower depth (upper coarse material, fishway or emergency spillway location) creating a preferential surface erosion path or deeper where overflow combined with piping at the exit point. The existence of the two whirlpools/vortices, the alignments of narrow erosion gullies that appeared as deterioration progressed and the path of these two gullies toward the two whirlpool locations show active piping was occurring. Overtopping likely caused accelerated erosion along the piping channels

Photo IV-19
Continued breach development showing expected core wall location
Note advancing erosion in original embankment section
(photo by T. McCarthy).

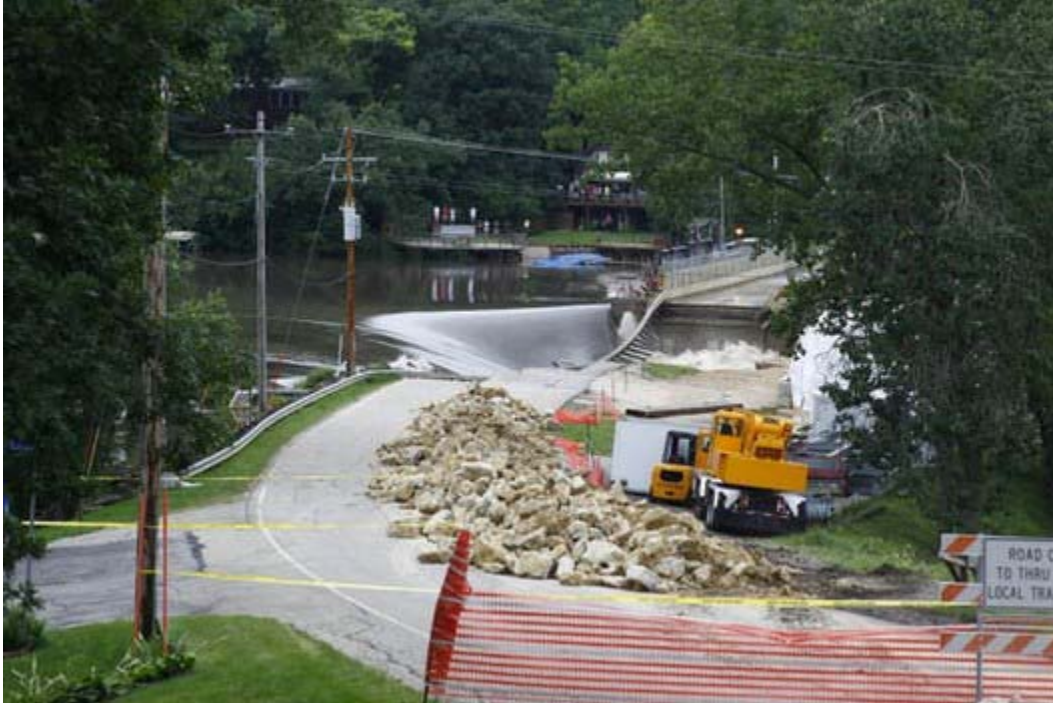
Photo IV-20. Breach expanding in width with loss of core wall (photo from DesMoinesRegister.com).

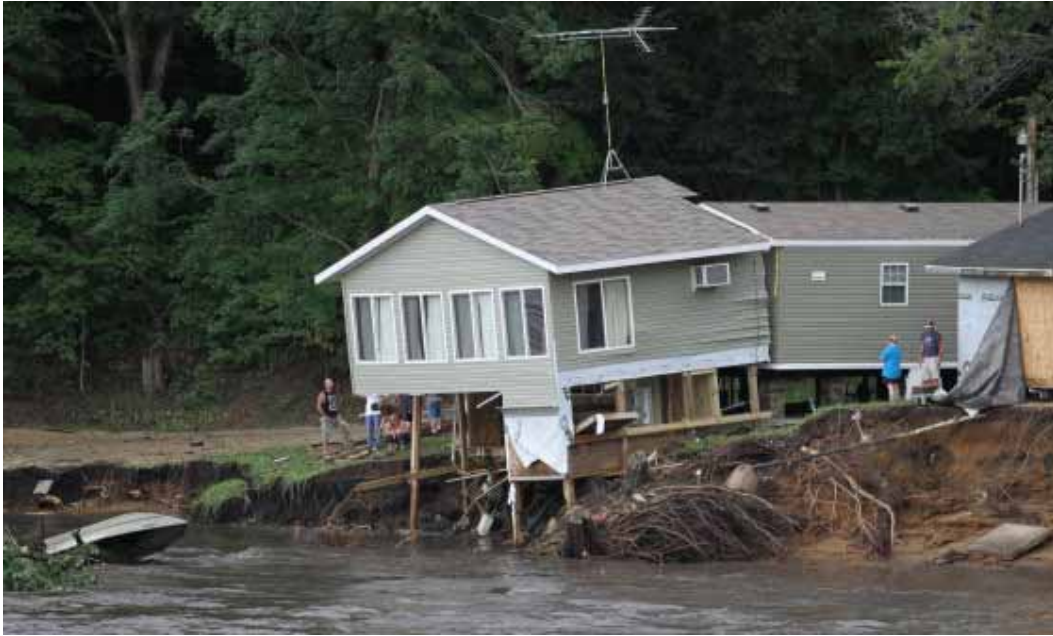
Photo VI-2
Damage and erosion immediately downstream of the dam after the breach
07/24/10
