Re: Report No. 2
FERC Independent Consultants Review Panel
Silver Lake Dam

REPORT NO. 2
FERC INDEPENDENT CONSULTANTS REVIEW PANEL
SILVER LAKE DAM

December, 2003

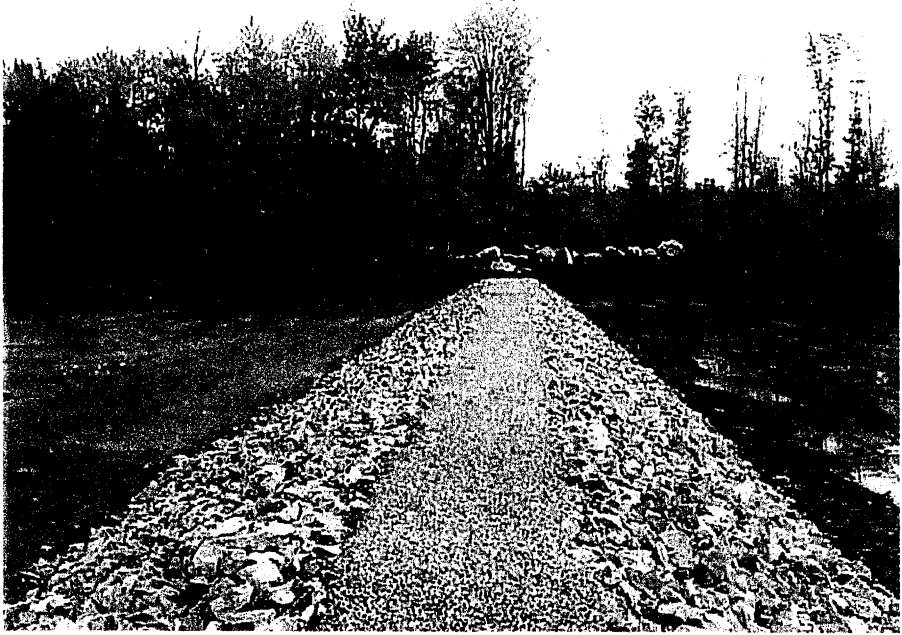
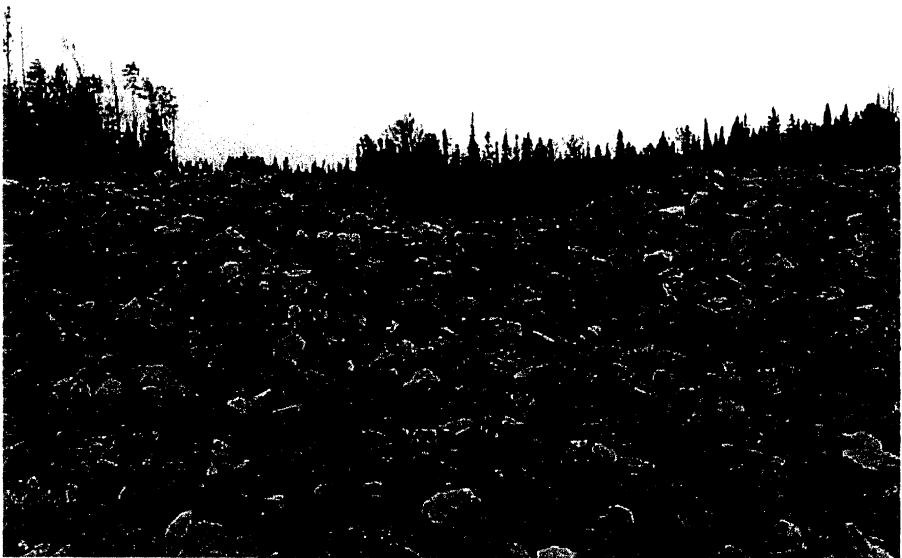
Figure 2.3.3-1 Fuse plug embankment during post-construction inspection

Fuse plug embankment at end of construction, October 8, 2002

Pilot channel across fuse plug embankment, October 8, 2002

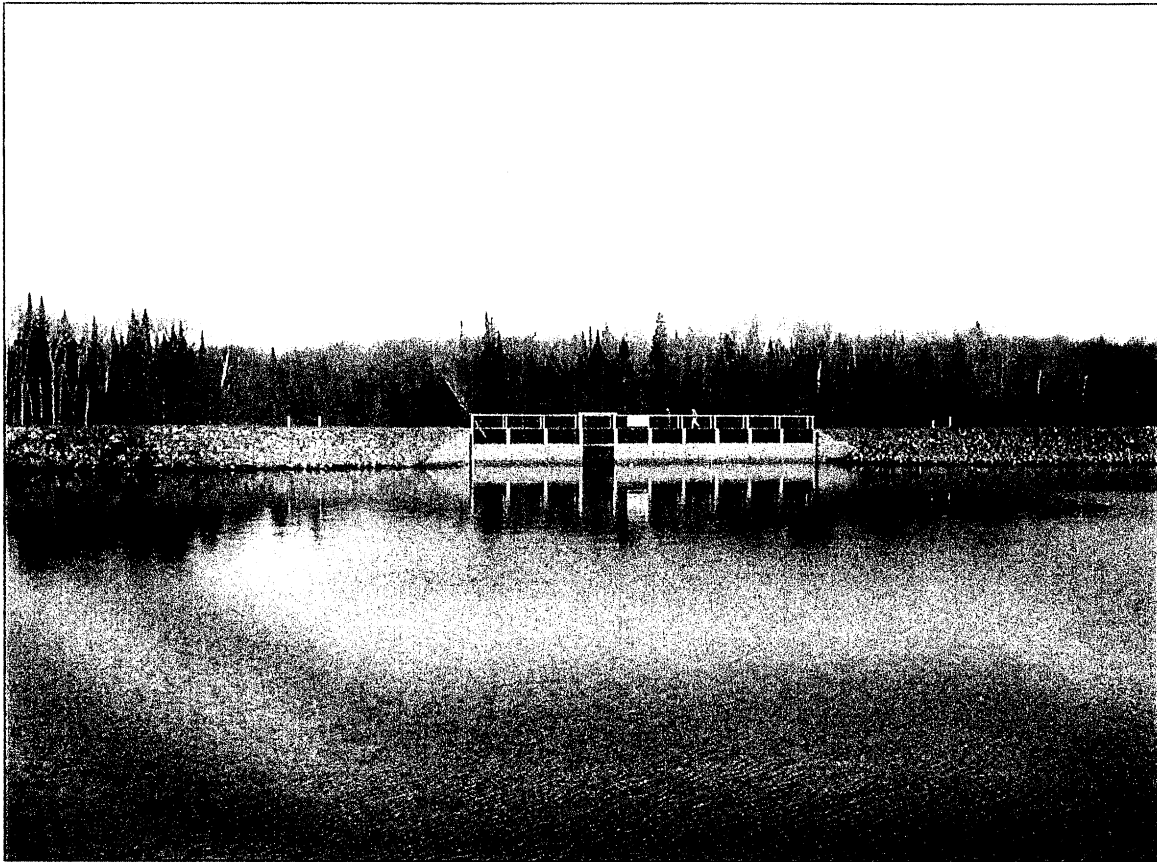
Figure 3.6.2-2 Upstream side of concrete spillway at about 8:30 PM, May 14, 2003

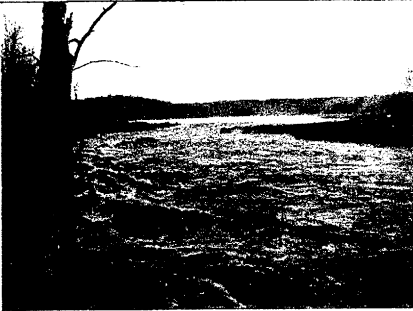
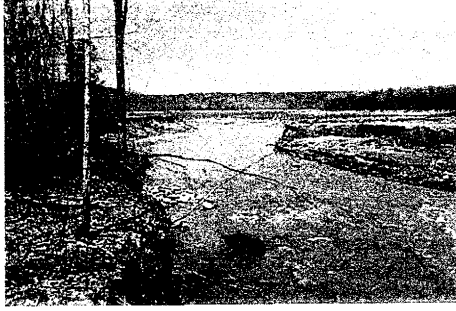
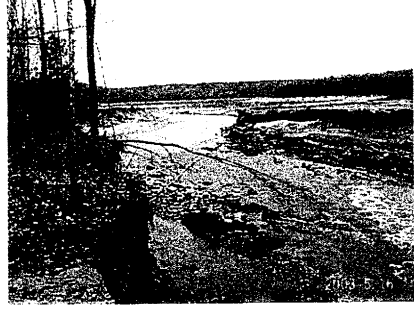
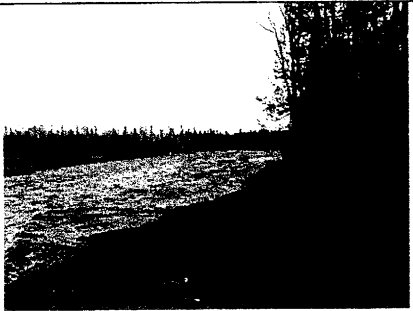
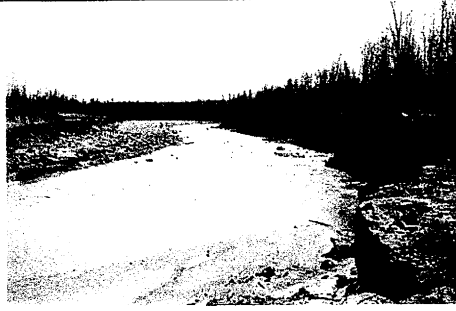
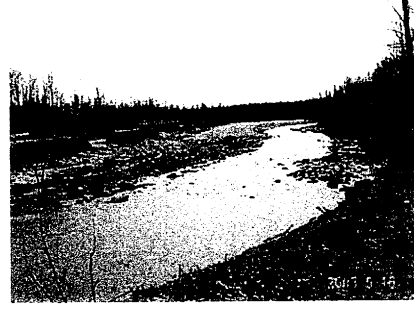
Upstream, October 8, 2002 (during post-construction inspection)	Upstream, May 14, 2003, about 8:30 PM (operator photo)	Upstream, May 15, 2003 (Spicer photo)	Upstream, May 16, 2003 (Evans photo)

Downstream, October 8, 2002 (during post-construction inspection)	Downstream, May 14, 2003, about 8:30 PM (operator photo)	Downstream, May 15, 2003 (Spicer photo)	Downstream, May 16, 2003 (Evans photo)

Figure 3.6.4-1 Photographs upstream and downstream from fuse plug embankment on October 8, 2002 at the end of construction, and on May 14; May 15; and May 16; 2003, showing progressively deepening erosion

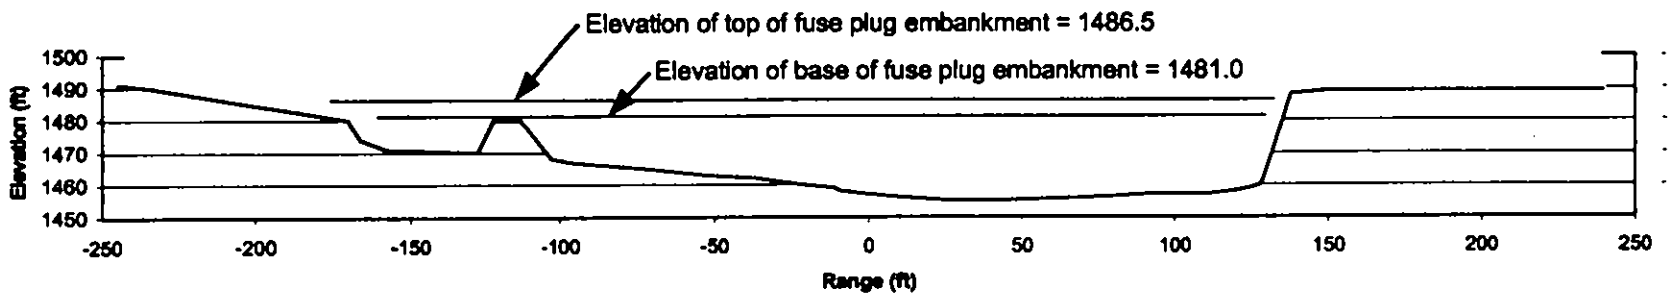
Figure 3.6.4-2 Cross section through eroded channel at STS Station 27+00, near fuse plug axis

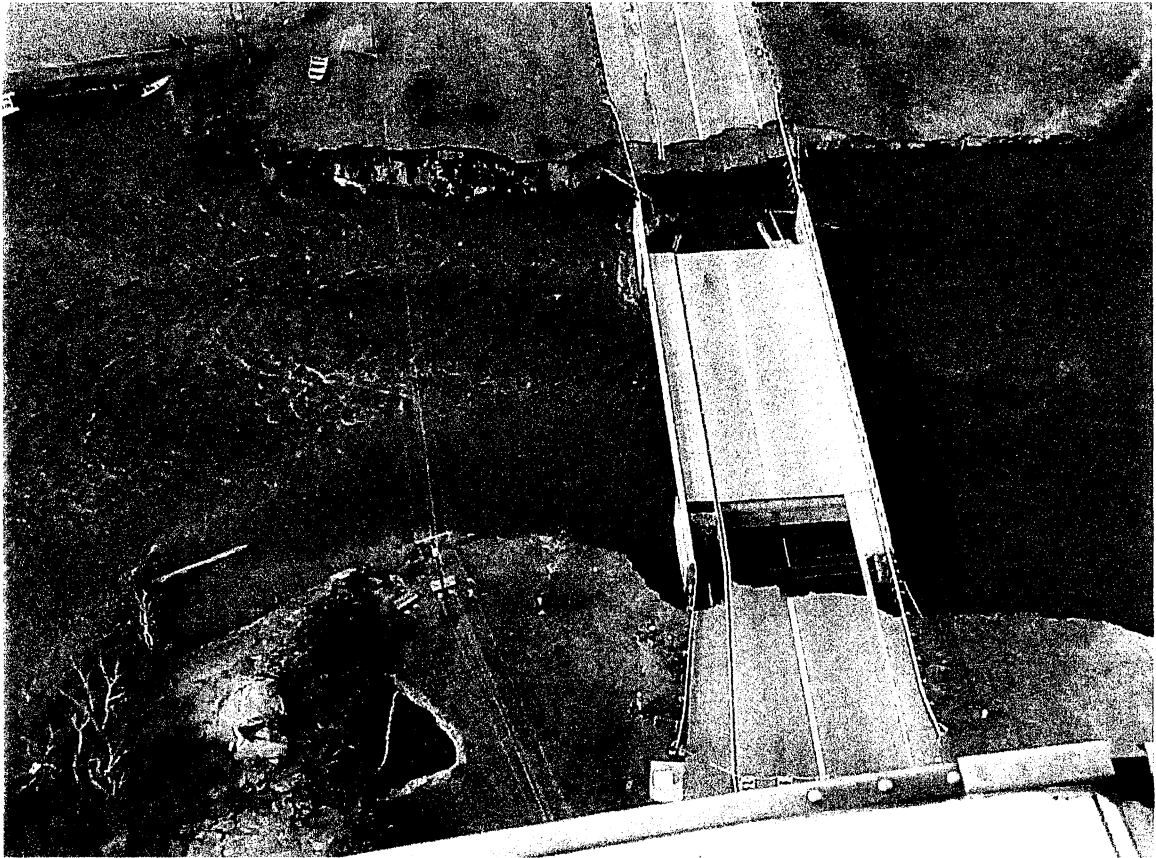
Several railroad and highway bridges suffered damage to foundations or abutments that rendered them unusable. One of the damaged highway bridges is shown in Figure 3.6.5-1. More than 1,700 people were evacuated from an area of about 485 acres (195 ha) in the city of Marquette from 8:45 AM on May 15 through 1:00 PM on May 16.

Figure 3.6.5-1 Bridge at mouth of Dead River after fuse plug breach
